# Preliminary Site Investigation (PSI)

Arumpo Street,  
Renmark

JHN Investments Pty  
Ltd & The Trustee for  
Callop Le Family Trust

# HAZARDOUS MATERIAL SURVEY AND REPORT

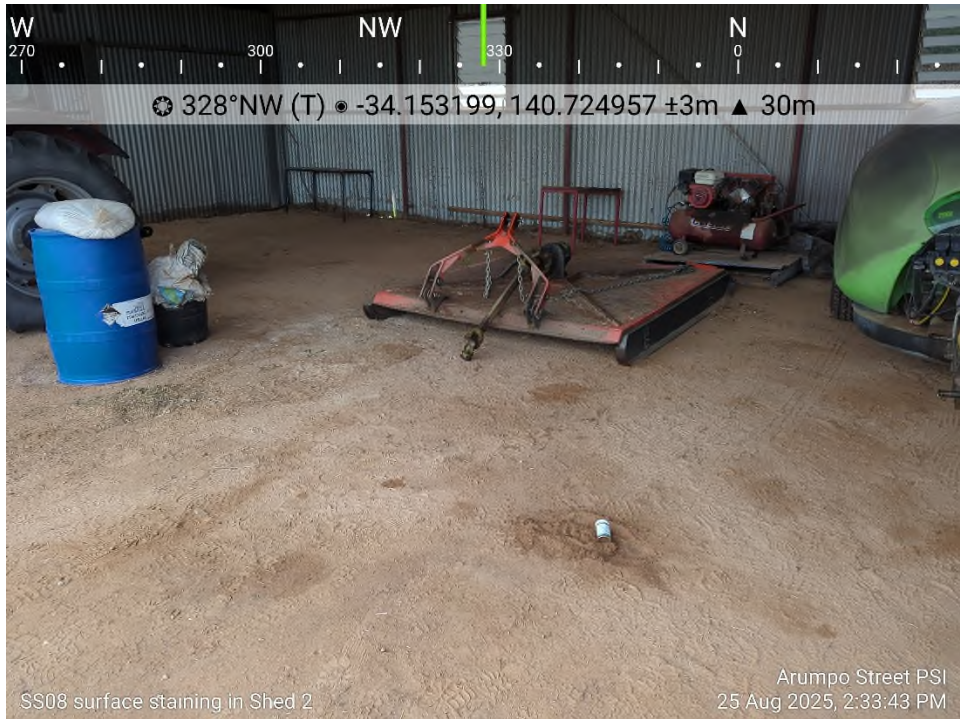
| Photo No. | 5. | |

- Several small patches of light staining with faint hydrocarbon odour were observed in the central area of Shed 2. Stained areas ranged from approximately 0.12 m<sup>2</sup> to 1.5 m<sup>2</sup> but collectively covered an area of ~10 m<sup>2</sup> (Surface Stain Area 1).

| Description: Light staining in Shed 2 with sodium hypochlorite and fertilizer stored | | |

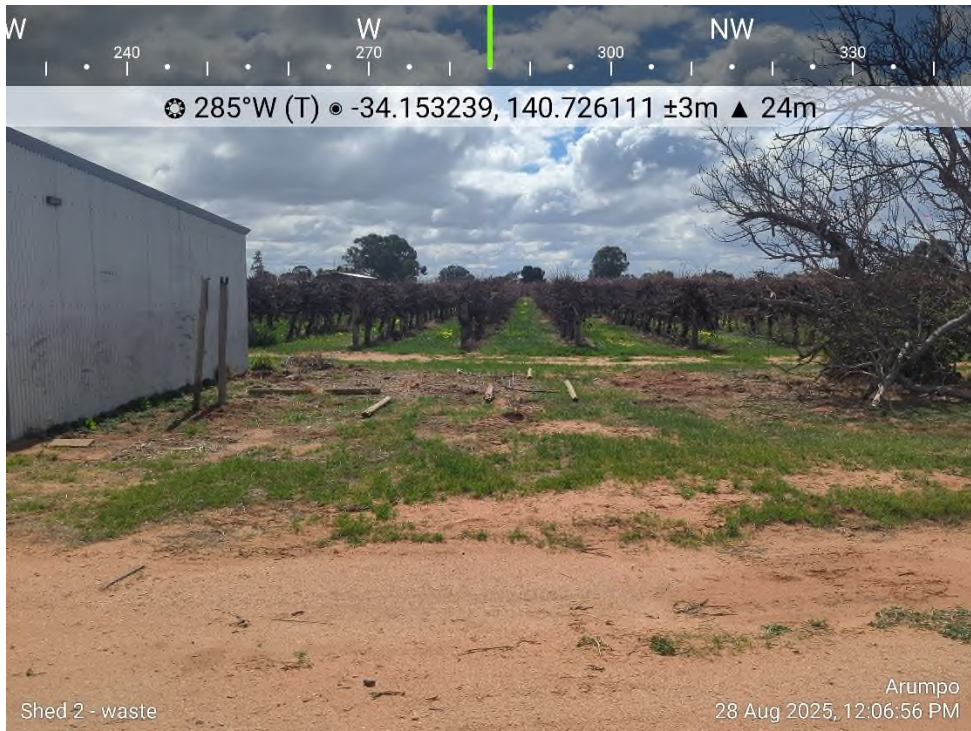
| Photo No. | 6. | |

| Description: Area adjacent to Shed 2 | | |

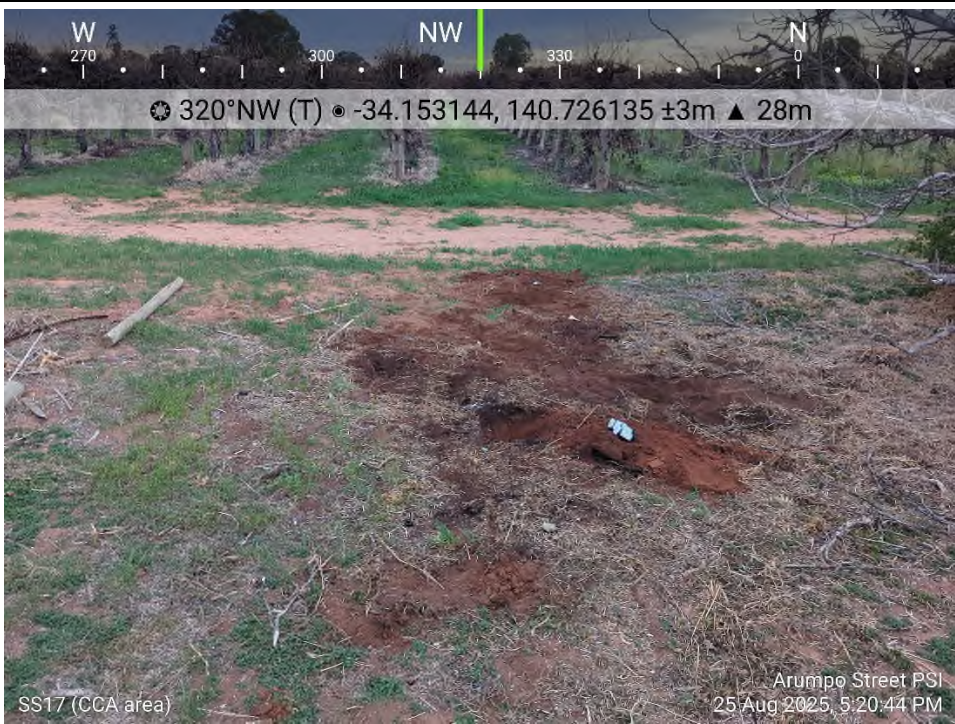
| <b>Photo No.</b> | <b>9.</b> | |

| Description: Hydrocarbon staining near tree in Shed 2 area | | |

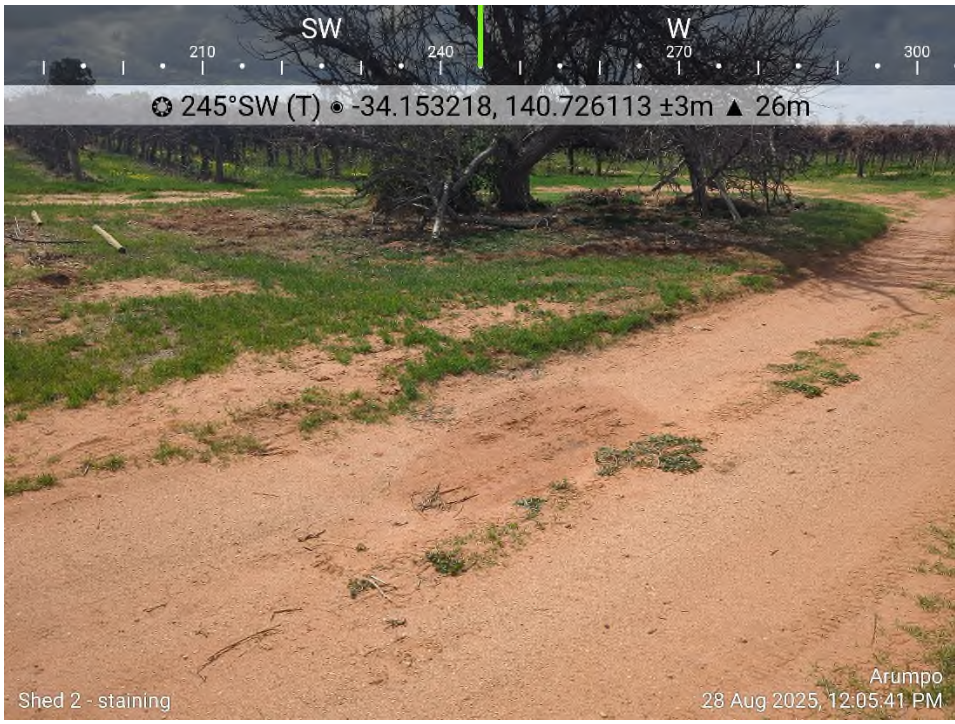
| <b>Photo No.</b> | <b>10.</b> | |

| Description: Hydrocarbon stain in road | | |

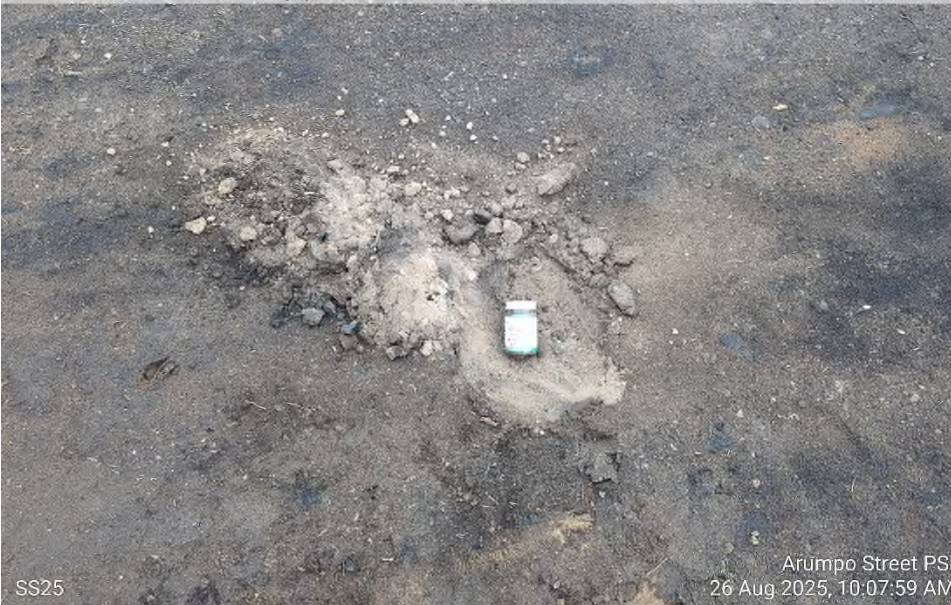
| <b>Photo No.</b> | <b>18.</b> | <div><div><div>W240W270NW300330</div><div>☉ 284°W (T) • -34.153945, 140.728176 ±6m ▲ 28m</div><div></div><div>SS25Arumpo Street PSI26 Aug 2025, 10:07:59 AM</div></div></div> |

| Description: Sample from burn pile in between Shed 4 and Picker's Quarters | | |

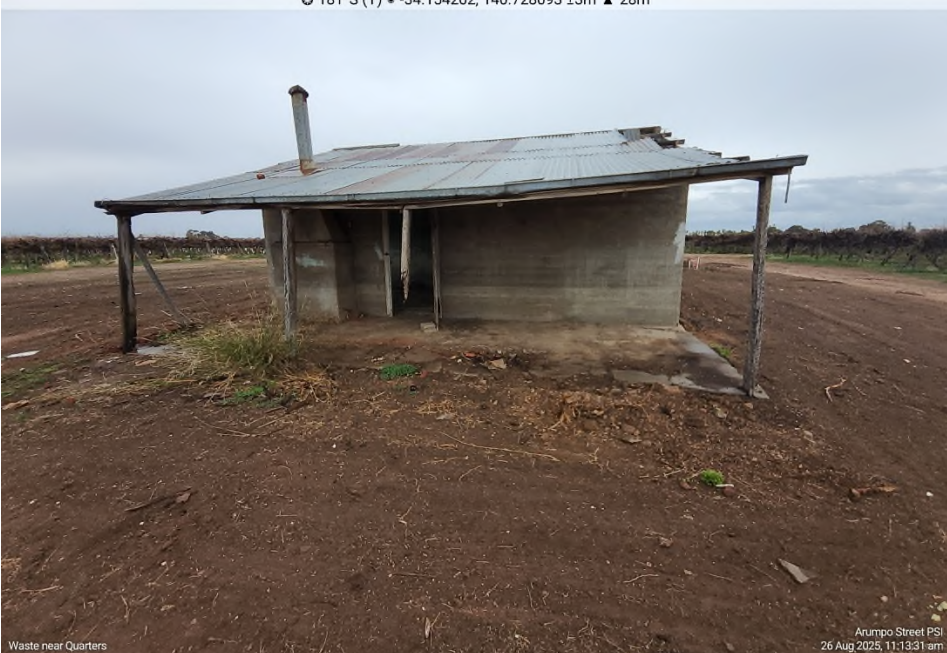
| <b>Photo No.</b> | <b>19.</b> | <div><div>SE150S180SW210240</div><div>181°S (T) • -34.154202, 140.728093 ±3m ▲ 28m</div><div>Waste near QuartersArumpo Street PSI<br/>26 Aug 2025, 11:13:31 am</div></div> |

| Description: Building waste at boundary of Quarters | | |

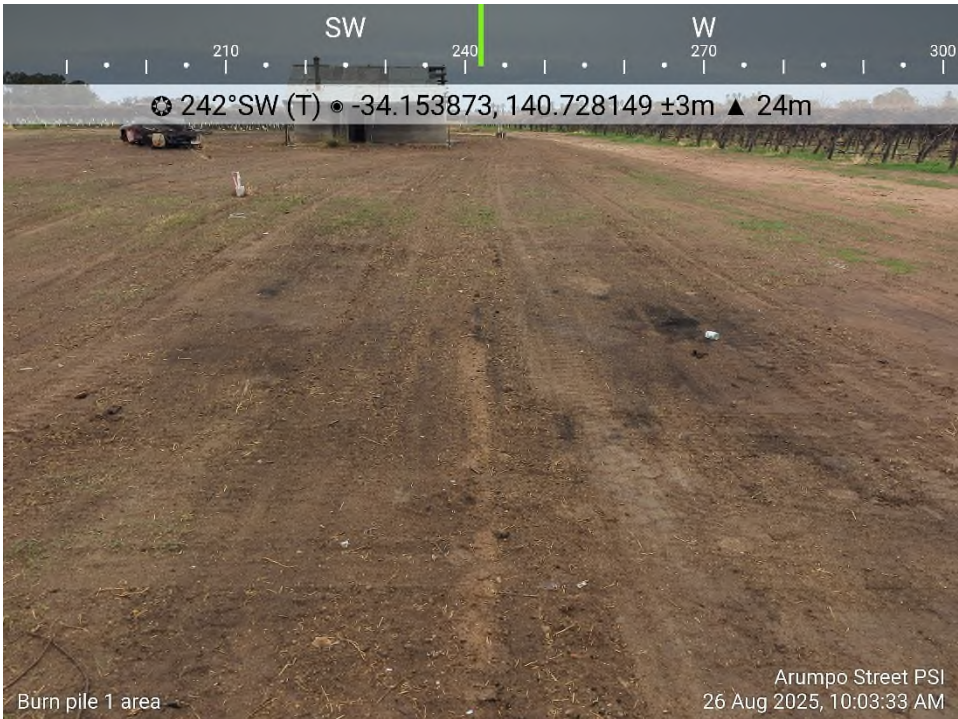
| <b>Photo No.</b> | <b>21.</b> | |

| Description: Ground stained with ash looking towards Quarters | | |

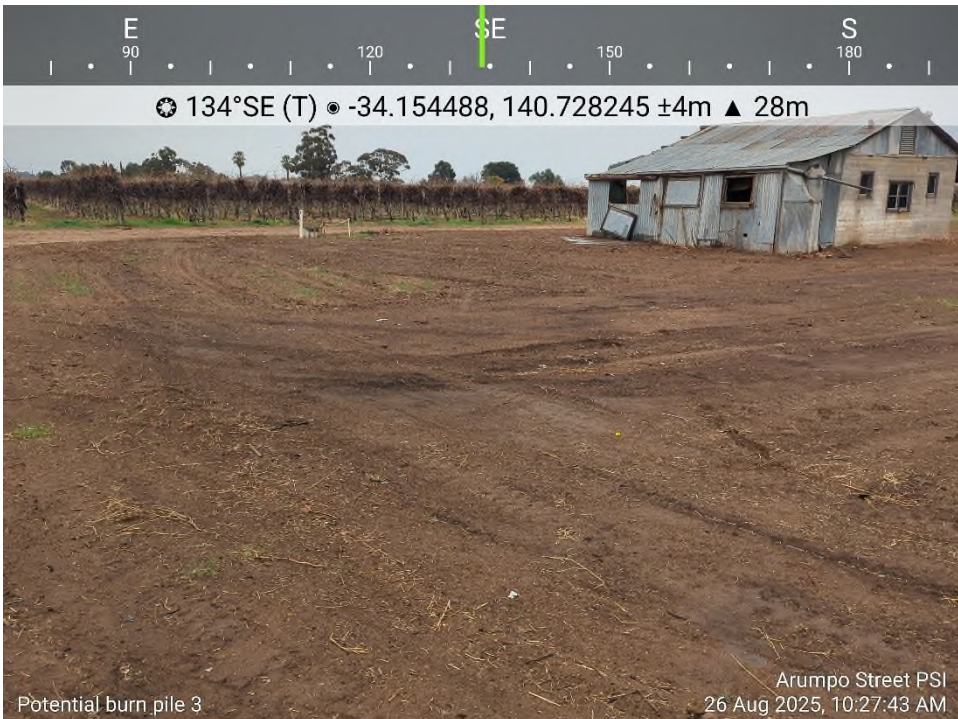
| <b>Photo No.</b> | <b>22.</b> | |

| Description: Waste and ash south east of Pickers Quarters | | |

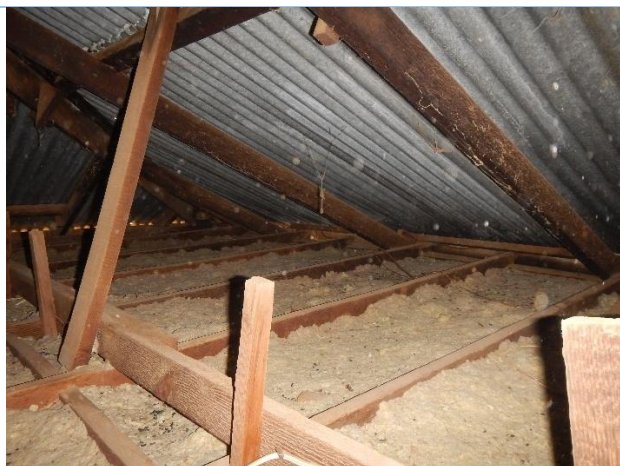
Throughout the main roof space, SMF as insulation loose on ceilings.

*Example: Ceiling insulation over ceilings to main roof of Residence*

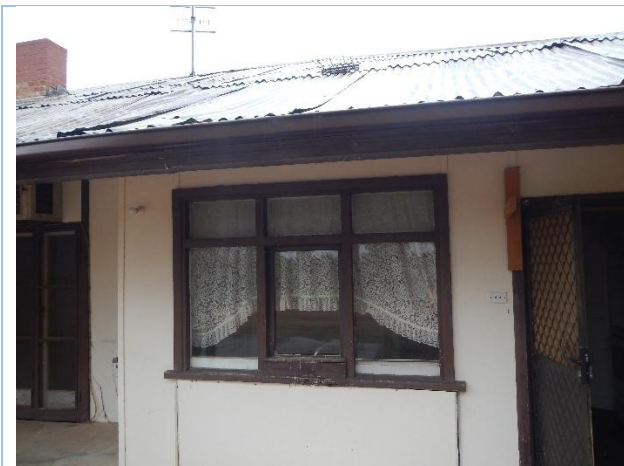
In some locations , for example the internal of the Old Pickers' Quarters, had paint in very poor condition.

*Example: External paint to Residence*

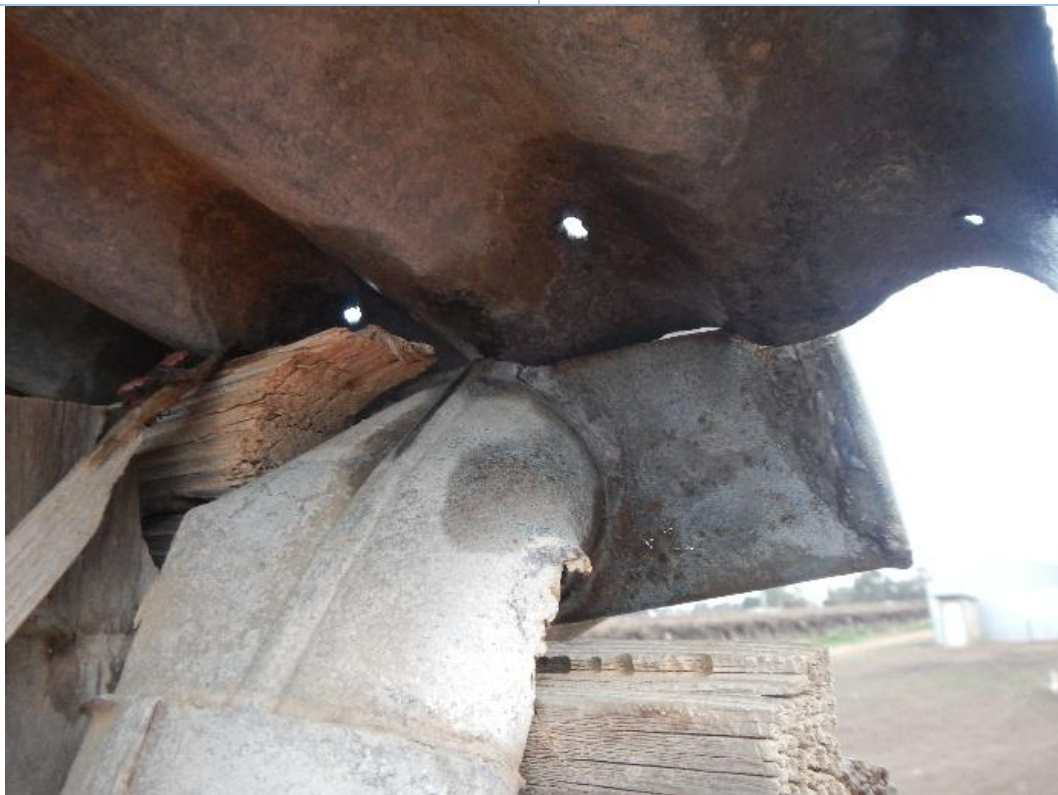
Example: Old Pickers' Quarters, External – solder to gutters/downpipes

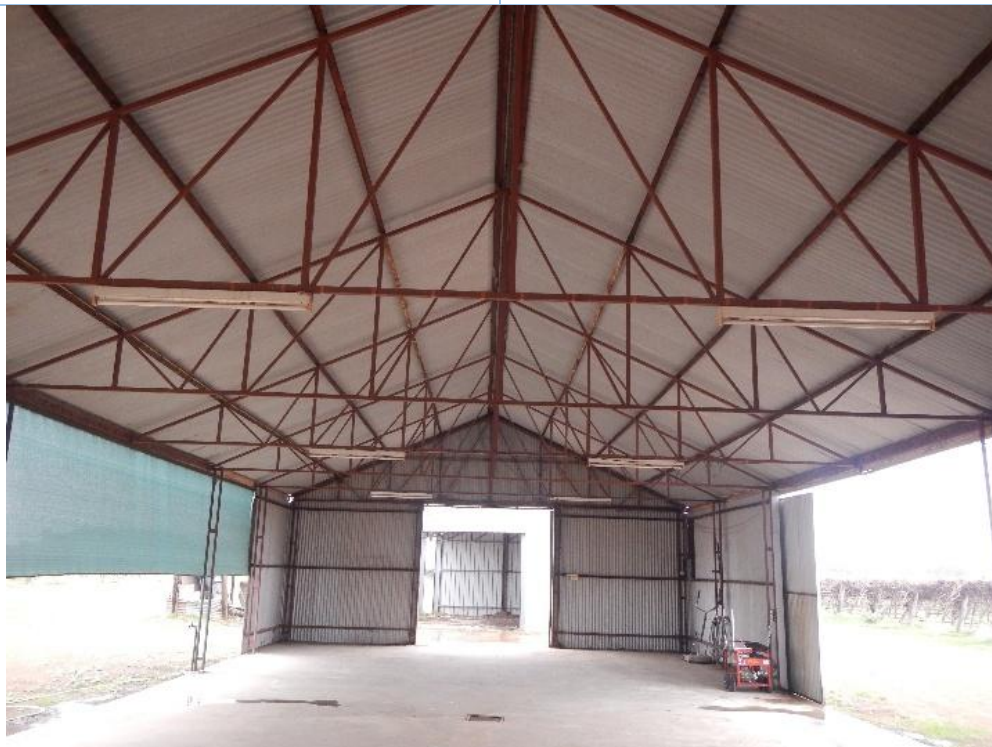
*Example: Fluorescent light fixtures in Shed 3*

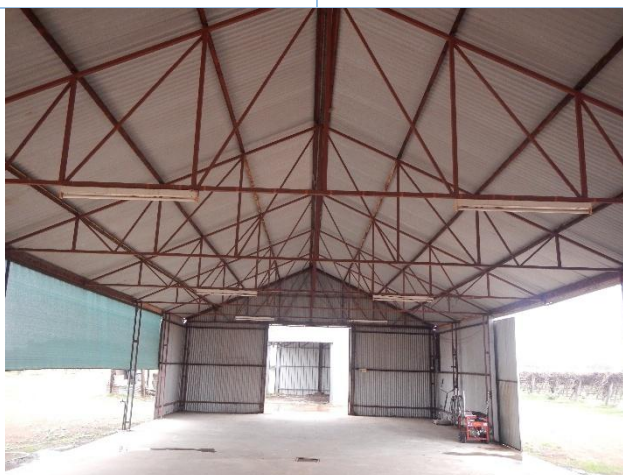
Example: Fluorescent lights x 5 in Shed 3

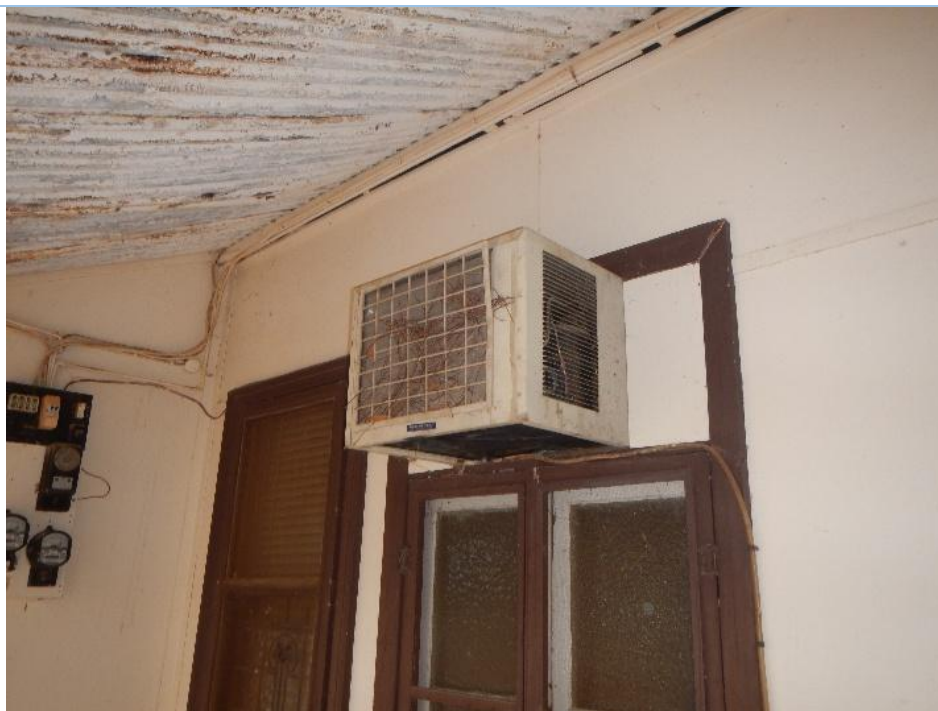
A box air conditioning unit was located above the northern entry doorway to the Residence.

*Example: Residence, installed air conditioning unit*

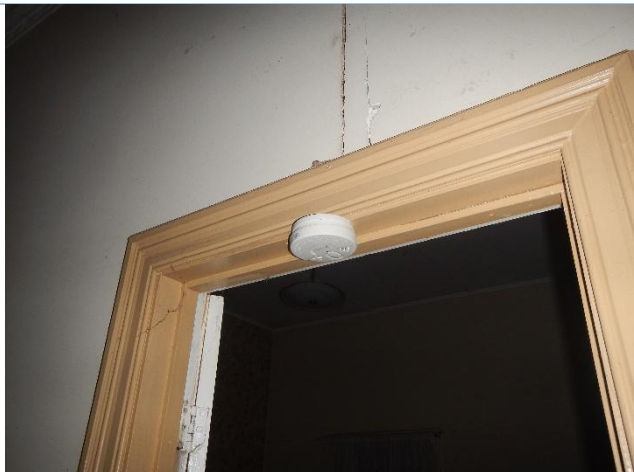
One fire detector was noted located at the Residence, internal, central Livingroom, southwestern doorway during this survey.

Example: Residence, internal, central Livingroom, southwestern doorway

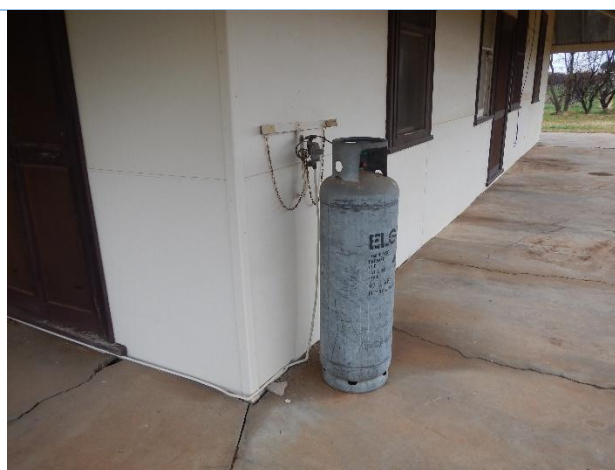
A 45kg propane gas bottle was noted at the southern side of the Residence

Example: Residence, 45kg gas bottle

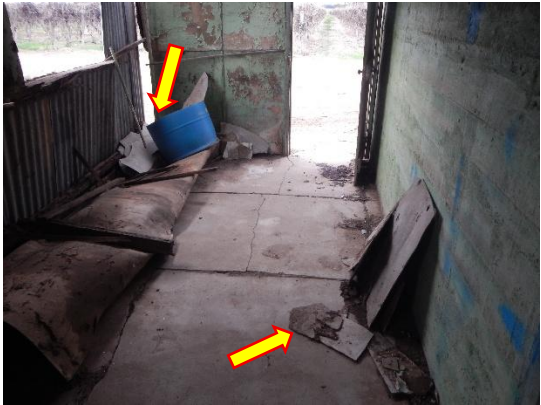
### 21. Main structure floors, lino/vinyl coverings

| Material: | Fibre impregnated tar sheeting |

| Findings: | Poor condition. Non-friable. Not painted.<br>Accessible.<br><br><b>The building is due for demolition.</b><br><b>Recommend remove prior to demolition.</b> |

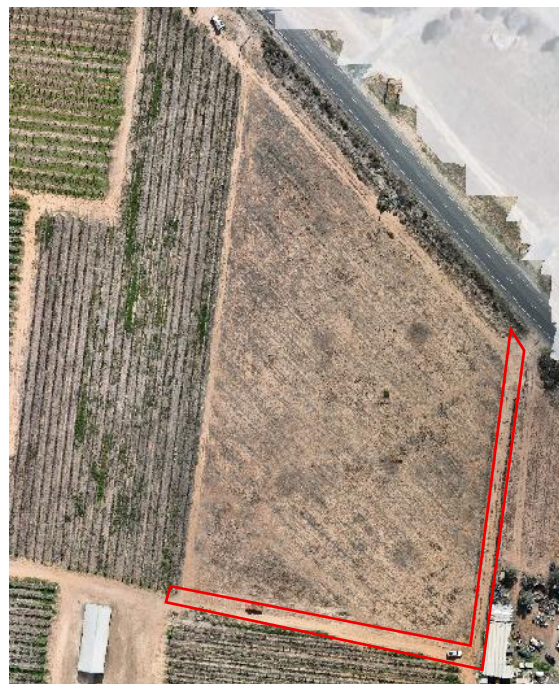
## 24. Five acre division, south and east tracks, debris on surface

| Material: | Fibrous cement fragments |
| Action Rating: | A2 |
