# Arboricultural Impact Assessment and Development Impact Report

Site: 105 Gibson Street, Bowden

Date: Thursday, 19 December 2024

ATS7886-105GibStDIR

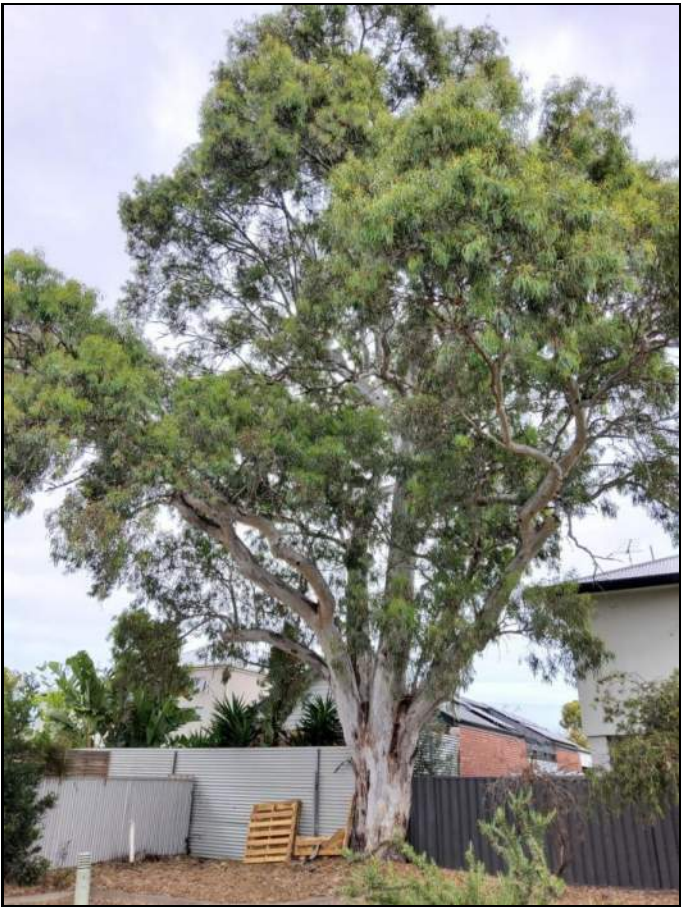
This tree is in good health but has a reduced overall condition due to the historical pruning resulting in increased epicormic growth. There is obvious deadwood within the crown but appears to be typical of the species and its age.

Legislative Status	Significant
This tree has a trunk circumference greater than two metres and is not subject to any exemption from regulation and therefore it is identified as a Significant Tree as defined in the Planning, Development and Infrastructure Act 2016.	
Retention Rating	Moderate
This tree has a Moderate Retention Rating and could be considered for retention if it can be protected. Tree damaging activity, including removal, may be approved if it is shown that reasonable alternative design solutions are not available.	
Development Impact	Low
The identified encroachment is greater than 10% of the TPZ area however there are factors that indicate the proposed development will not negatively impact tree viability.	
Action	Protect Root Zone
Protect the root zone and crown in accordance with the recommendations and principles of AS4970-2009 Protection of trees on development sites.

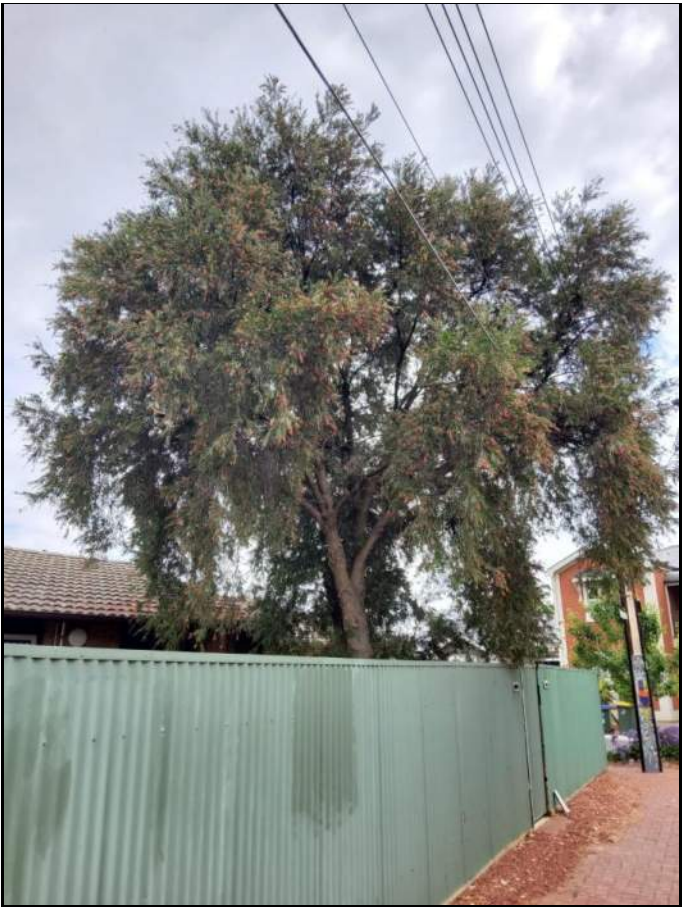
Weeping Bottlebrush

The health and structure of this tree indicate it is in good overall condition and has adapted to its local environment. The dimensions of this tree have been estimated due to access restrictions.

Legislative Status	Exempt
This tree is within 3 metres of a dwelling or inground swimming pool and is therefore exempt from control under the Planning, Development and Infrastructure Act 2016.	
Retention Rating	Moderate
This tree has a Moderate Retention Rating and could be considered for retention if it can be protected. Tree damaging activity, including removal, may be approved if it is shown that reasonable alternative design solutions are not available.	
Development Impact	Conflicted
This tree is in the building envelope and the encroachment covers the entire TPZ area, the SRZ and the trunk. This tree cannot be successfully retained in this proposal.	
Action	Removal Required
Tree removal is required to facilitate the proposed development.

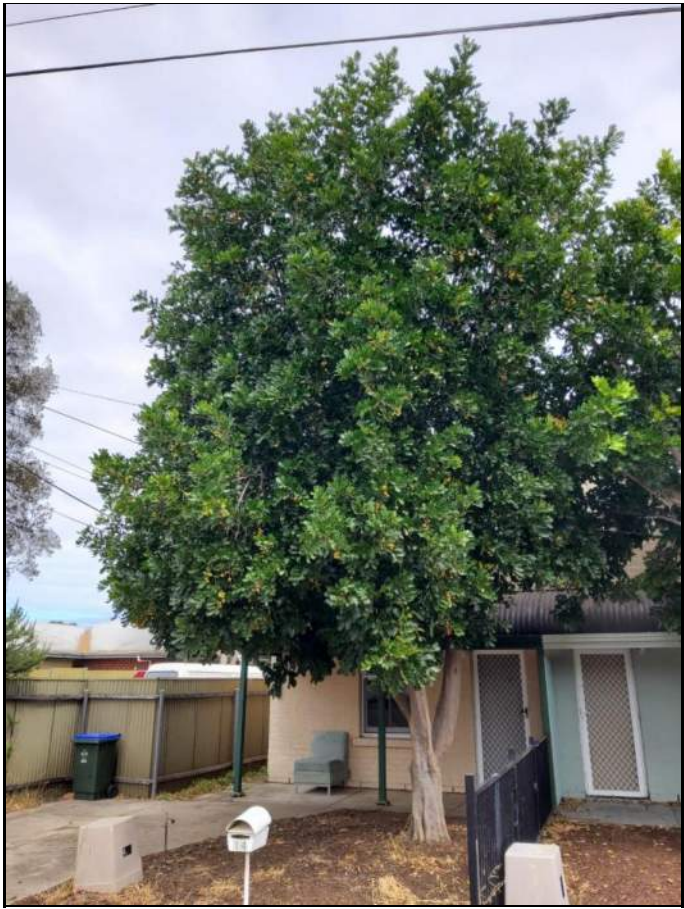
Tuckeroo

The health and structure of this tree indicate it is in good overall condition and has adapted to its local environment. There is evidence of early stage included bark, however this is not significant or impacting the structural rating for this tree.

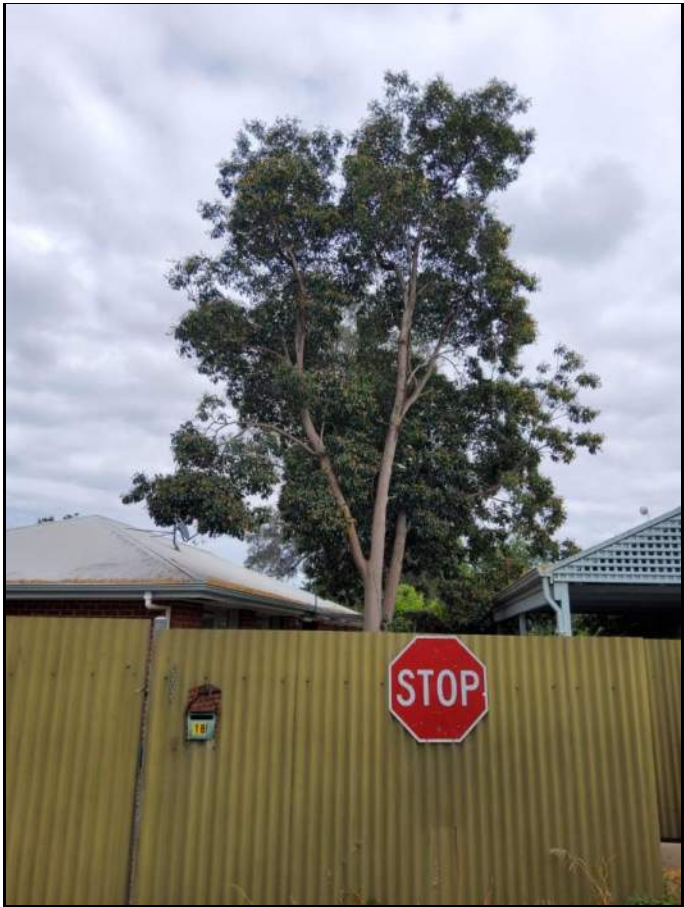
The health and structure of this tree indicate it is in good overall condition and has adapted to its local environment. This trees dimensions have been estimated due to access restrictions.

Legislative Status	Exempt
This tree is within 3 metres of a dwelling or inground swimming pool and is therefore exempt from control under the Planning, Development and Infrastructure Act 2016.	
Retention Rating	Moderate
This tree has a Moderate Retention Rating and could be considered for retention if it can be protected. Tree damaging activity, including removal, may be approved if it is shown that reasonable alternative design solutions are not available.	
Development Impact	Conflicted
This tree is in the building envelope and the encroachment covers the entire TPZ area, the SRZ and the trunk. This tree cannot be successfully retained in this proposal.	
Action	Removal Required
Tree removal is required to facilitate the proposed development.

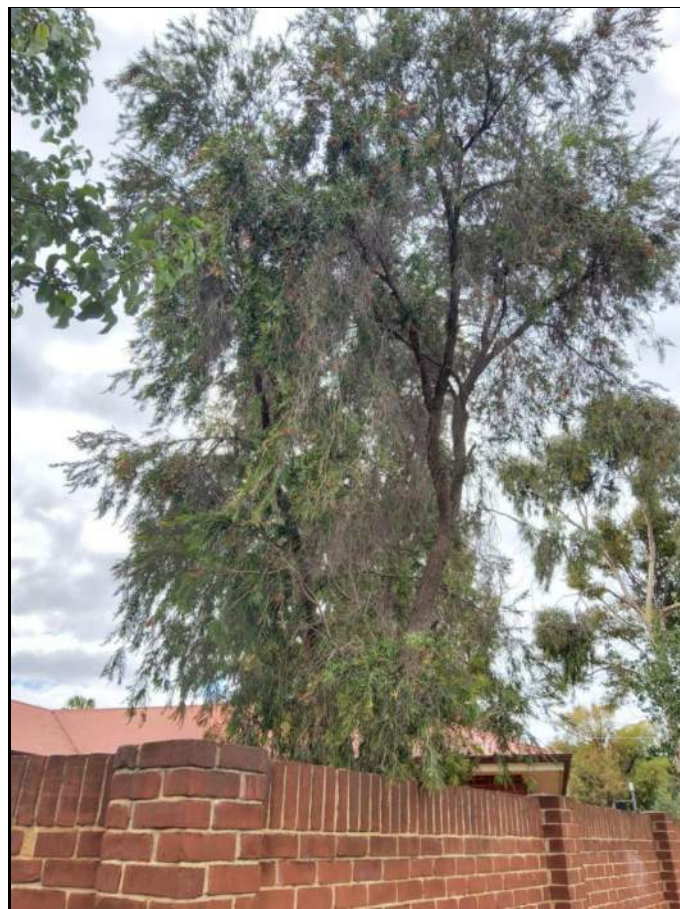
## Weeping Bottlebrush

The health and structure of this tree indicate it is in good overall condition and has adapted to its local environment. There is evidence of early stage included bark, however this is not significant or impacting the structural rating for this tree. The dimensions of this tree have been estimated due to access restrictions.

<b>Legislative Status</b>	<b>Regulated</b>
This tree has a trunk circumference greater than one metre but less than two metres and is not subject to any exemption from regulation and therefore it is identified as a Regulated Tree as defined in the Planning, Development and Infrastructure Act 2016.	
<b>Retention Rating</b>	<b>Moderate</b>
This tree has a Moderate Retention Rating and could be considered for retention if it can be protected. Tree damaging activity, including removal, may be approved if it is shown that reasonable alternative design solutions are not available.	
<b>Development Impact</b>	<b>Conflicted</b>
This tree is in the building envelope and the encroachment covers the entire TPZ area, the SRZ and the trunk. This tree cannot be successfully retained in this proposal.	
<b>Action</b>	<b>Removal Required</b>
Tree removal is required to facilitate the proposed development.

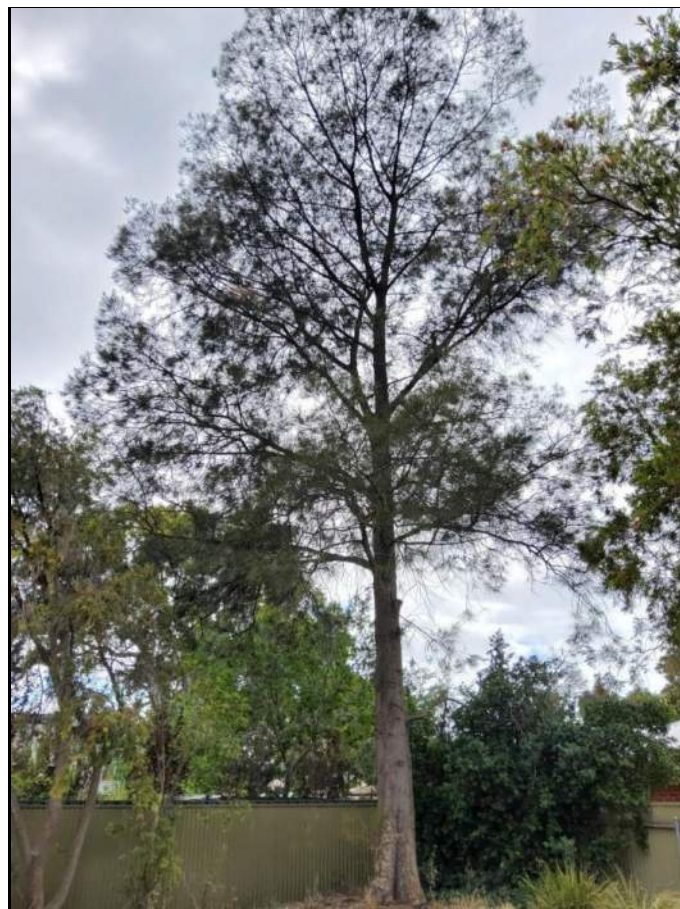
## River She Oak

The health and structure of this tree indicate it is in good overall condition and has adapted to its local environment. There is obvious deadwood within the crown, however this is within normal levels and not an indicator of reduced health.

<b>Legislative Status</b>	<b>Regulated</b>
This tree has a trunk circumference greater than one metre but less than two metres and is not subject to any exemption from regulation and therefore it is identified as a Regulated Tree as defined in the Planning, Development and Infrastructure Act 2016.	
<b>Retention Rating</b>	<b>Moderate</b>
This tree has a Moderate Retention Rating and could be considered for retention if it can be protected. Tree damaging activity, including removal, may be approved if it is shown that reasonable alternative design solutions are not available.	
<b>Development Impact</b>	<b>Conflicted</b>
This tree is in the building envelope and the encroachment covers the entire TPZ area, the SRZ and the trunk. This tree cannot be successfully retained in this proposal.	
<b>Action</b>	<b>Removal Required</b>
Tree removal is required to facilitate the proposed development.

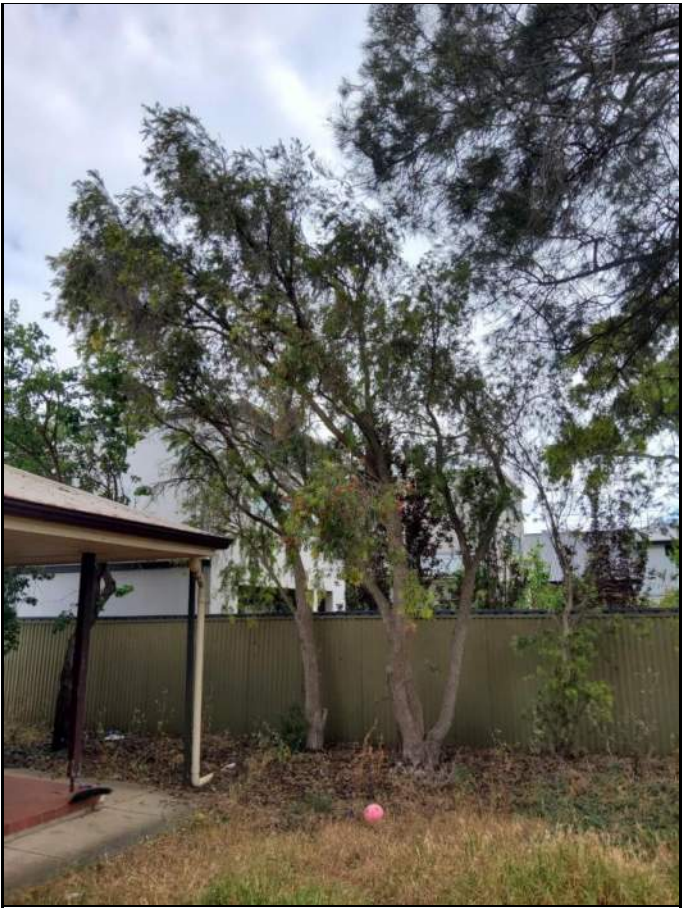
Weeping Bottlebrush

This tree is considered to be in fair overall condition due to the presence of a moderate level of decay and a currently stable included bark union in the primary trunk division.

Legislative Status	Exempt
This tree is within 3 metres of a dwelling or inground swimming pool and is therefore exempt from control under the Planning, Development and Infrastructure Act 2016.	
Retention Rating	Low
This tree has a Low Retention Rating and should not form a material constraint to the redevelopment of this site. Tree damaging activity, including removal, is likely to be approved as part of an otherwise reasonable development.	
Development Impact	Conflicted
This tree is in the building envelope and the encroachment covers the entire TPZ area, the SRZ and the trunk. This tree cannot be successfully retained in this proposal.	
Action	Removal Required
Tree removal is required to facilitate the proposed development.

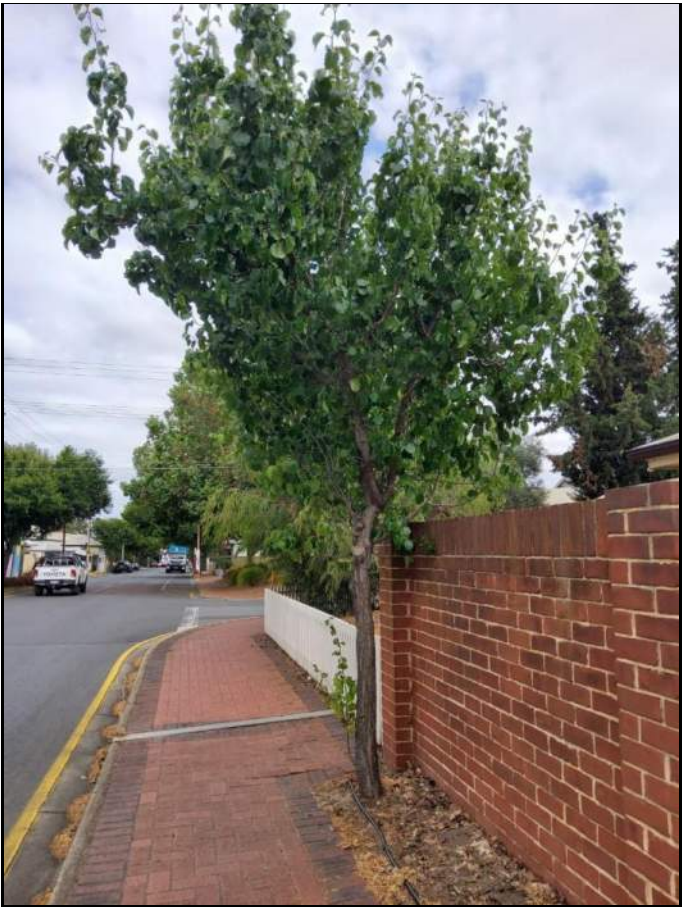
Callery Pear

The health and structure of this tree indicate it is in good overall condition and has adapted to its local environment.

Legislative Status	Unregulated
This tree does not achieve a regulated trunk circumference and therefore is not regulated by the Planning, Development and Infrastructure Act 2016.	
Retention Rating	Low
This tree has a Low Retention Rating and should not form a material constraint to the redevelopment of this site. Tree damaging activity, including removal, is likely to be approved as part of an otherwise reasonable development.	
Development Impact	Conflicted
This tree is in the building envelope and the encroachment covers the entire TPZ area, the SRZ and the trunk. This tree cannot be successfully retained in this proposal.	
Action	Removal Required
Tree removal is required to facilitate the proposed development.

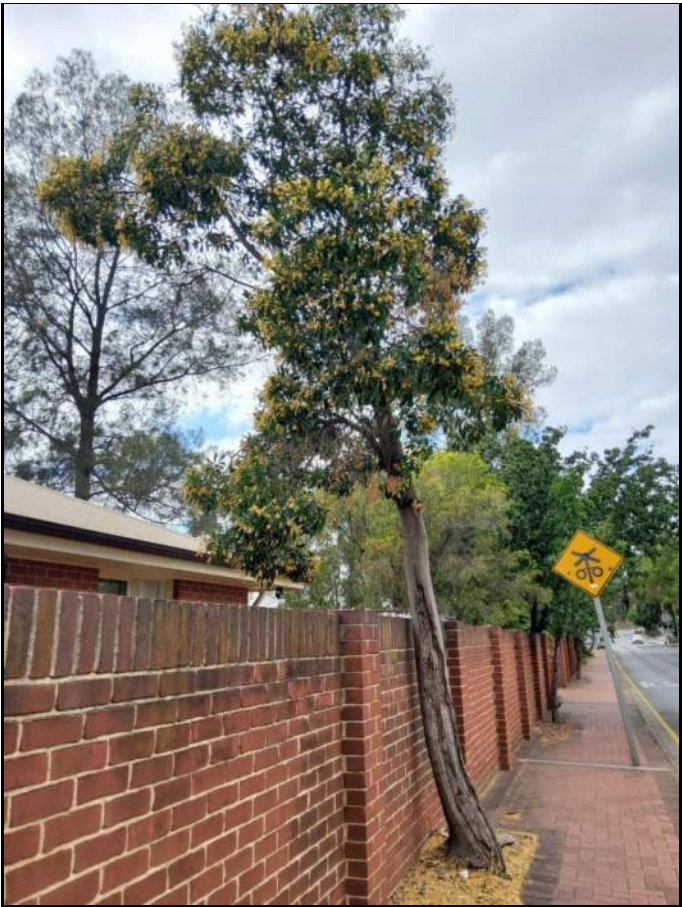
Native Frangipani

This tree is considered to be in poor overall condition due to the compromising level of decay in the primary trunk and the modest dieback within the crown.

Legislative Status	Unregulated
This tree does not achieve a regulated trunk circumference and therefore is not regulated by the Planning, Development and Infrastructure Act 2016.	
Retention Rating	Low
This tree has a Low Retention Rating and should not form a material constraint to the redevelopment of this site. Tree damaging activity, including removal, is likely to be approved as part of an otherwise reasonable development.	
Development Impact	Conflicted
This tree is in the building envelope and the encroachment covers the entire TPZ area, the SRZ and the trunk. This tree cannot be successfully retained in this proposal.	
Action	Removal Required
Tree removal is required to facilitate the proposed development.

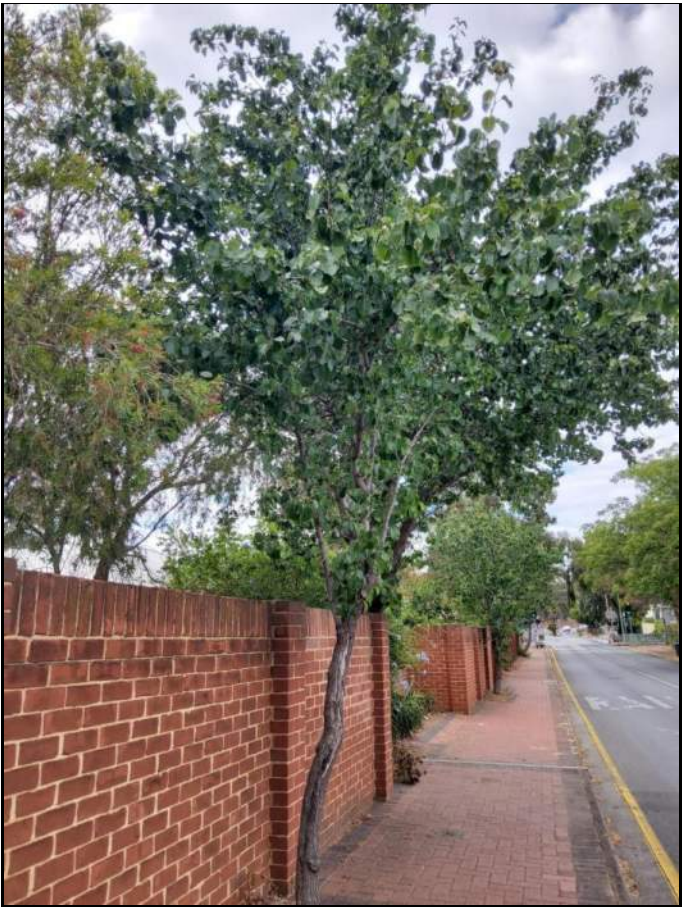
Callery Pear

This tree is considered to be in fair overall condition. There is a moderate level of decay within the primary trunk and/or branches, however the tree is otherwise healthy and appears to be self optimising.

Legislative Status	Unregulated
This tree does not achieve a regulated trunk circumference and therefore is not regulated by the Planning, Development and Infrastructure Act 2016.	
Retention Rating	Low
This tree has a Low Retention Rating and should not form a material constraint to the redevelopment of this site. Tree damaging activity, including removal, is likely to be approved as part of an otherwise reasonable development.	
Development Impact	Conflicted
This tree is in the building envelope and the encroachment covers the entire TPZ area, the SRZ and the trunk. This tree cannot be successfully retained in this proposal.	
Action	Removal Required
Tree removal is required to facilitate the proposed development.

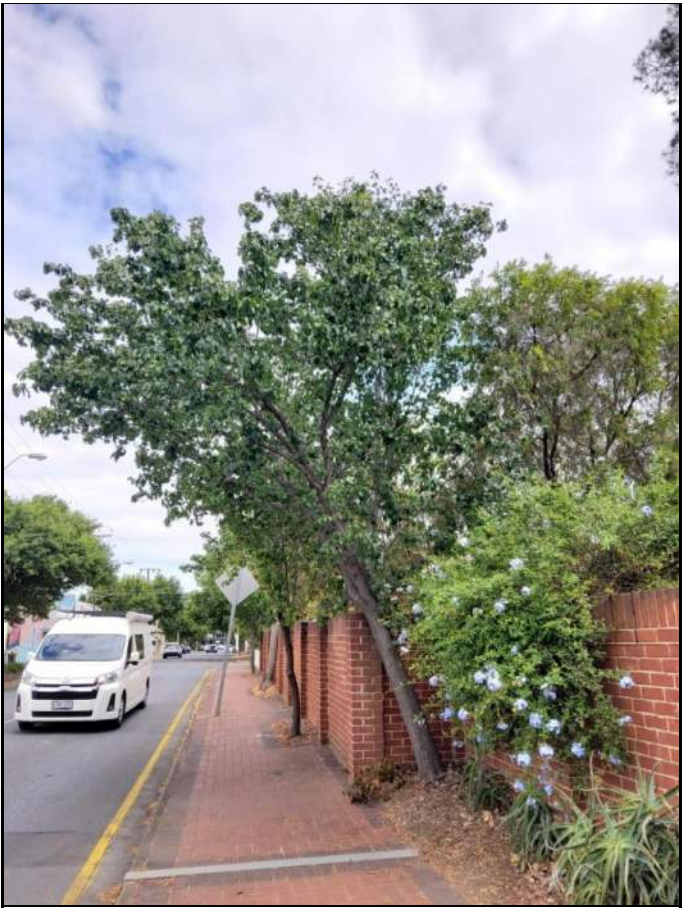
Callery Pear

This tree has increased epicormic growth on the scaffold branches but is otherwise in good health.

Legislative Status	Unregulated
This tree does not achieve a regulated trunk circumference and therefore is not regulated by the Planning, Development and Infrastructure Act 2016.	
Retention Rating	Low
This tree has a Low Retention Rating and should not form a material constraint to the redevelopment of this site. Tree damaging activity, including removal, is likely to be approved as part of an otherwise reasonable development.	
Development Impact	Conflicted
This tree is in the building envelope and the encroachment covers the entire TPZ area, the SRZ and the trunk. This tree cannot be successfully retained in this proposal.	
Action	Removal Required
Tree removal is required to facilitate the proposed development.

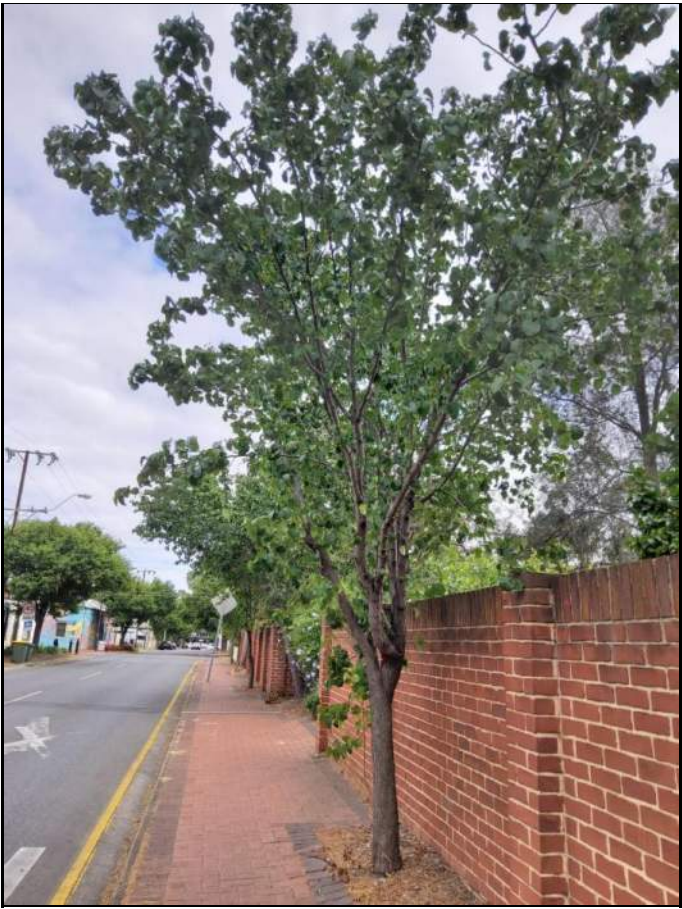
Callery Pear

This tree has increased epicormic growth on the scaffold branches but is otherwise in good health.

Legislative Status	Unregulated
This tree does not achieve a regulated trunk circumference and therefore is not regulated by the Planning, Development and Infrastructure Act 2016.	
Retention Rating	Low
This tree has a Low Retention Rating and should not form a material constraint to the redevelopment of this site. Tree damaging activity, including removal, is likely to be approved as part of an otherwise reasonable development.	
Development Impact	Conflicted
This tree is in the building envelope and the encroachment covers the entire TPZ area, the SRZ and the trunk. This tree cannot be successfully retained in this proposal.	
Action	Removal Required
Tree removal is required to facilitate the proposed development.

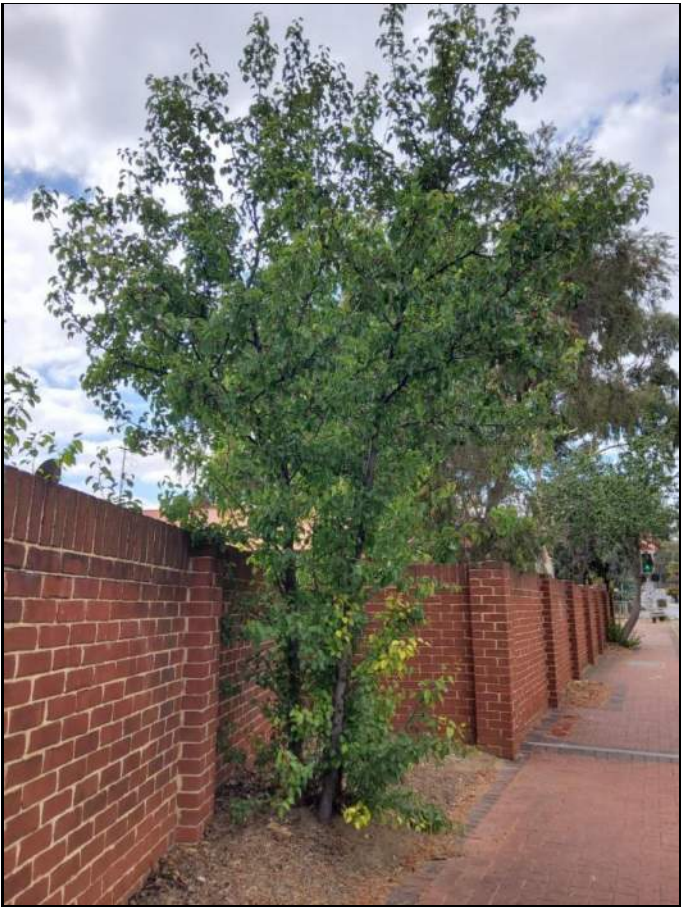
Callery Pear

This tree is considered to be in poor overall condition due to the lopping of the crown and poor attachment of the resultant epicormic growth. This tree appears to have been previously removed and is regrowth from a buried stump.

Legislative Status	Unregulated
This tree does not achieve a regulated trunk circumference and therefore is not regulated by the Planning, Development and Infrastructure Act 2016.	
Retention Rating	Low
This tree has a Low Retention Rating and should not form a material constraint to the redevelopment of this site. Tree damaging activity, including removal, is likely to be approved as part of an otherwise reasonable development.	
Development Impact	Conflicted
This tree is in the building envelope and the encroachment covers the entire TPZ area, the SRZ and the trunk. This tree cannot be successfully retained in this proposal.	
Action	Removal Required
Tree removal is required to facilitate the proposed development.

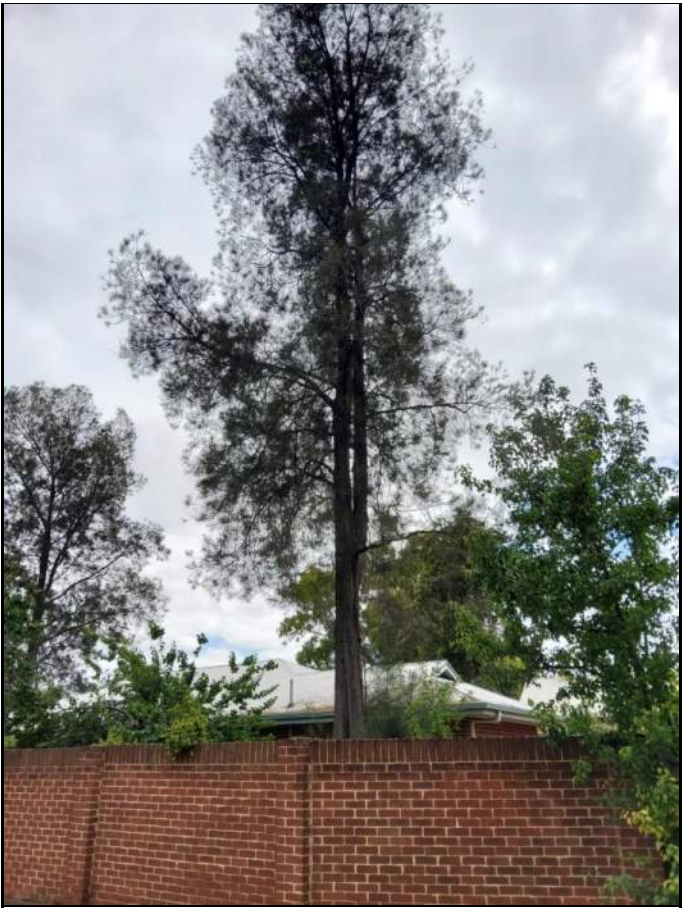
River She Oak

The health and structure of this tree indicate it is in good overall condition and has adapted to its local environment. There is obvious deadwood within the crown, however this is within normal levels and not an indicator of reduced health.

Legislative Status	Exempt
This tree is within 3 metres of a dwelling or inground swimming pool and is therefore exempt from control under the Planning, Development and Infrastructure Act 2016.	
Retention Rating	Moderate
This tree has a Moderate Retention Rating and could be considered for retention if it can be protected. Tree damaging activity, including removal, may be approved if it is shown that reasonable alternative design solutions are not available.	
Development Impact	Conflicted
This tree is in the building envelope and the encroachment covers the entire TPZ area, the SRZ and the trunk. This tree cannot be successfully retained in this proposal.	
Action	Removal Required
Tree removal is required to facilitate the proposed development.

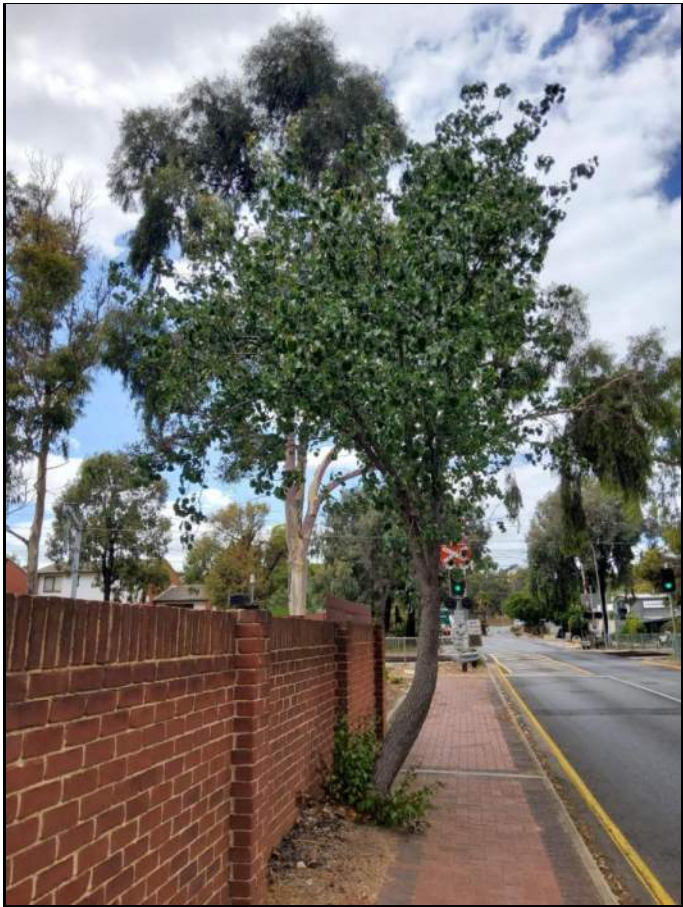
Callery Pear

The health and structure of this tree indicate it is in good overall condition. There is a slight increase in the level of epicormic growth within the crown but this is not at a level that would affect the overall condition rating.

Legislative Status	Unregulated
This tree does not achieve a regulated trunk circumference and therefore is not regulated by the Planning, Development and Infrastructure Act 2016.	
Retention Rating	Low
This tree has a Low Retention Rating and should not form a material constraint to the redevelopment of this site. Tree damaging activity, including removal, is likely to be approved as part of an otherwise reasonable development.	
Development Impact	Conflicted
This tree is in the building envelope and the encroachment covers the entire TPZ area, the SRZ and the trunk. This tree cannot be successfully retained in this proposal.	
Action	Removal Required
Tree removal is required to facilitate the proposed development.

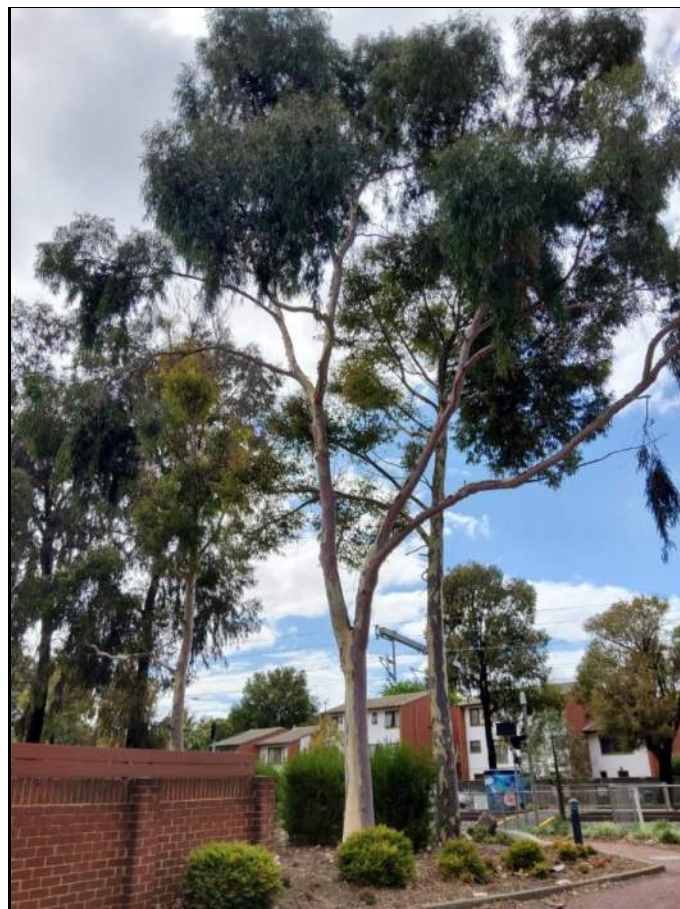
## Northern Spotted Gum

The health and structure of this tree indicate it is in good overall condition and has adapted to its local environment.

<b>Legislative Status</b>	<b>Regulated</b>
This tree has a trunk circumference greater than one metre but less than two metres and is not subject to any exemption from regulation and therefore it is identified as a Regulated Tree as defined in the Planning, Development and Infrastructure Act 2016.	
<b>Retention Rating</b>	<b>Moderate</b>
This tree has a Moderate Retention Rating and could be considered for retention if it can be protected. Tree damaging activity, including removal, may be approved if it is shown that reasonable alternative design solutions are not available.	
<b>Development Impact</b>	<b>Low</b>
The identified encroachment is less than 10% of the TPZ area and not expected to impact tree viability.	
<b>Action</b>	<b>Protect Root Zone</b>
Protect the root zone and crown in accordance with the recommendations and principles of AS4970-2009 Protection of trees on development sites.

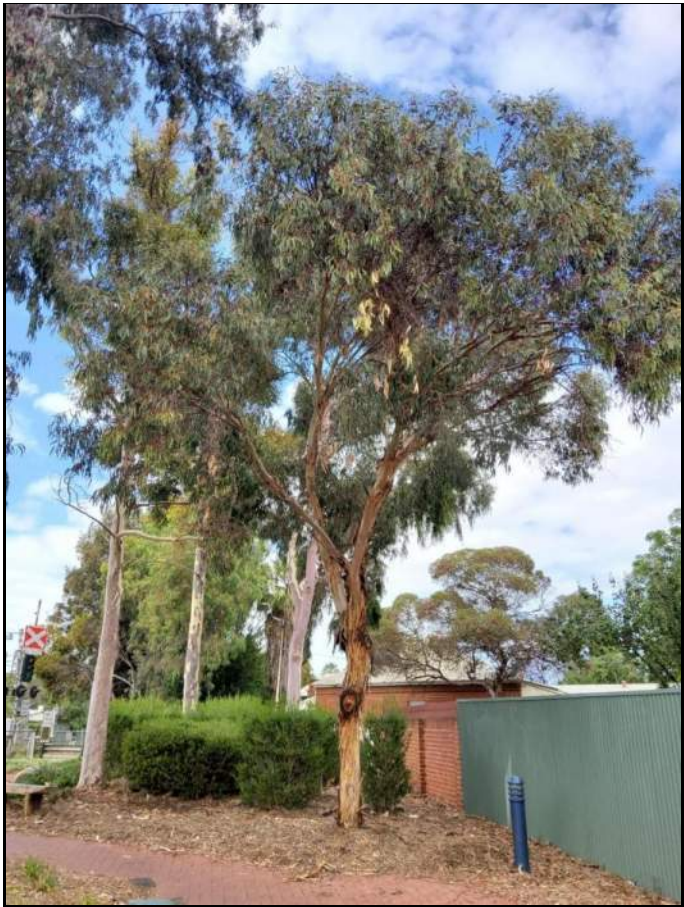
Mallee Blue Gum

The health and structure of this tree indicate it is in good overall condition. There is a slight increase in the level of epicormic growth within the crown but this is not at a level that would affect the overall condition rating.

Legislative Status	Unregulated
This tree does not achieve a regulated trunk circumference and therefore is not regulated by the Planning, Development and Infrastructure Act 2016.	
Retention Rating	Moderate
This tree has a Moderate Retention Rating and could be considered for retention if it can be protected. Tree damaging activity, including removal, may be approved if it is shown that reasonable alternative design solutions are not available.	
Development Impact	Low
The identified encroachment is less than 10% of the TPZ area and not expected to impact tree viability.	
Action	Protect Root Zone
Protect the root zone and crown in accordance with the recommendations and principles of AS4970-2009 Protection of trees on development sites.
