# **Two Wells SAAS Ambulance Station**

## **Geotechnical Investigation Report**

30 January 2025  
Ref: 241697R002RevB

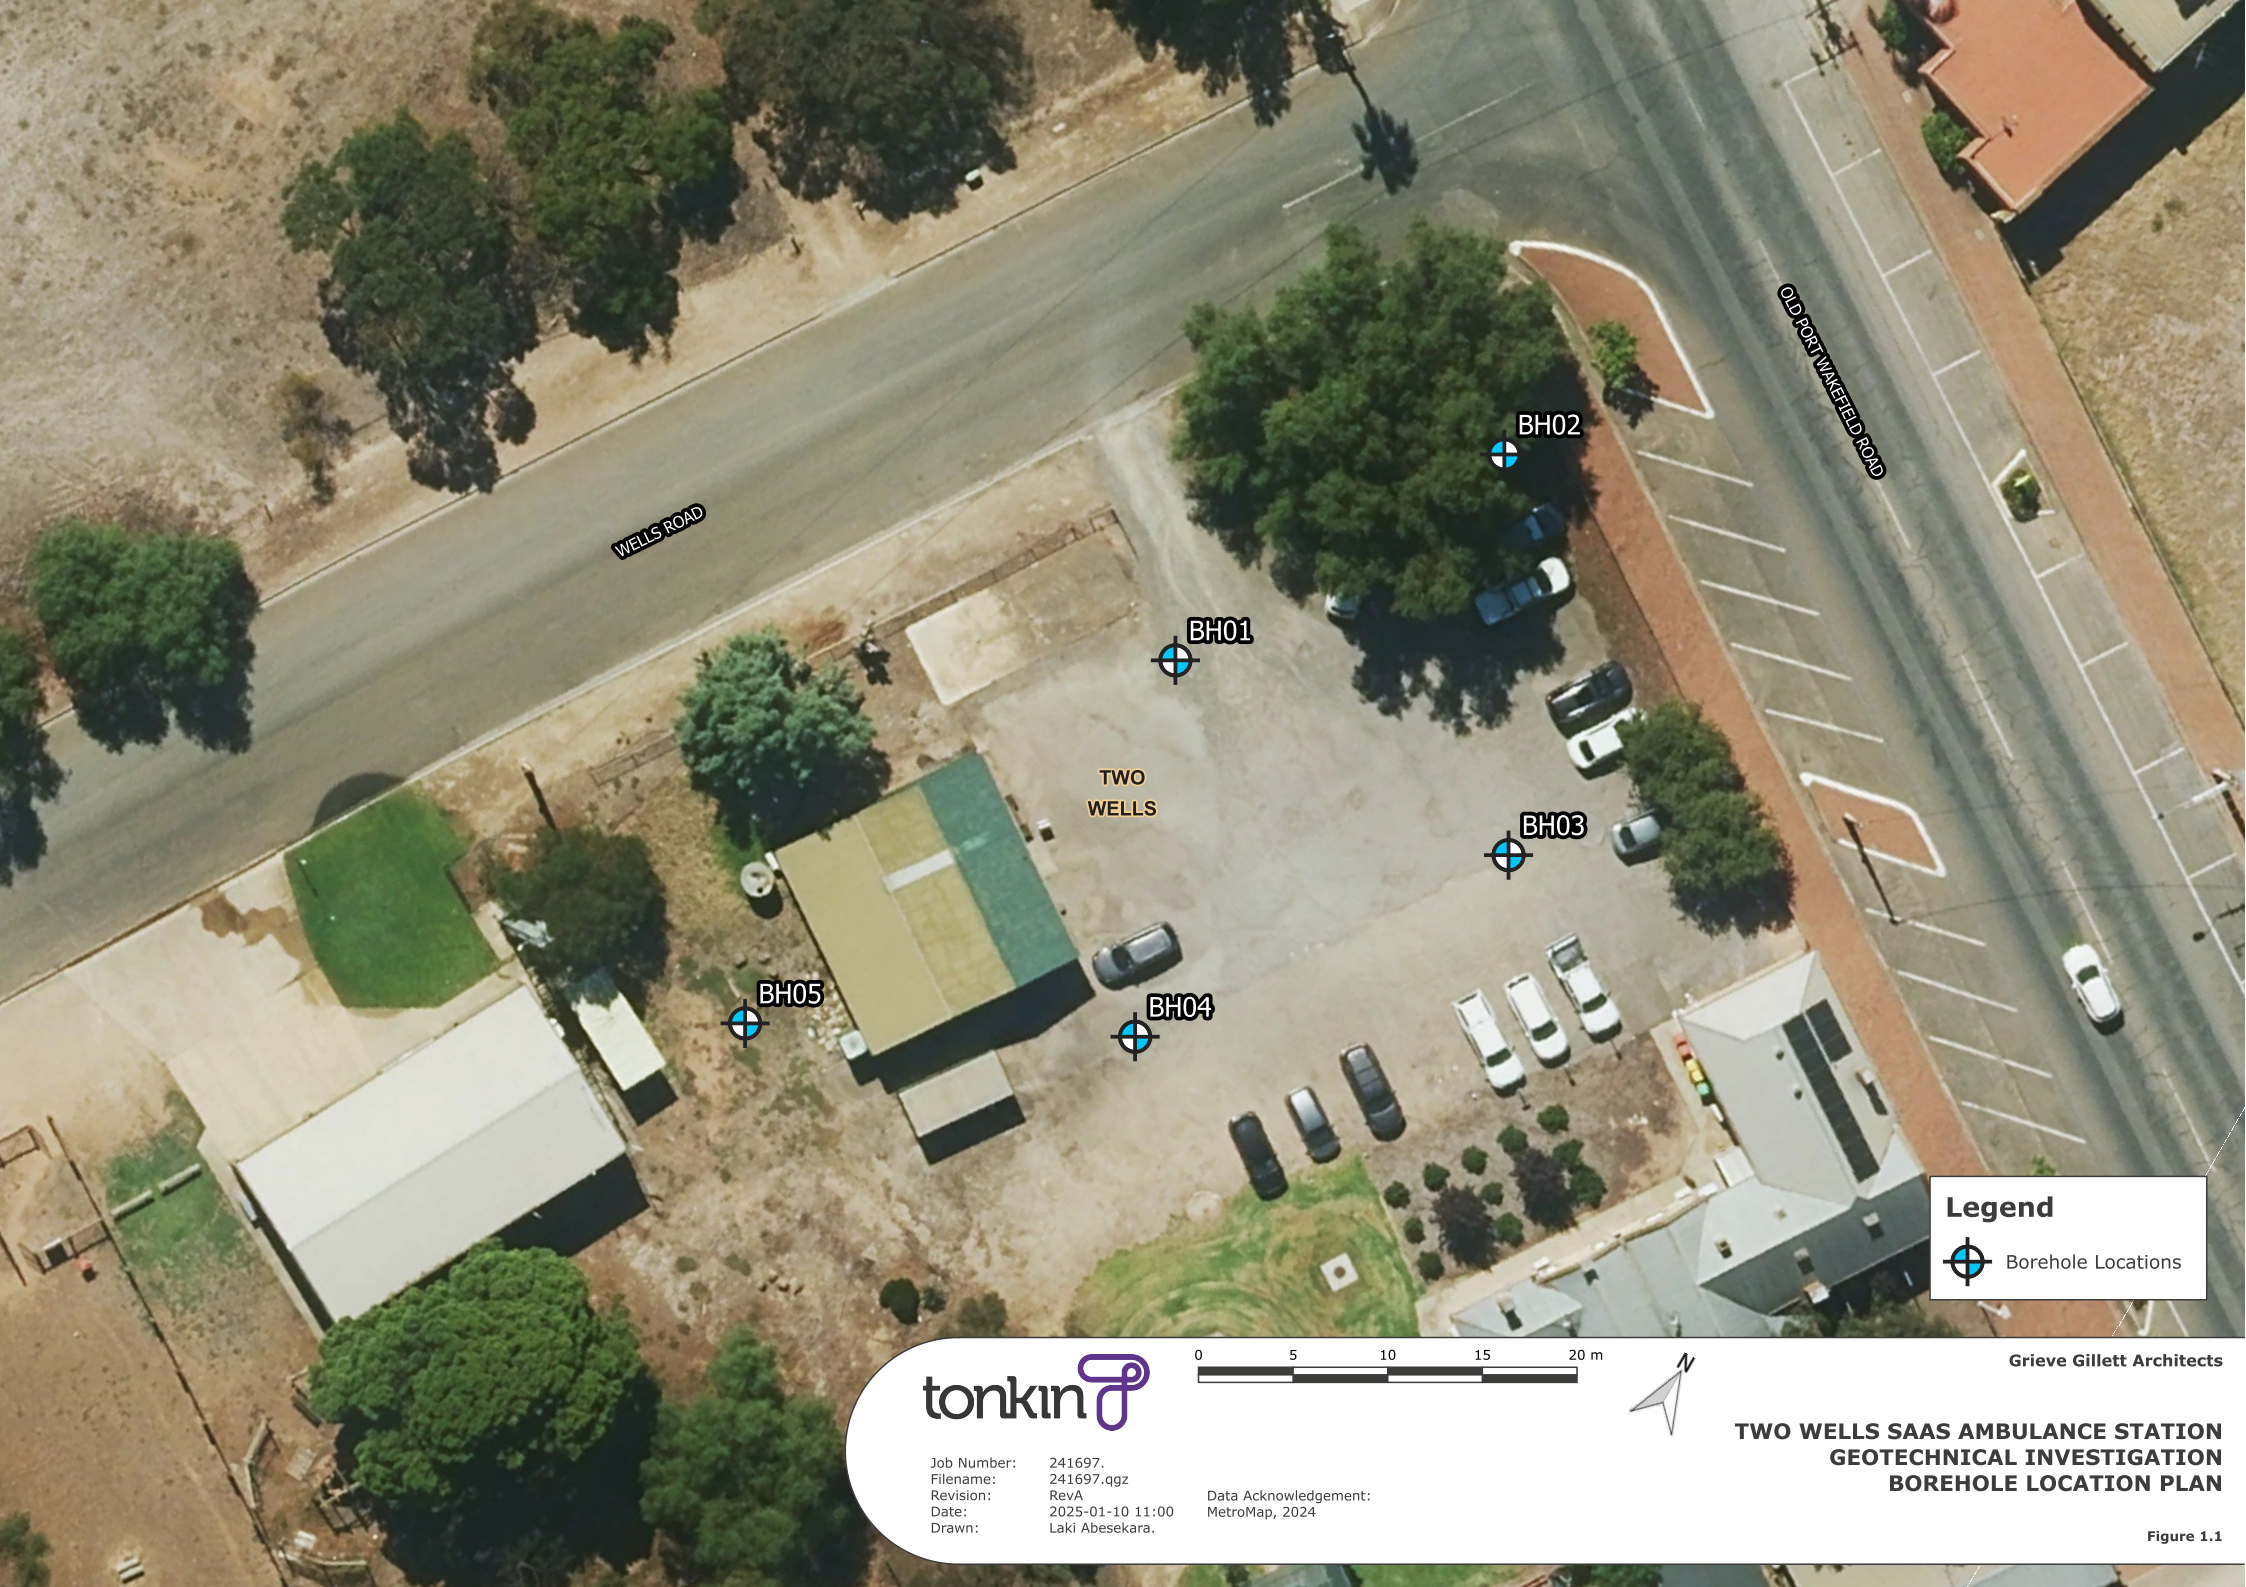
Figure 1.1

A plan showing the borehole locations is shown in Figure 1.1.

**TWO WELLS SAAS AMBULANCE STATION  
GEOTECHNICAL INVESTIGATION  
BOREHOLE LOCATION PLAN**

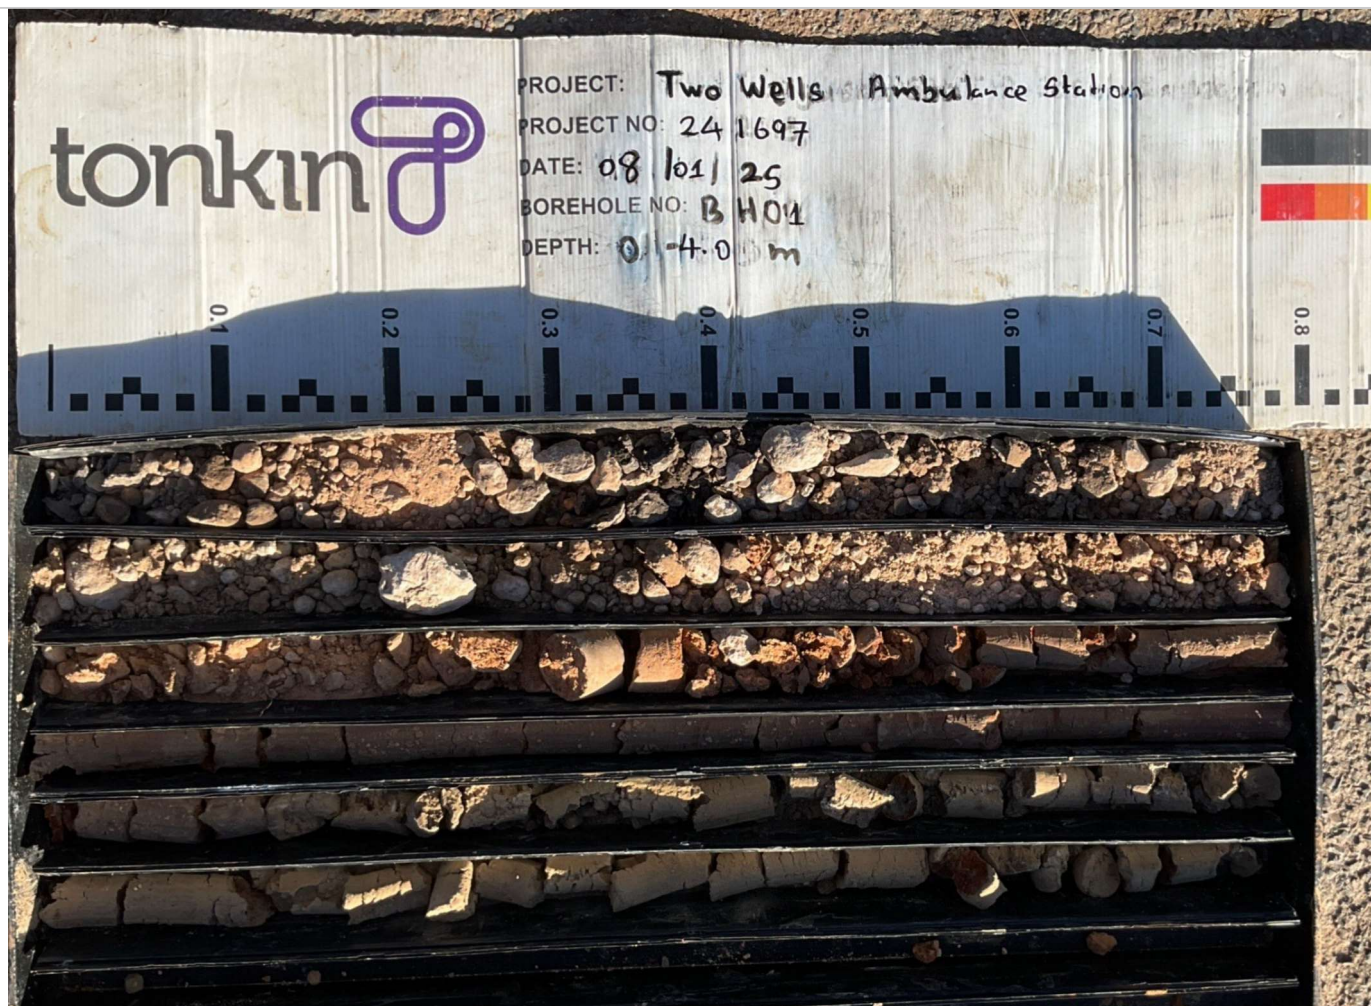
1.50		CL- CI	Calcareous Sandy CLAY. low to medium plasticity, pale reddish brown, fine to coarse grained sand, trace fine to coarse sized gravel.				1.7 - 1.8 m ENV		1.5, PP 600	
	10		2		CL- CI	CLAY. medium plasticity, red brown, trace fine to medium grained sand, inorganic.	w < PL			2 - 2.1 m ENV			
PT			2.50		CI	CLAY. medium plasticity, red brown mottled pale grey, with fine to medium grained sand, inorganic.							
	9		3									3, PP 600

3.50		CI								With calcareous pockets
	8												
						BH01 Target Depth Reached at 4m (Target Depth Reached)

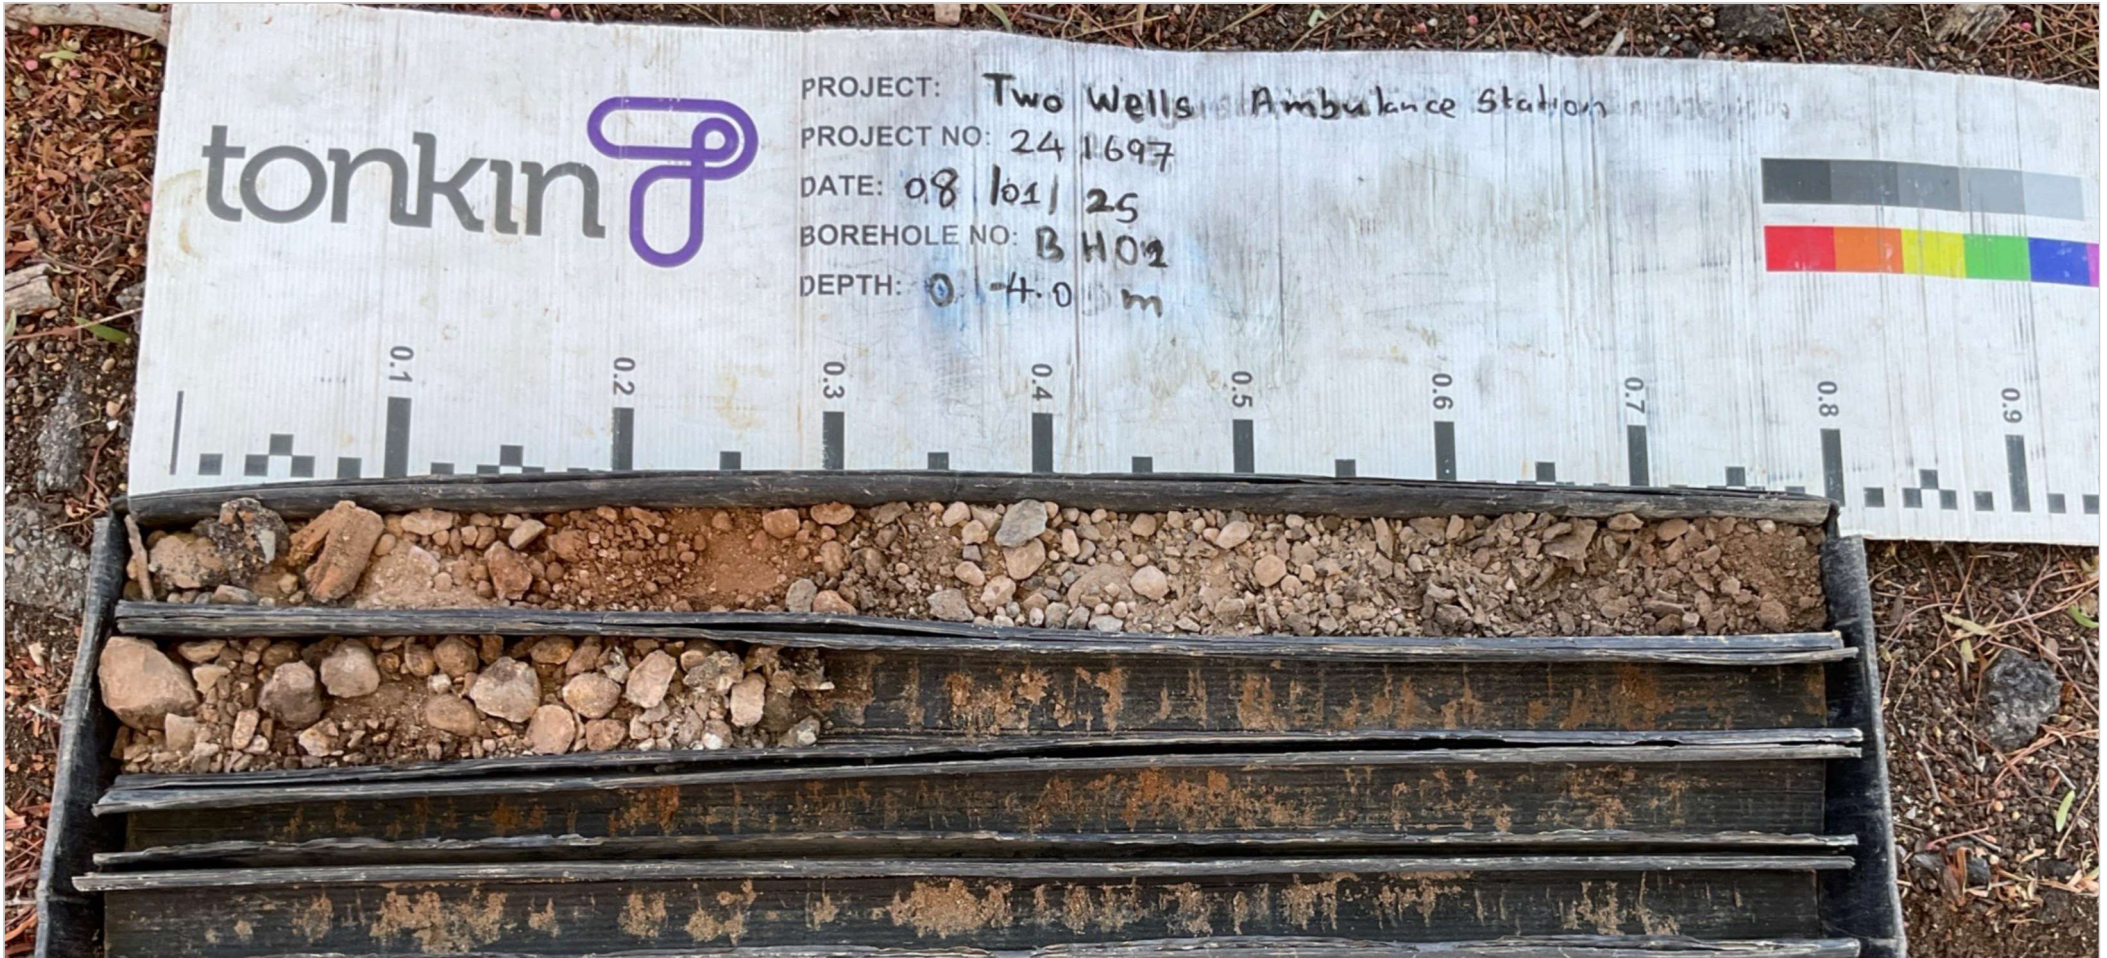
FILL, Sandy GRAVEL, grey brown, fine to coarse sized, fine to coarse grained sand.				0.3 - 0.4 m ENV			
						Calcareous Sandy GRAVEL, pale grey brown, fine to coarse sized, fine to coarse grained sand.				0.5 - 0.6 m ENV			
										0.9 - 1 m ENV			
						BH02 refusal Encountered at 1m (Push tube and Auger Refusal)

Indurated soils (Calcrete) were encountered at shallow depths at all borehole locations. In borehole BH02, Calcrete could not be drilled by the solid auger. Excavation with conventional earthmoving machinery is expected to be feasible within this harder indurated material, however buckets with rock teeth, and excavators with higher capacities may be required for excavation in these areas.

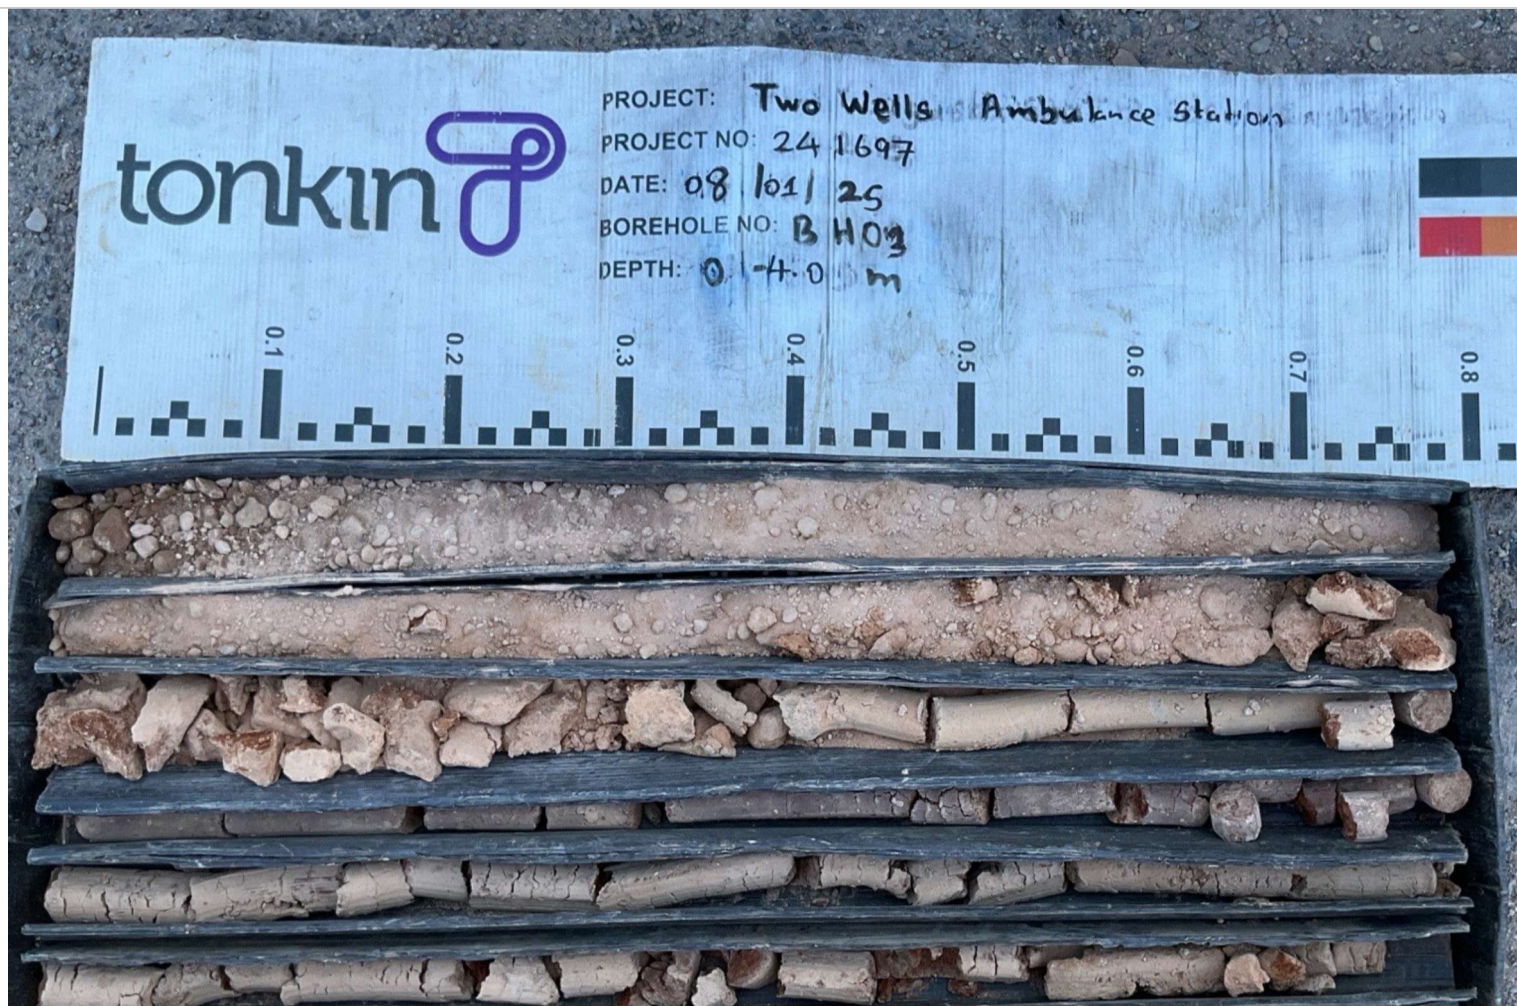
CI	CLAY. medium plasticity, red brown, trace fine to medium grained sand, inorganic.						1.4 - 1.5 m ENV		
													1.5 - 1.9 m GEO PI+PSD		
	10		2

2.50												
	9		3												
			3.50												
	8														
						BH03 Target Depth Reached at 4m (Target Depth Reached)

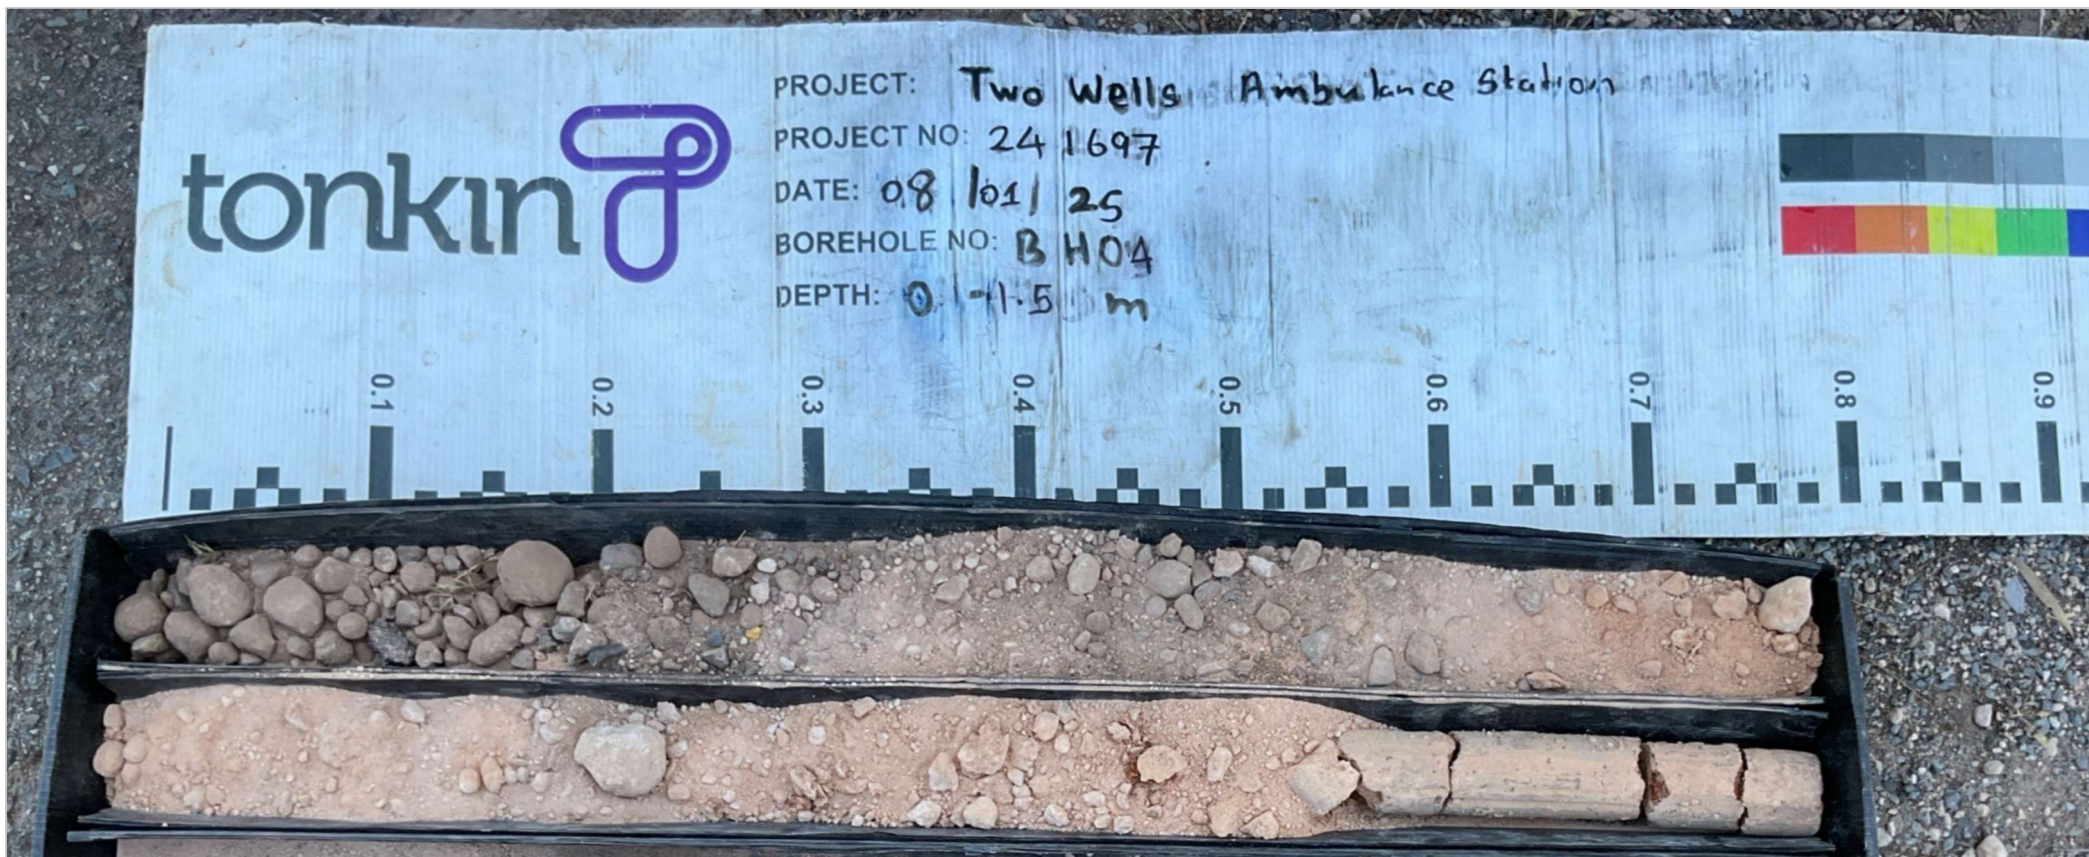
BH04

Calcrete layer
	11		1		CL- CI	Calcareous Sandy CLAY. low to medium plasticity, pale reddish grey brown, fine to coarse grained sand, trace fine to coarse sized gravel, inorganic.	w < PL	VSt	1 - 1.1 m ENV				
					CI	CLAY. medium plasticity, red brown, trace fine to medium grained sand, inorganic.	w < PL		1.3 - 1.4 m ENV			1.3, PP 600	
						<b>BH04 Target Depth Reached at 1.5m (Target Depth Reached)</b>

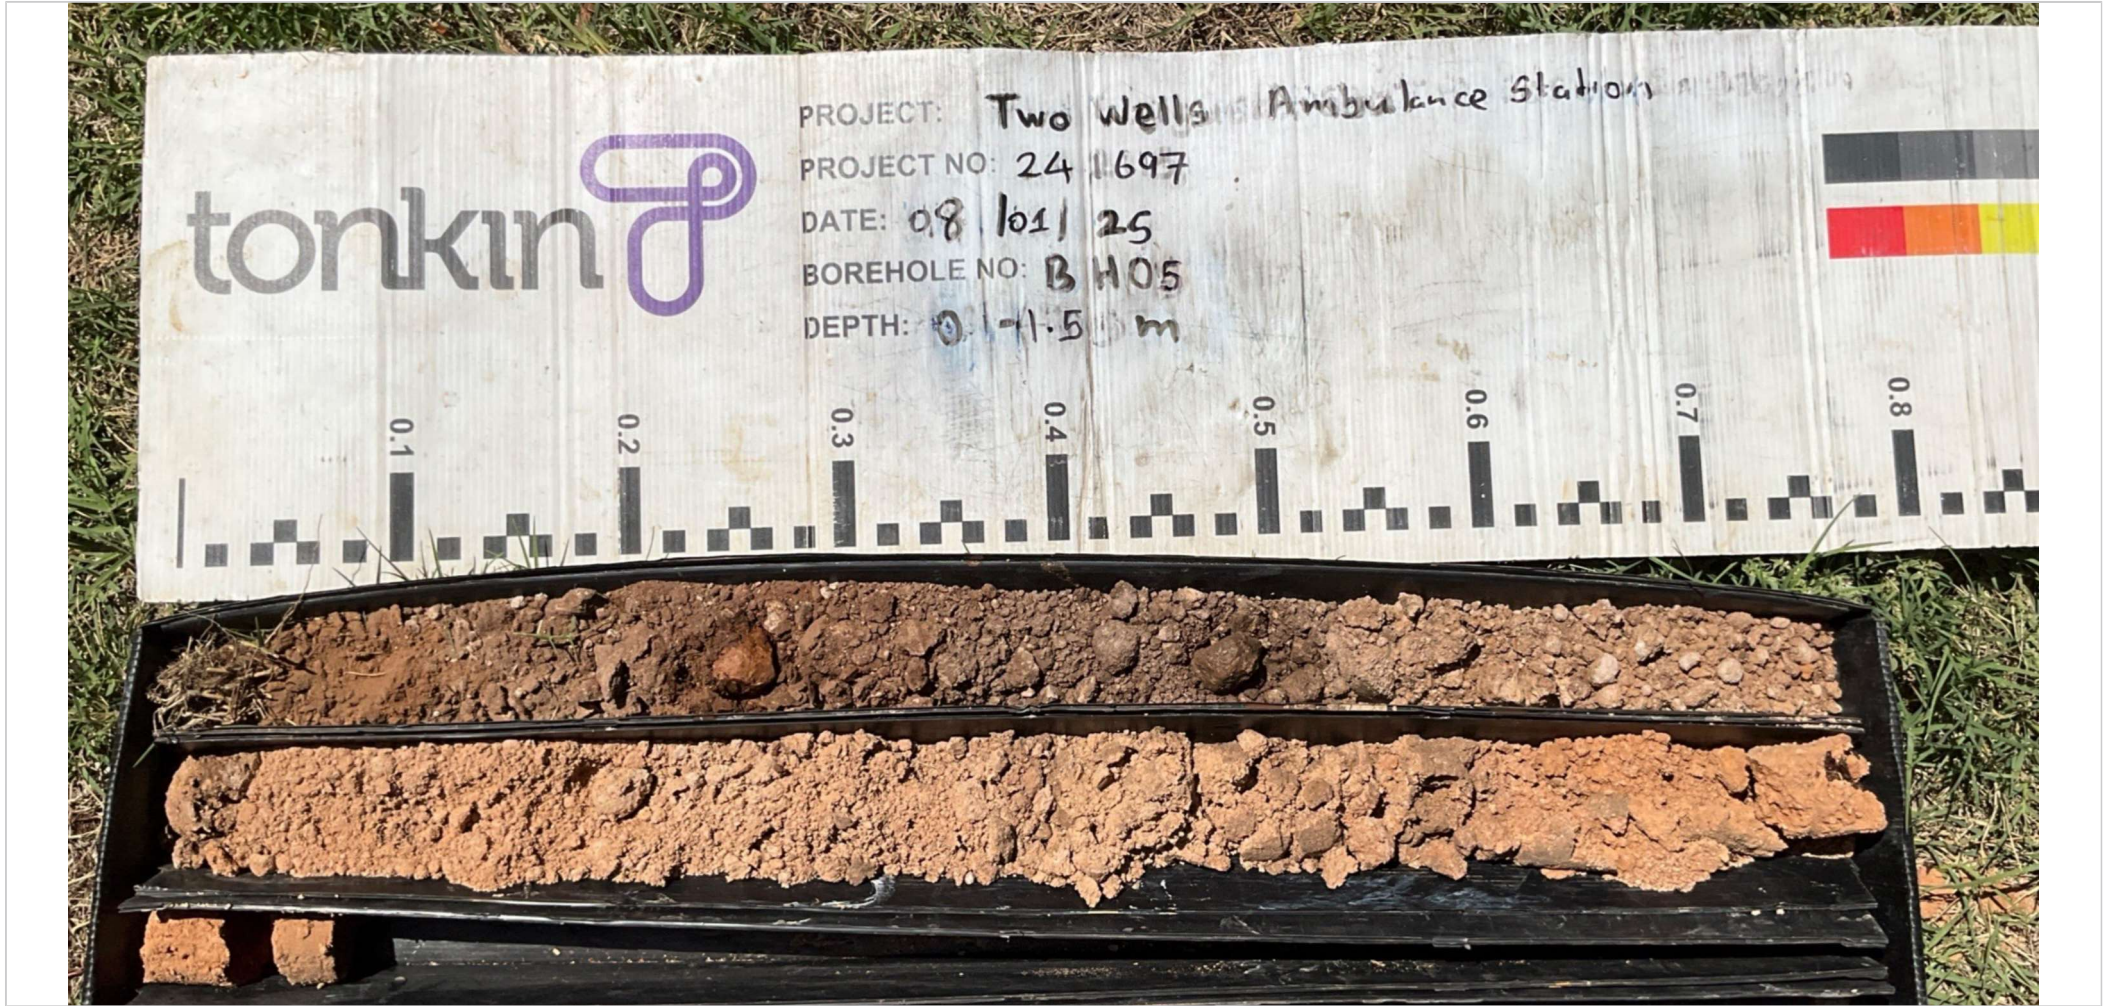
CL- CI	Calcareous Sandy CLAY. low to medium plasticity, pale grey brown, fine to coarse grained sand, trace fine to medium sized gravel, inorganic.	w < PL	St-Vst	1.2 - 1.4 m ENV				
						<b>BH05 Target Depth Reached at 1.5m (Target Depth Reached)</b>

Photo description	BH05		
Client	Grieve Gillett Architects		
Location	120 Port Wakefield Hwy, Two Wells SA 5501, Australia		
Project name	Two Wells Ambulance Station		
Project No	241697	Scale	Not to Scale
BH No	BH05	BH Depth	CorePhoto

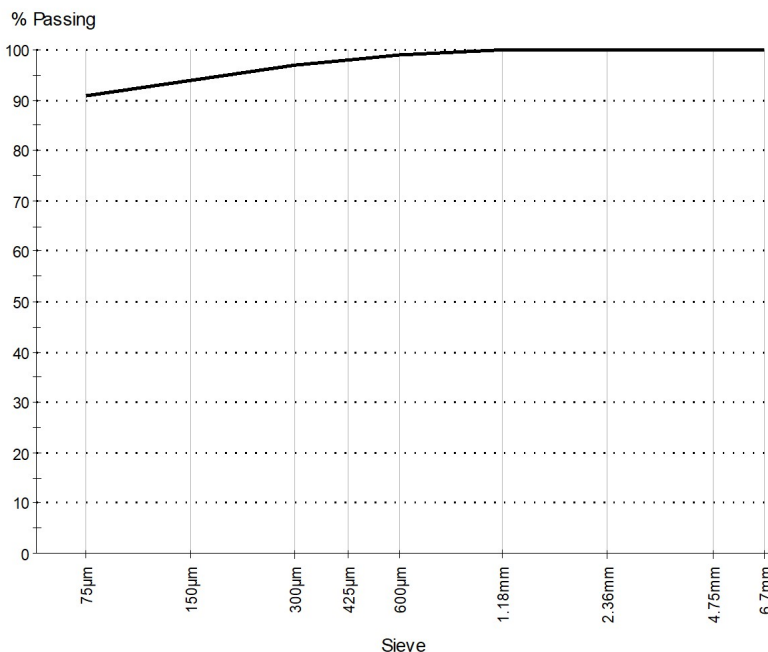
### Particle Size Distribution

Description	Method	Result	Limits
Sample History	AS 1289.1.1	Oven-Dried	
Preparation	AS 1289.1.1	Dry Sieved	
Linear Shrinkage (%)	AS 1289.3.4.1	14.5	
Mould Length (mm)		250	
Crumbling		No	
Curling		No	
Cracking		Yes	
Liquid Limit (%)	AS 1289.3.1.2	43	
Plastic Limit (%)	AS 1289.3.2.1	14	
Plasticity Index (%)	AS 1289.3.3.1	29

**Method:** AS 1289.3.6.1  
**Drying By:** Oven

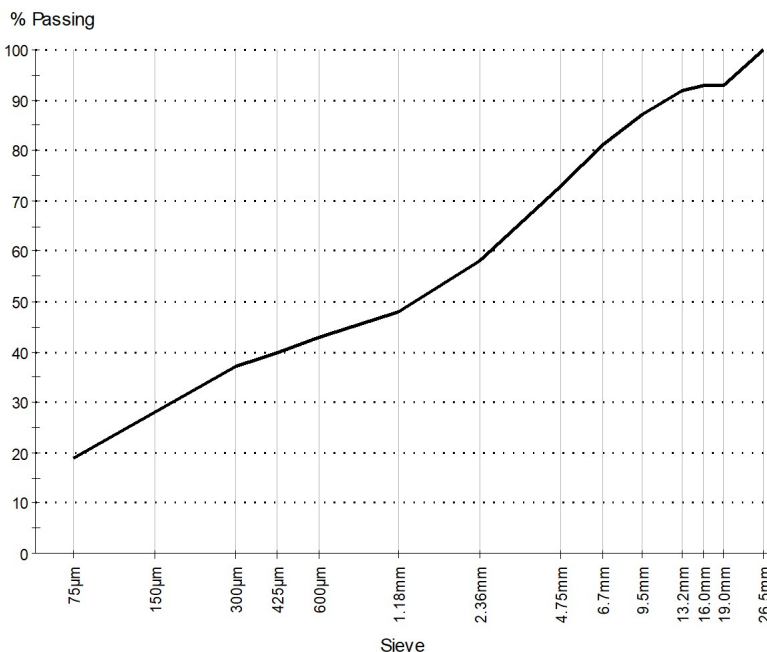
### Particle Size Distribution

Description	Method	Result	Limits
Sample History	AS 1289.1.1	Oven-Dried	
Preparation	AS 1289.1.1	Dry Sieved	
Linear Shrinkage (%)	AS 1289.3.4.1	2.0	
Mould Length (mm)		250	
Crumbling		No	
Curling		No	
Cracking		Yes	
Liquid Limit (%)	AS 1289.3.1.2	23	
Plastic Limit (%)	AS 1289.3.2.1	17	
Plasticity Index (%)	AS 1289.3.3.1	6

**Method:** AS 1289.3.6.1

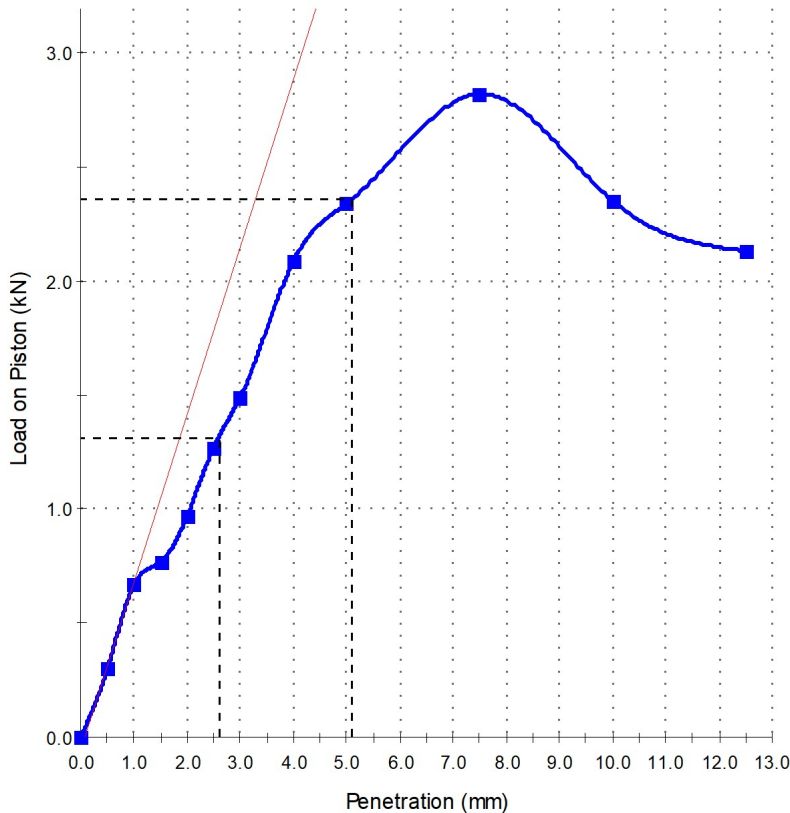
### Load vs Penetration

<b>Sample ID:</b> PR-25/0016-2	<b>Date Sampled:</b> 8/01/2025
<b>Client Sample ID:</b> BH04 0.5 - 1.0	
<b>Field Sample ID:</b>	<b>Sampled By:</b> submitted by Client
<b>Sampling Method:</b> AS1289.1.2.1 (6.5.2) Hand Auger Drilling	
<b>Source:</b> On site	<b>Material:</b> Soil Investigation Sample
<b>Specification:</b> Soil Investigation Sample	<b>Location:</b> BH04 0.5 - 1.0
<b>Tested By:</b> Jordan Michalanney	<b>Date Tested:</b> 17/01/2025

Dry Density before Soaking (t/m<sup>3</sup>): 1.91  
Density Ratio before Soaking (%): 98.0  
Moisture Content before Soaking (%): 10.8  
Moisture Ratio before Soaking (%): 95.5  
Dry Density after Soaking (t/m<sup>3</sup>): 1.90  
Density Ratio after Soaking (%): 98.0  
Swell (%): 0.0  
Moisture Content of Top 30mm (%): 16.0  
Compaction Hammer Used: Standard  
AS 1289.5.1.1

Surcharge Mass (kg): 4.50  
Period of Soaking (Days): 4  
Retained on 19 mm Sieve (%): 0  
CBR Moisture Content Method: AS 1289.2.1.1  
Sample Curing Time (h): 48  
Plasticity Determination Method: AS 1289.3.1.2

The CBR test conducted on the BH04 soil sample indicates a CBR value of 12% 5 mm penetration, with all other estimated and tested CBR values being higher than this. Therefore, a design subgrade CBR of 10.0% is recommended for the design of the pavements founded on the natural calcrete layer.

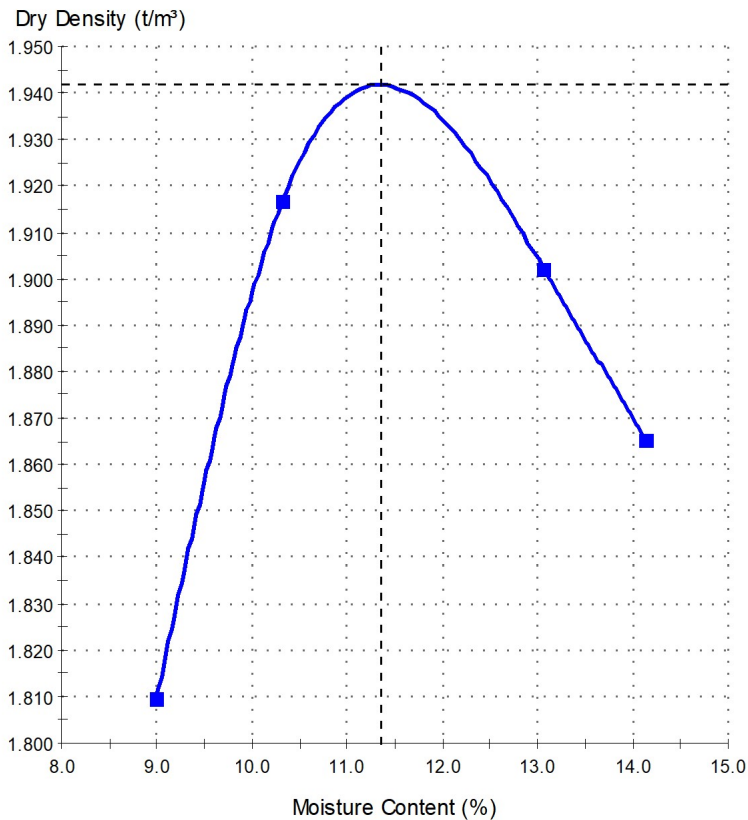
### Dry Density - Moisture Content Relationship

AS 1289.5.1.1 - 2017

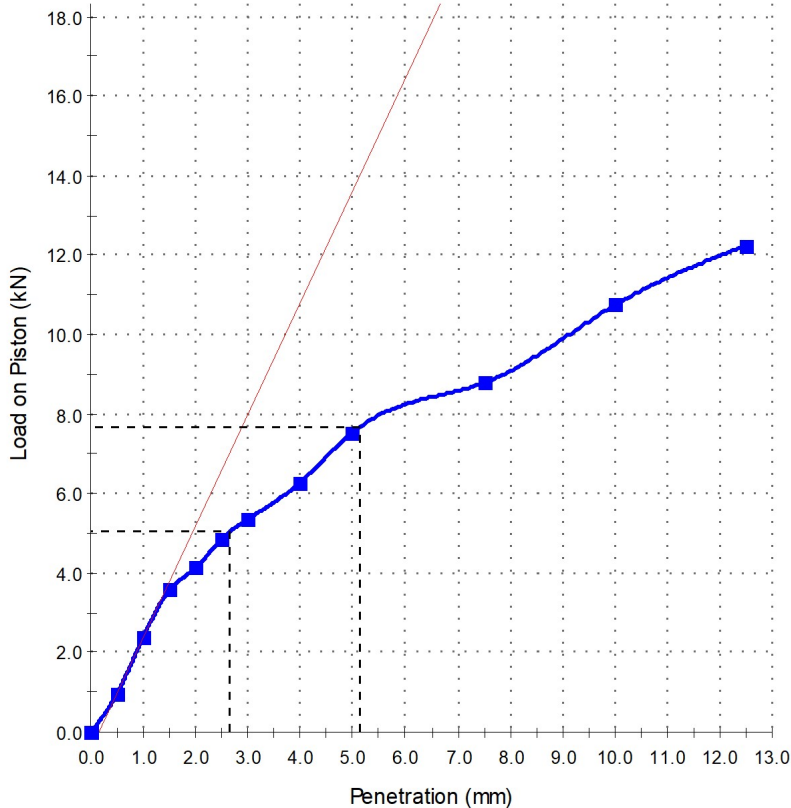
### Load vs Penetration

<b>Sample ID:</b> PR-25/0016-3	<b>Date Sampled:</b> 8/01/2025
<b>Client Sample ID:</b> BH05 0.3 - 0.8	
<b>Field Sample ID:</b>	<b>Sampled By:</b> submitted by Client
<b>Sampling Method:</b> AS1289.1.2.1 (6.5.2) Hand Auger Drilling	
<b>Source:</b> On site	<b>Material:</b> Soil Investigation Sample
<b>Specification:</b> Soil Investigation Sample	<b>Location:</b> BH05 0.3 - 0.8
<b>Tested By:</b> Jordan Michalanney	<b>Date Tested:</b> 17/01/2025

Moisture Content before Soaking (%): 9.4

Moisture Ratio before Soaking (%): 76.5

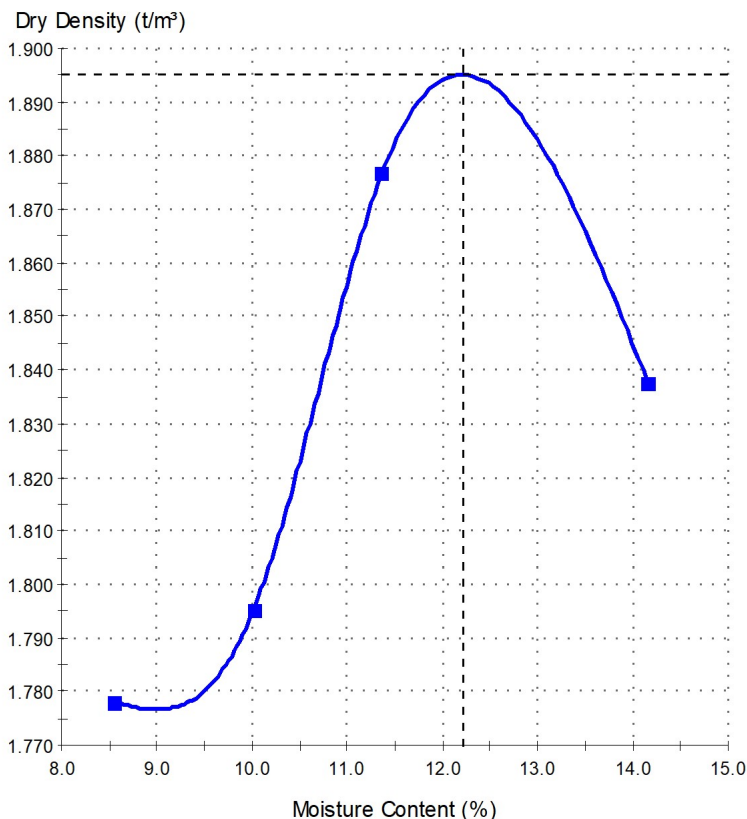
### Dry Density - Moisture Content Relationship

AS 1289.5.1.1 - 2017
