Port Augusta Renewable Energy Park

Stage 2

Development Application

Volume 4: Technical Appendices

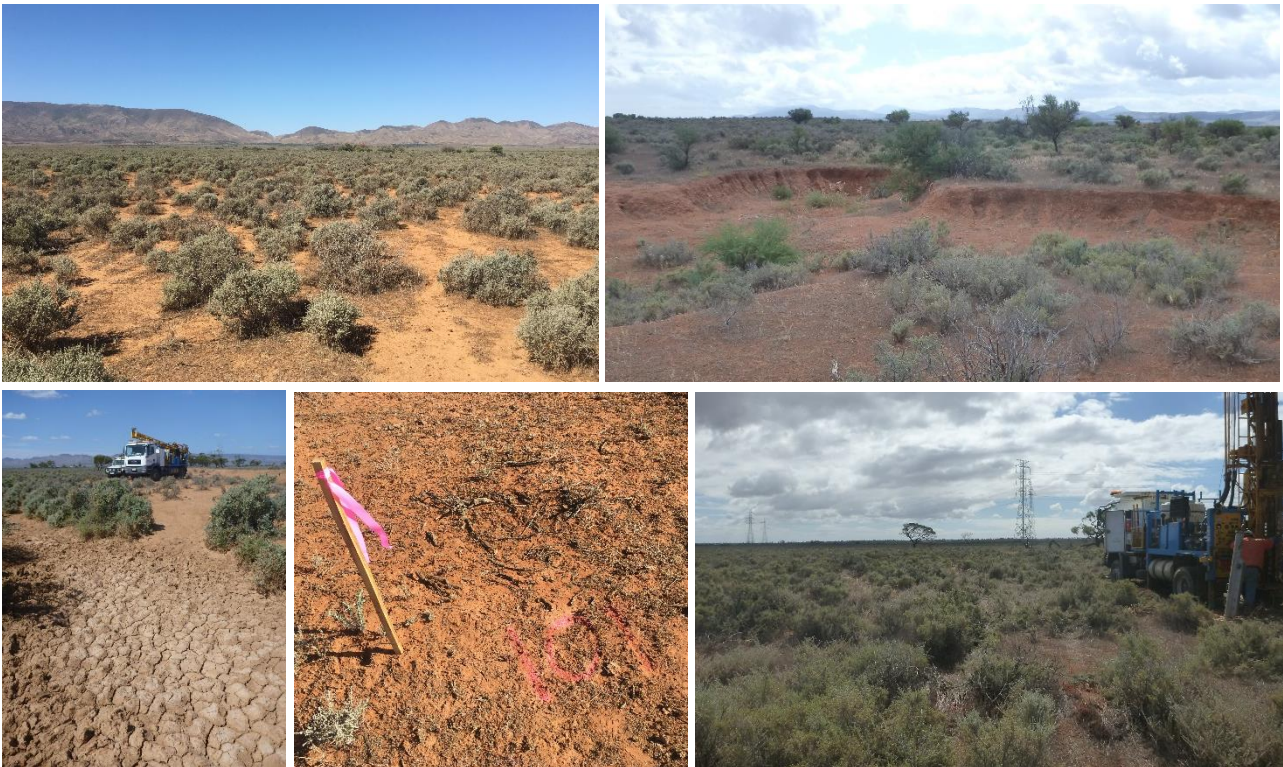
Figure A: Selected Site Photographs

The site encompasses areas of fenced off farm land that generally appears to be used for sheep and cattle grazing. Vegetation across the site includes saltbush (varying in size and density) and some trees. The site slopes downwards in a westerly direction from the mountain range to the Spencer Gulf although the topography of the site is relatively flat. Some incised creek channels were observed across areas of the site, extending from the east. Two sets of electrical transmission wires are aligned approximately northwest-to-southeast across the site extending from the Davenport Substation to the east side of the Augusta Highway. Where possible, access to investigation locations was obtained via existing access tracks across the paddocks.

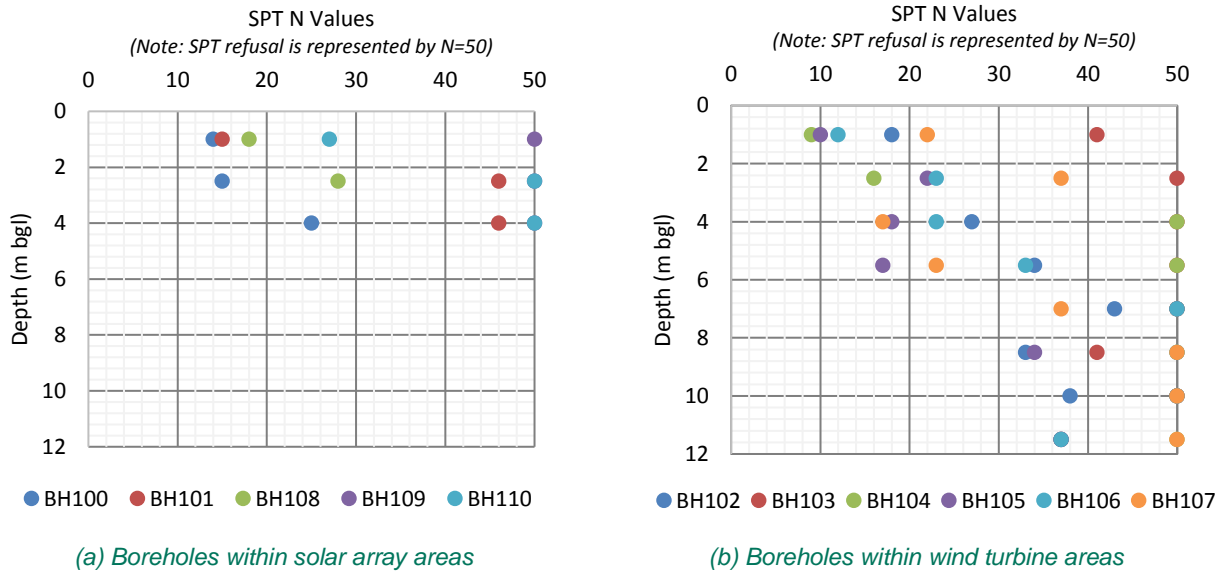
Figure B: Summary of SPT Results

A numerical result, 'N' value, is calculated based on the number of blows required to drive the last 300 mm of the 450 mm penetration (or part thereof, i.e. refusal). Summary graphs of the SPT 'N' values is presented below (Figure B), where SPT refusal is represented on the plot by N=50. SPTs undertaken during advancement of the boreholes resulted in 'N' values ranging between 9 and greater than 50.

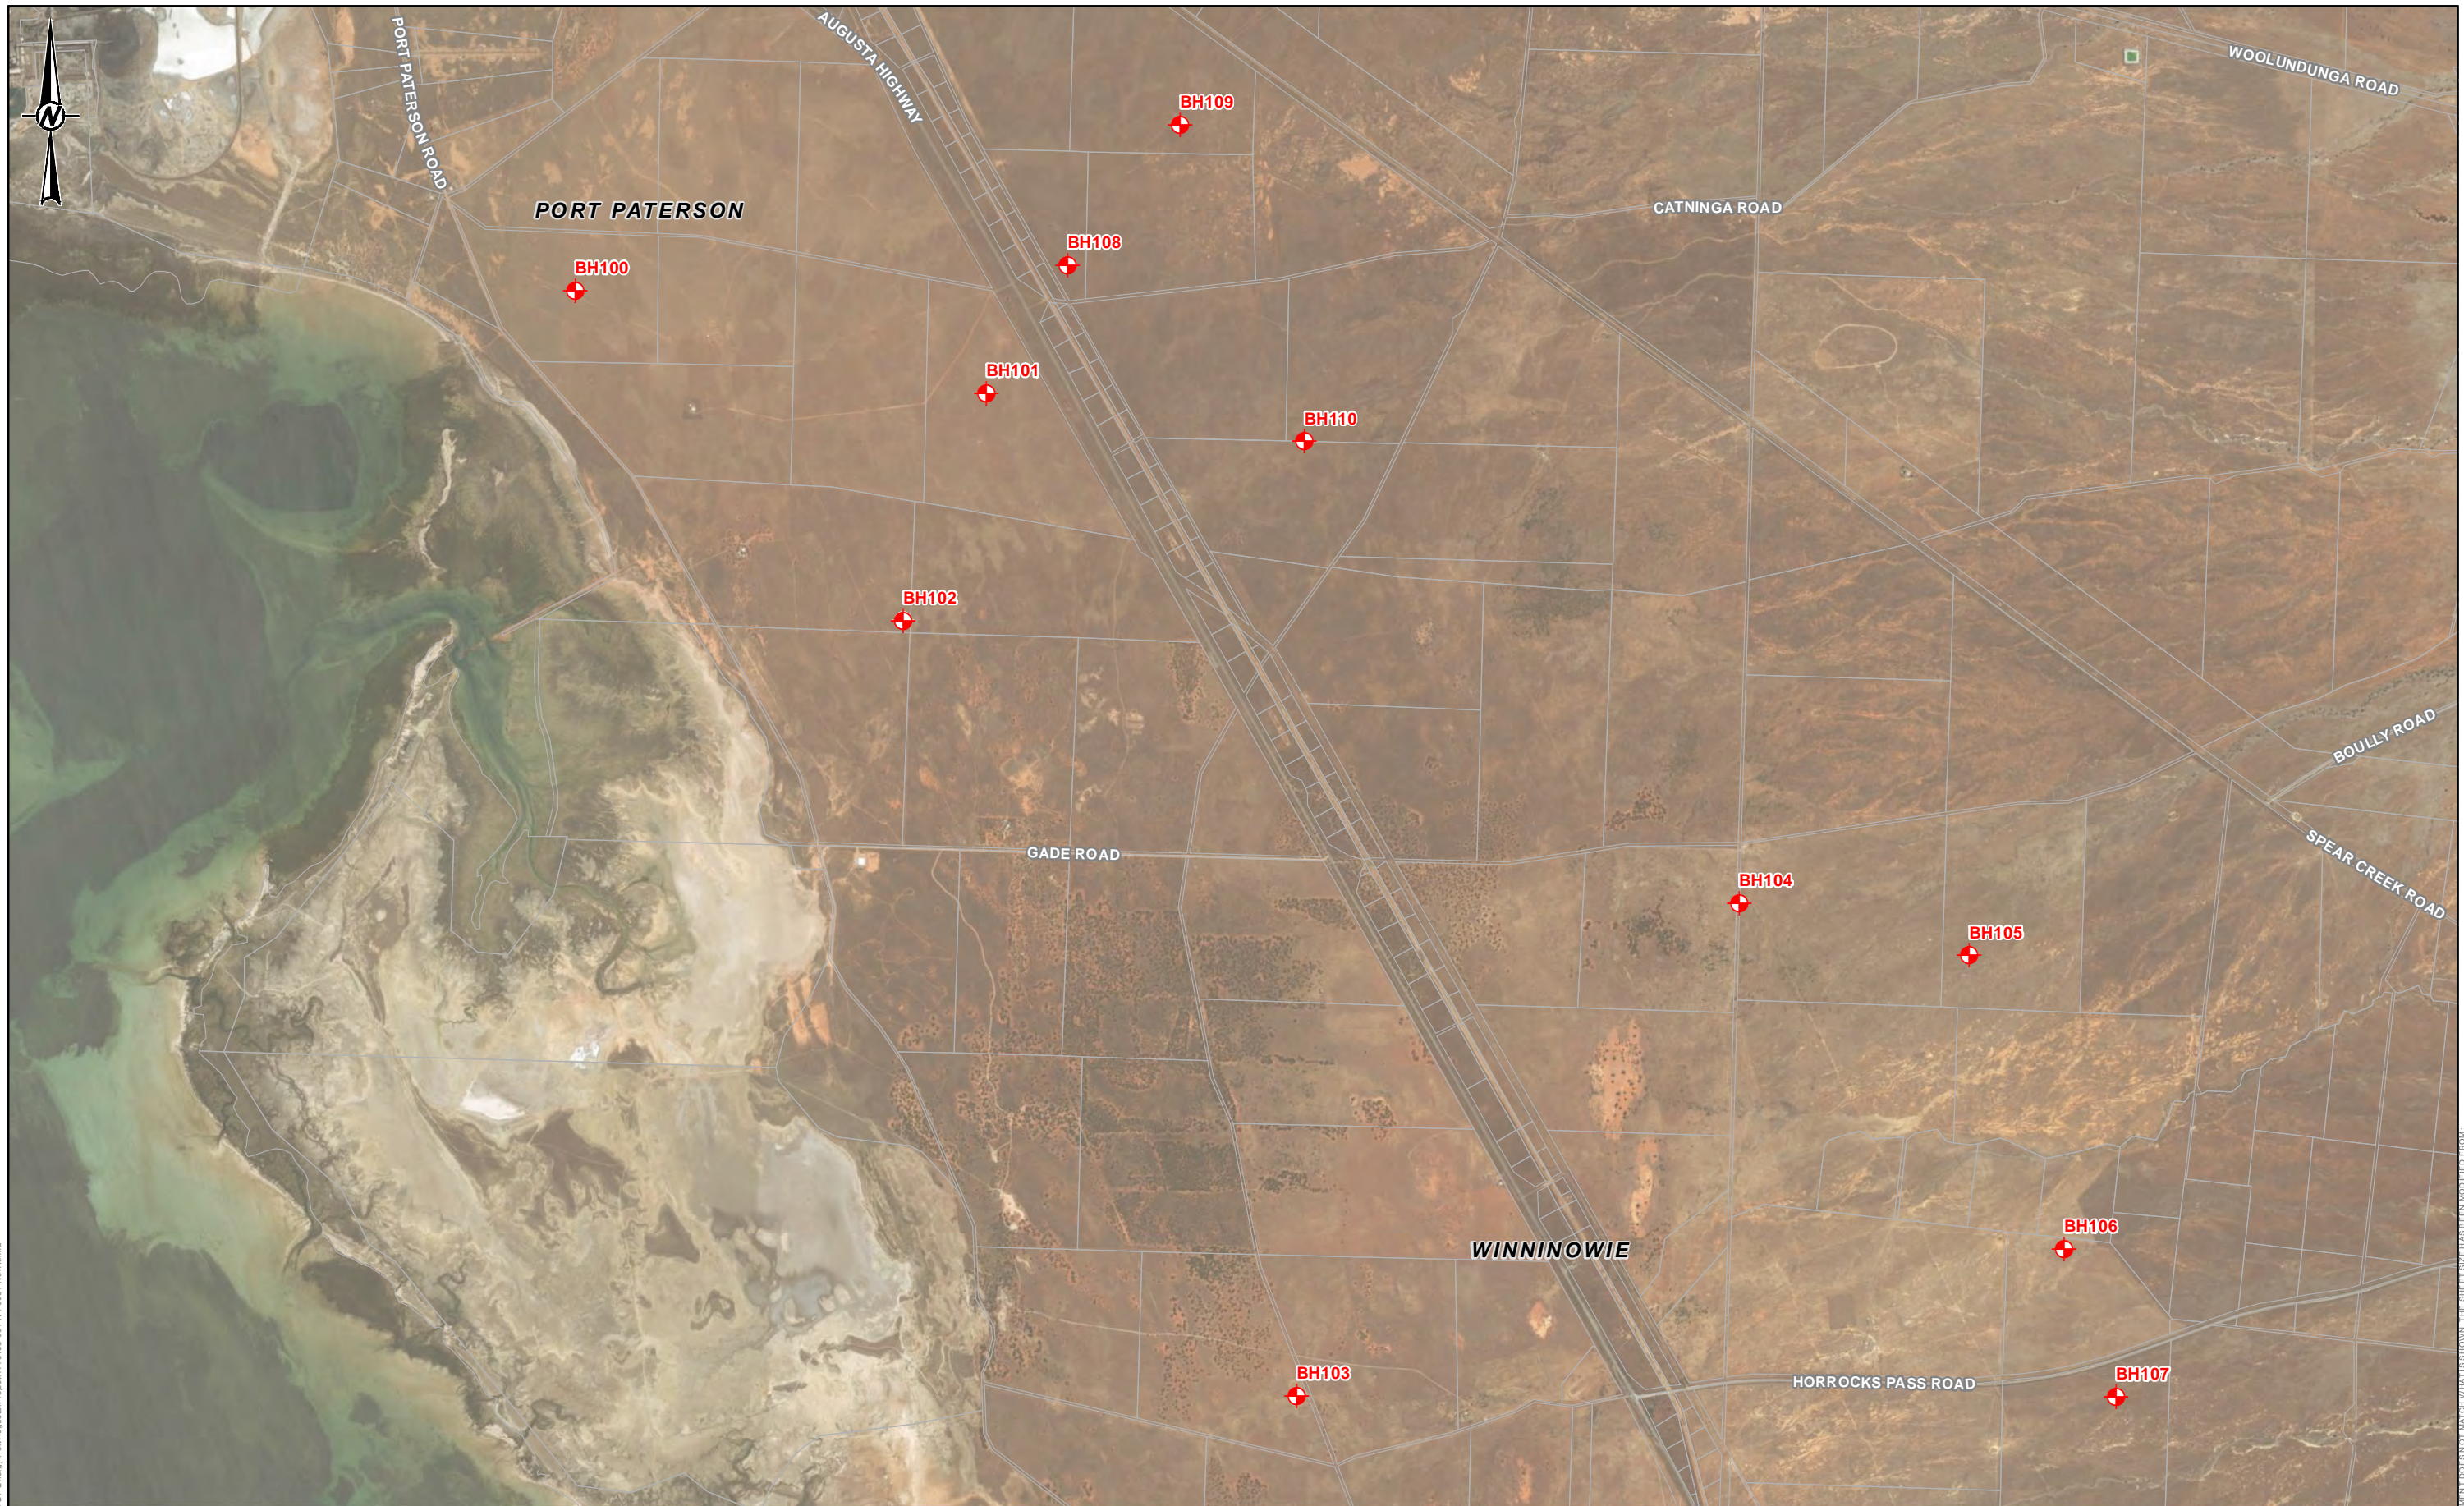
Figure 1 – Investigation Location Plan
Figure 2 – Regional Geology

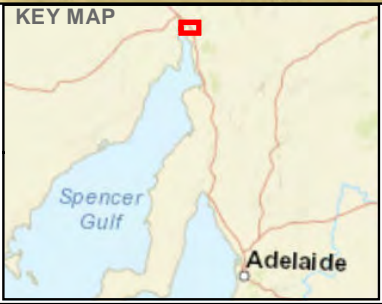
DRAFT **FIGURE 2**

IMAGERY & BASEMAP SOURCED FROM ESRI ONLINE BASEMAPS.
 ROAD & PROPERTY (C) THE STATE OF SOUTH AUSTRALIA, DEPARTMENT OF PLANNING, TRANSPORT AND INFRASTRUCTURE, 2017.
 LOCALITIES (C) STREETPRO, 2004.
 SURFACE GEOLOGY (C) THE STATE OF SOUTH AUSTRALIA, DEPARTMENT OF PRIMARY INDUSTRIES & REGIONS, 2008.

‘Orange siliceous aeolian sand’ (Fulham Sand) and ‘Unconsolidated locally mobile yellow-grey pale orange well-sorted medium to fine frosted quartz sand. Aeolian dunes’ (Molineaux Sand);

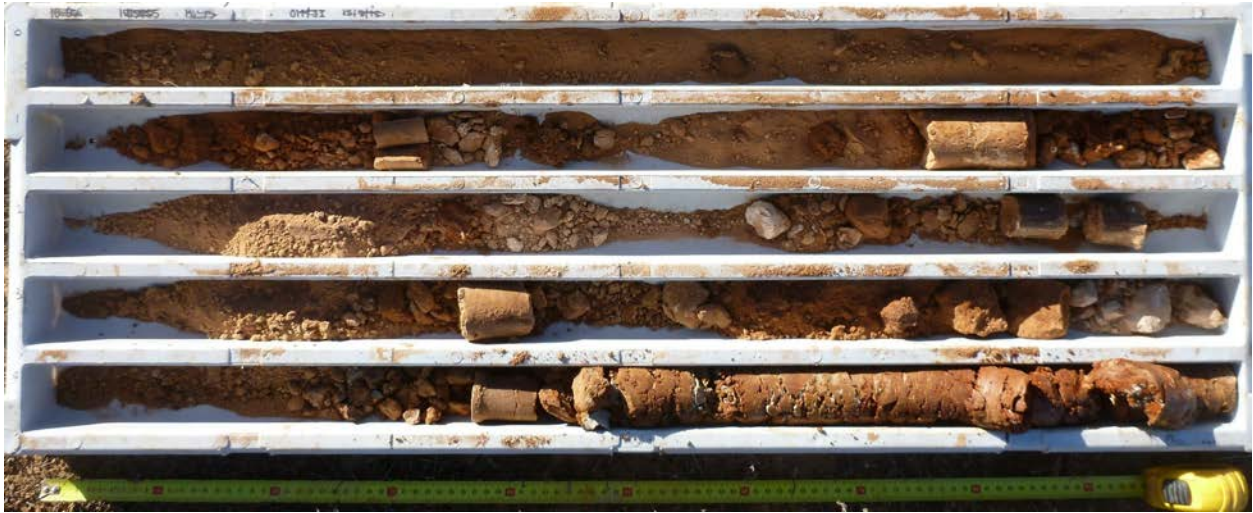
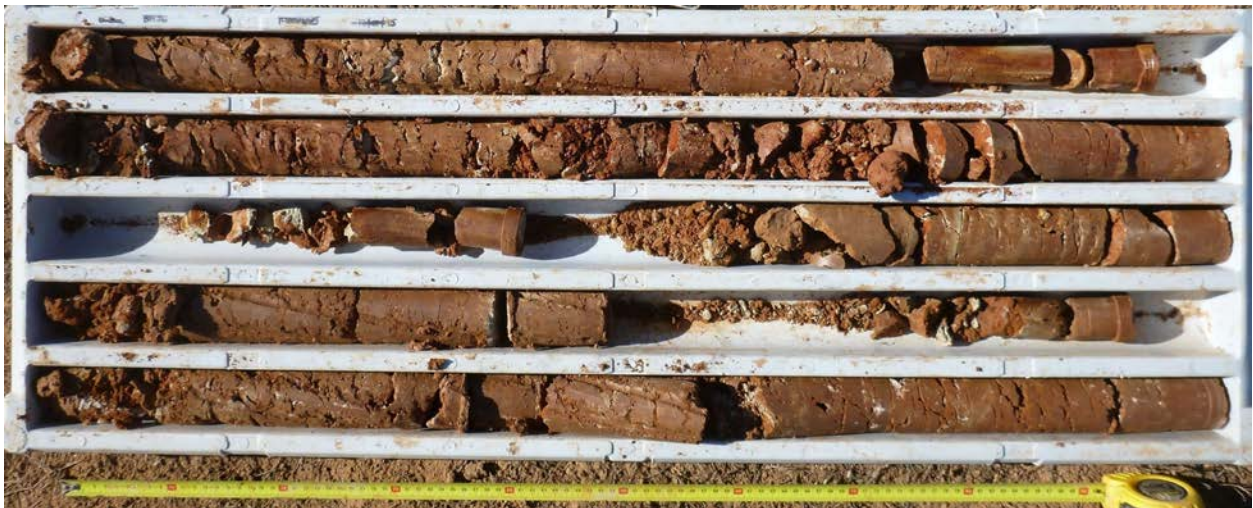
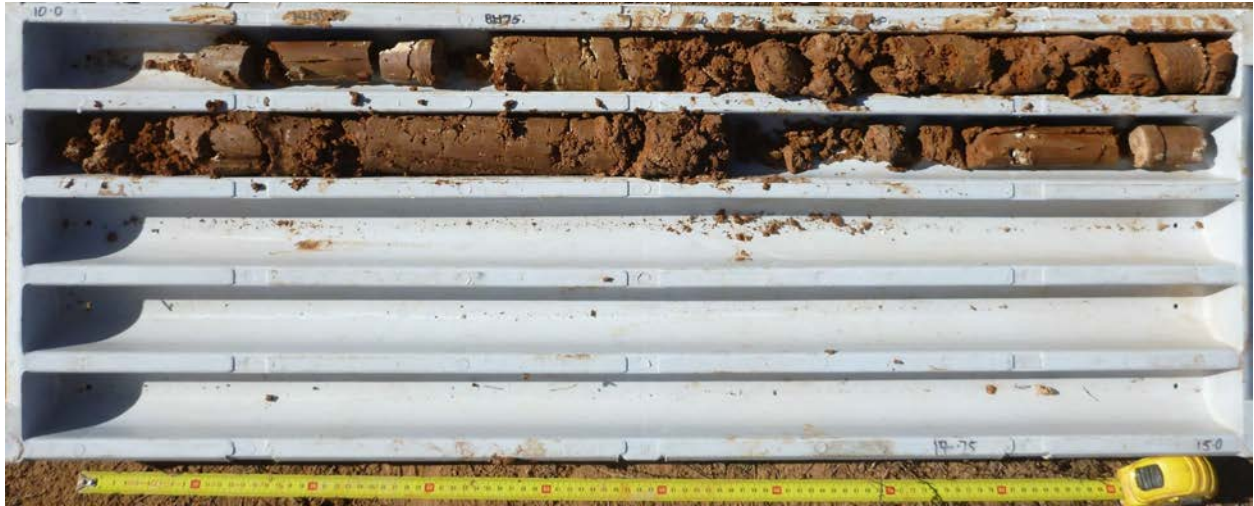
BH102, 00.00 m to 05.00 m

The subsurface conditions encountered in the deeper boreholes put down within the wind turbine areas on the west side of the Augusta Highway (i.e. BH102 and BH103) generally comprised interbedded orange brown sands and clays extending to 4.25 m in BH102 and 7.3 m in BH103; overlying mottled red-brown and grey clay extending to the maximum depth investigated (about 12 m bgl). These materials can generally be summarised by the following geological units:

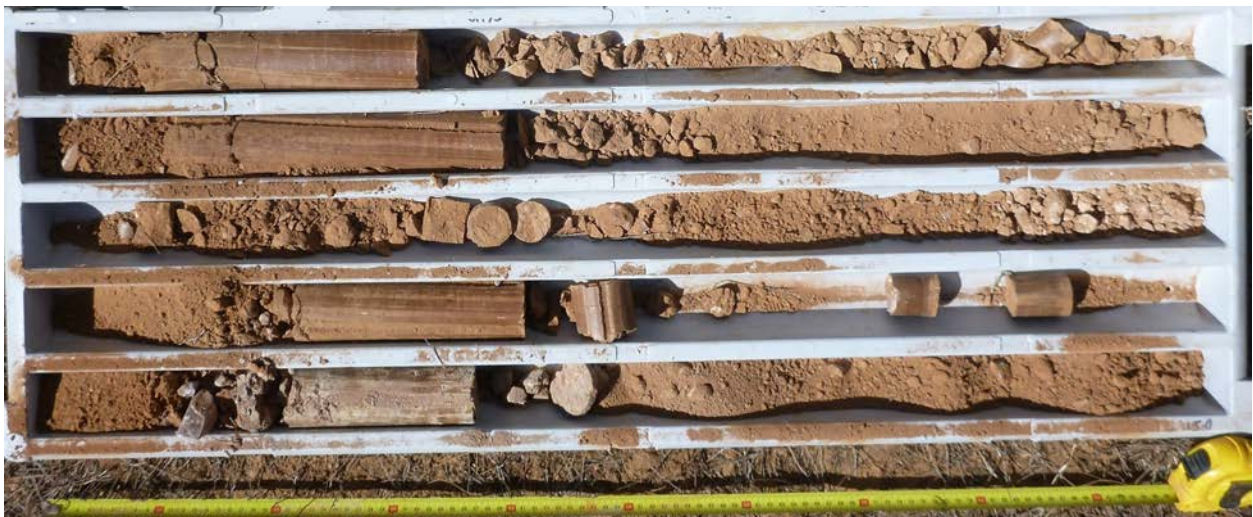
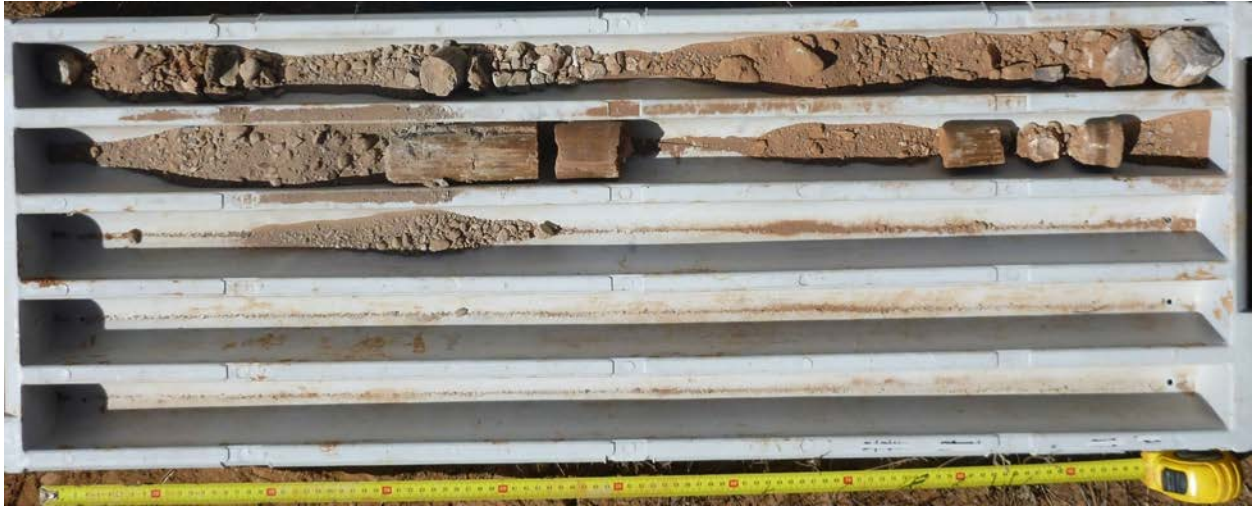
BH107, 05.00 m to 10.00 m

The subsurface conditions encountered in the deeper boreholes put down within the wind turbine areas in the southeast quadrant of the site (i.e. BH104 to BH107) generally comprised interbedded sands, clays and gravels. These materials can generally be summarised by the following geological units:

- Silty/Clayey Sand: fine to medium grained, orange brown with some pale brown/white mottling (inferred calcareous), loose to very dense; interbedded with
- Sandy/Silty Clay and Clay: low plasticity, orange brown with some pale brown/white mottling (inferred calcareous), stiff to hard consistency, with some dry and friable materials; overlying
- Clayey/Sandy Gravel and Gravelly Clayey Sand: fine to coarse grained, grey gravel in orange brown sandy clay matrix, dense to very dense, with interbedded layers of sandy clay and clayey sand; overlying
- Sandy/Silty Clay, low plasticity, orange brown with some pale brown/white mottling, hard, with some dry and friable materials; interbedded with
- Silty/Clayey Sand: fine to medium grained, orange brown with some pale brown/white mottling (inferred calcareous), dense to very dense.

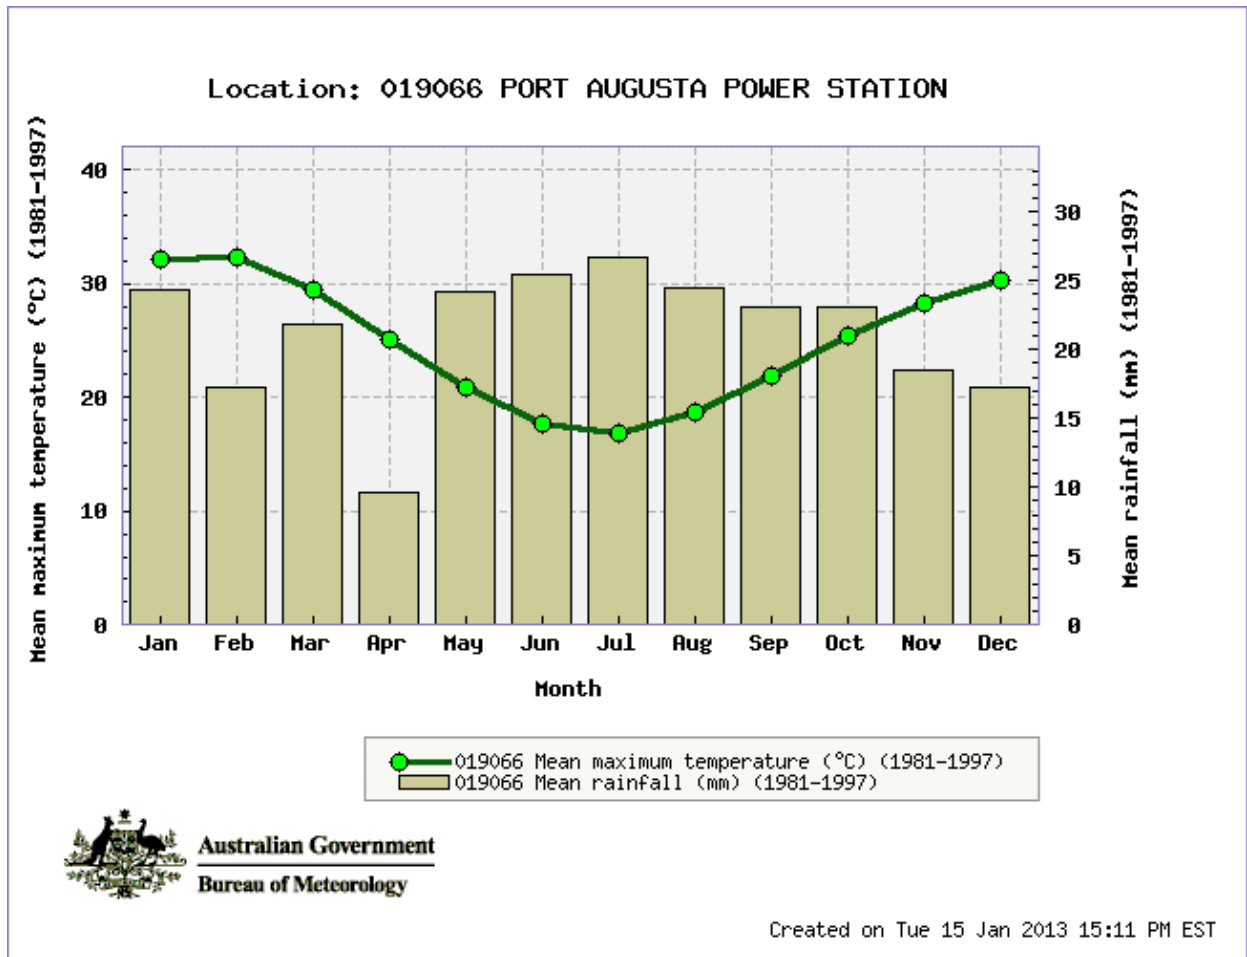
The most comprehensive available climate dataset is from the Port Augusta weather station approximately 9 km north of the project site. Both rainfall and temperature follow a warm desert climate with cool wet winter months and hot dry summer months. The long-term mean annual rainfall for the area is 255.3 mm, with May through to October typically the wettest months and some summer rainfall (BOM 2011) (Figure 2).

Figure 2. Mean maximum temperature and rainfall data for Port Augusta Power Station weather station (1981-2010). Data source: Bureau of Meteorology 2017.

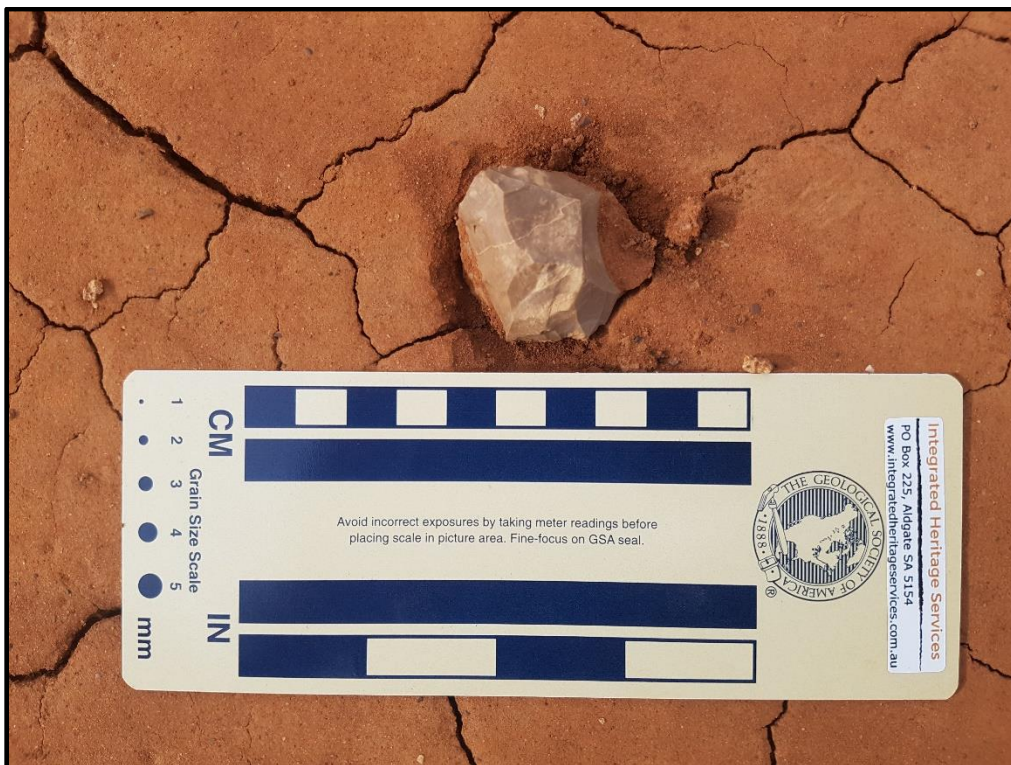
Figure 5 – Small chert core

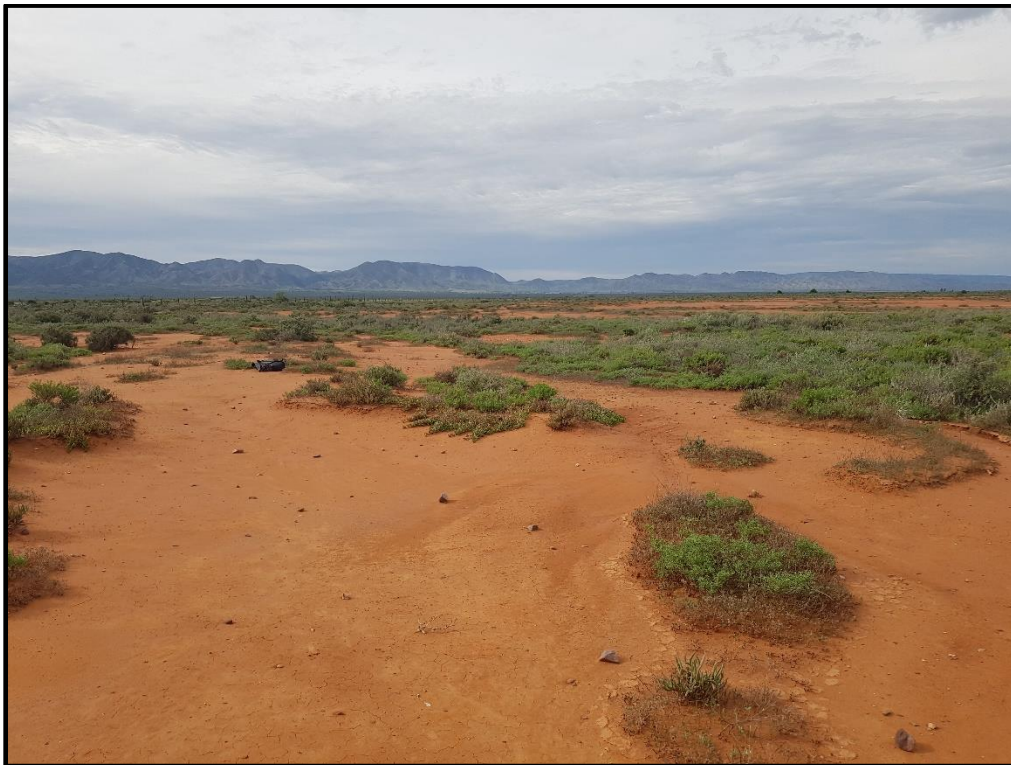
Figure 6 – View south across Stage 2 East 2

Stage 2 East 2 is situated approximately 80 metres to the north of Stage 2 East 1 within the same exposed and disturbed landscape on the middle-eastern fringe of the project area. The site is subject to regular inundation and wind erosion. Stage 2 East 2 consists of 15+ artefacts including flakes and broken flakes. The primary raw material represented is silcrete and there is also quartz and a light-medium brown chert at the site. The artefacts are spatially relatable and as such represent a locus of human activity constituting an Aboriginal site. Artefact density is variable and would average about 1/4m². The artefacts are subject to natural disturbances in the form of wind and water erosion and it is possible that some artefacts are buried in the loose sands. See Figures 6-8.

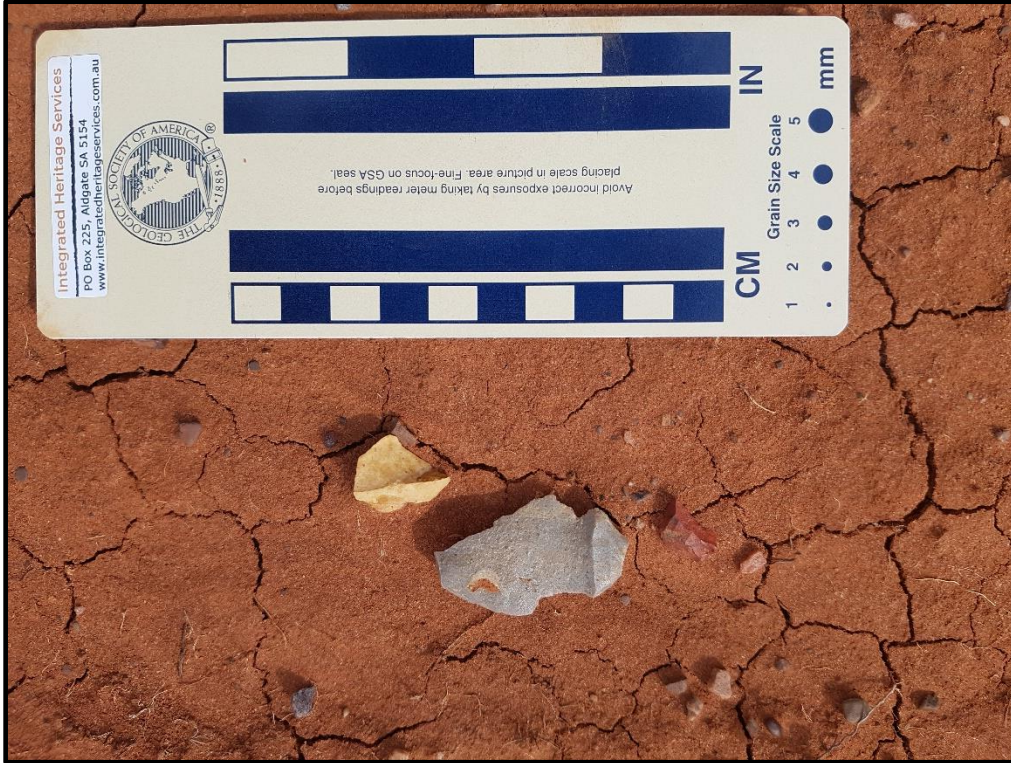
Figure 7 – Chert and silcrete flakes

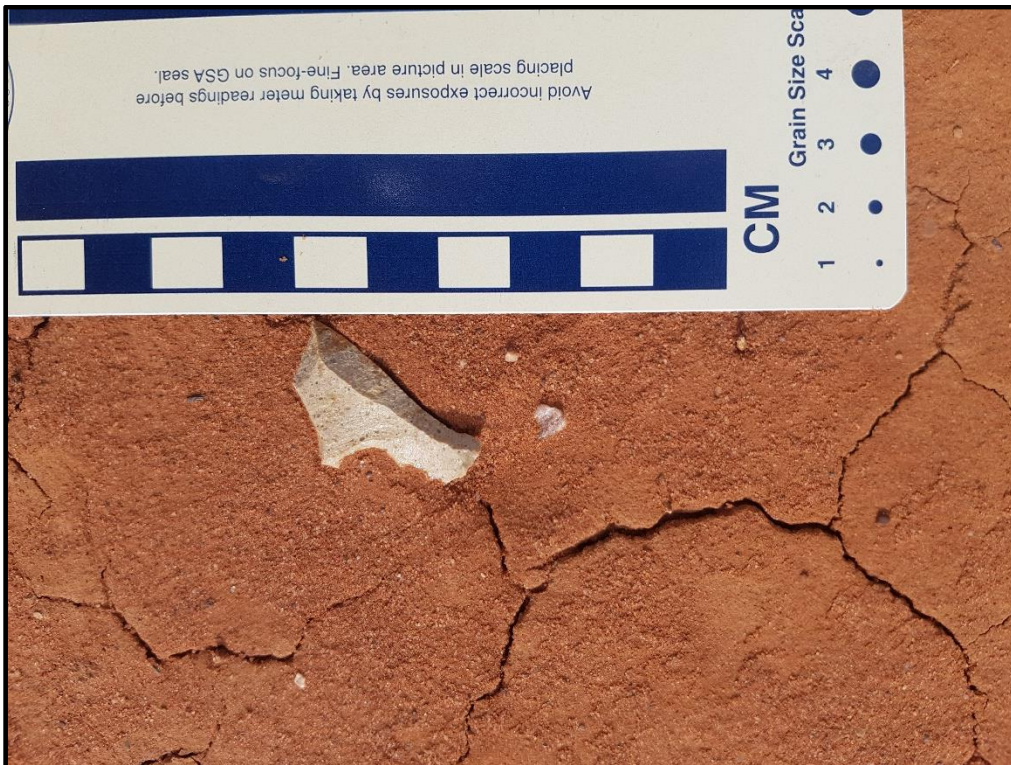
Figure 8 – Partially buried silcrete flake

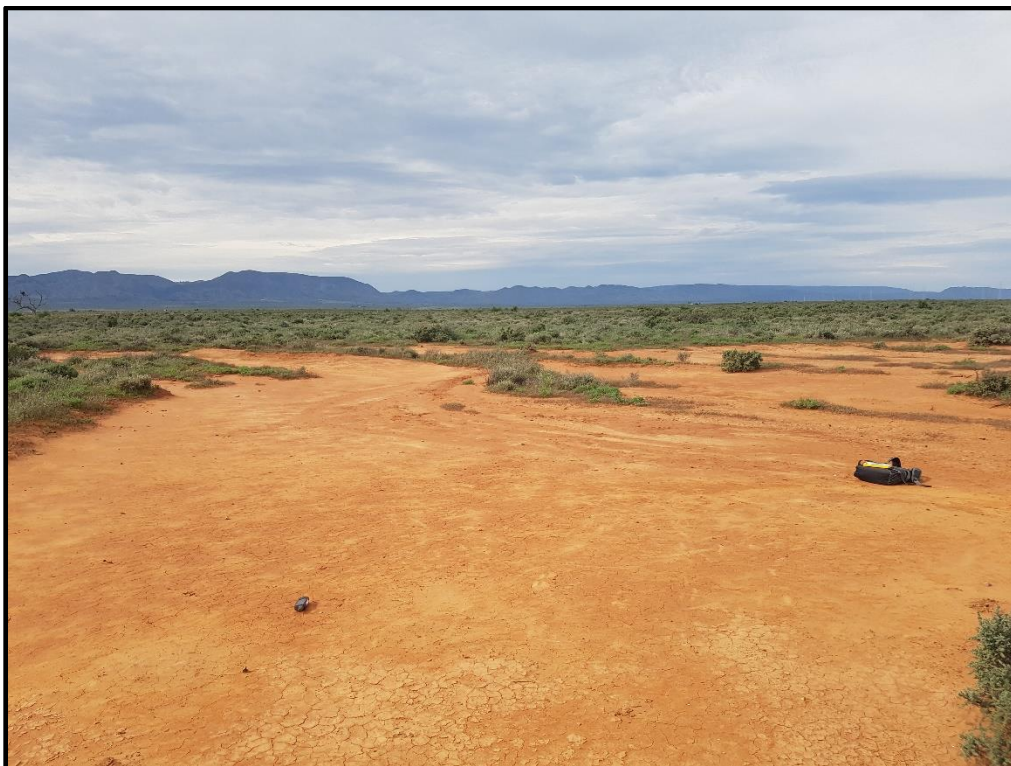
Figure 9 – View southeast across Stage 2 East 3

Stage 2 East 3 is situated approximately 270 metres to the west of Stage 2 East 2. The vegetation is thicker towards the inner sections of the paddocks with sandy exposures being less frequent. The site is subject to regular inundation and wind erosion. A distinct sandy exposure features approximately 15 artefacts including flakes and broken flakes and one core (including one broken quartz flake with distinct edge work). The primary raw material represented is silcrete and quartz at the site. The artefacts are spatially relatable and as such represent a locus of human activity constituting an Aboriginal site. Artefact density is variable and would average about 1/5m². The artefacts are subject to natural disturbances in the form of wind and water erosion and it is possible that some artefacts are buried in the loose sands. See Figures 9-10.

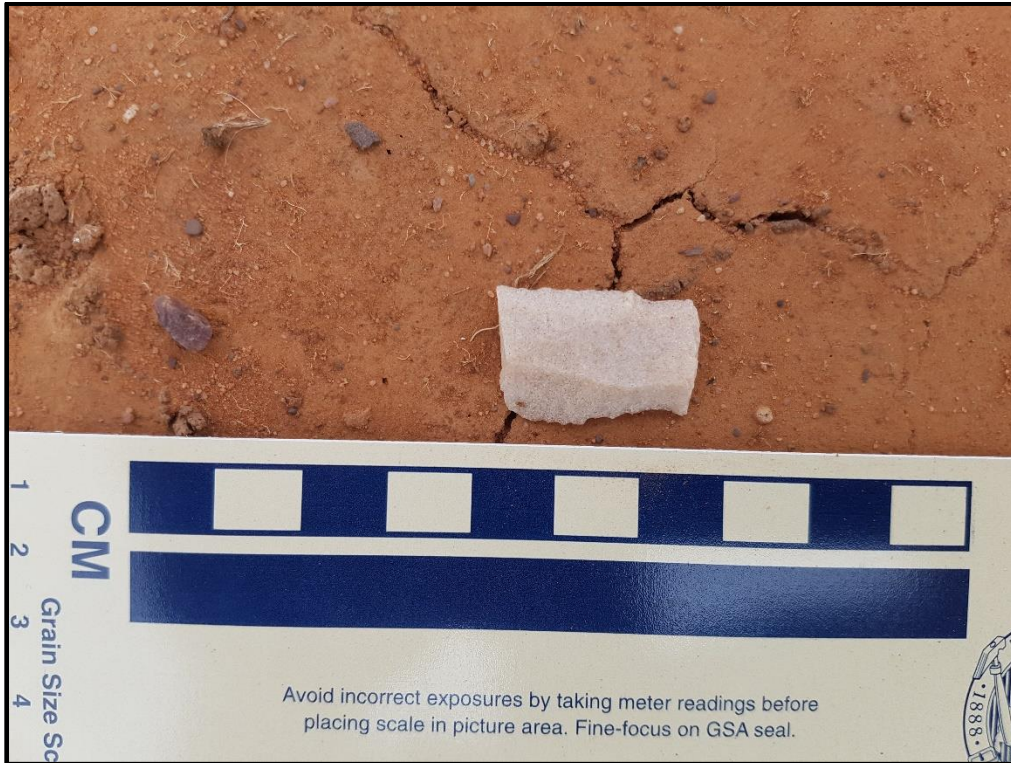
Figure 10 – Broken silcrete flake

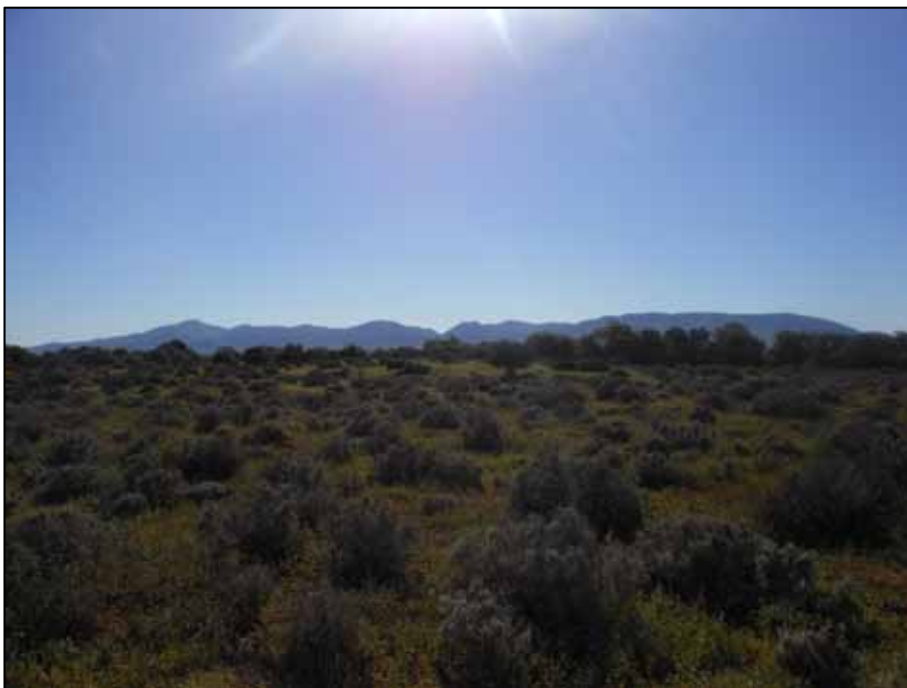
Figure 11-1: Sand dunes near turbines 50 and 51. Image facing east.

- Medium Sensitivity relating to turbines intersecting with watercourses (turbines 55 to 58, see Figure 11-2)
- Medium Sensitivity relating to turbines intersecting with sand dunes and undisturbed areas (turbines 42, 16, 43, 50 and 51, see Figure 11-1)
- Low Sensitivity relating to all other turbines (turbines 1 to 8, 10 to 15, 17 to 23, 25, 26, 31 to 34, 36 to 39, 40 to 41, 44 to 49, 52 to 54 and 59 to 67)
- Low Sensitivity relating to the two Solar Array areas, with the exception of a small area within the western Solar Array area which was determined to have Medium Sensitivity

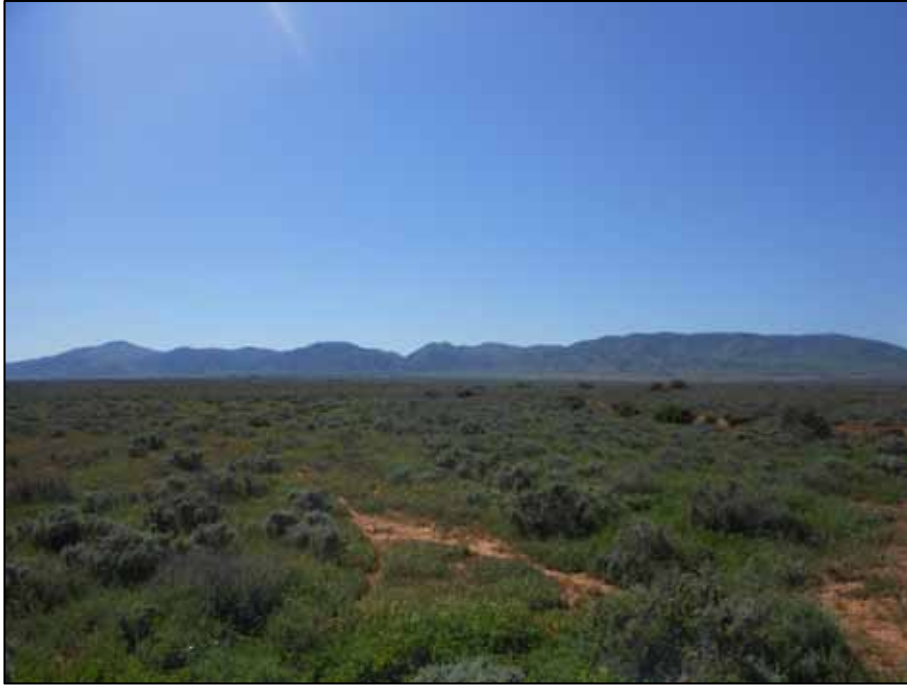
Figure 11-2: Project Site facing east near turbine 55. Note ephemeral water way running along proposed turbine alignment to the right of slide.
