Detailed Site Investigation

Pieces 501 and 502 Gillman
208 Eastern Parade, Gillman
North Arm Road, Dry Creek
South Australia

Prepared for: Department for Infrastructure
and Transport
Date: 3 June 2024
Reference: JC1406_DSI.03_FINAL
Version: 03

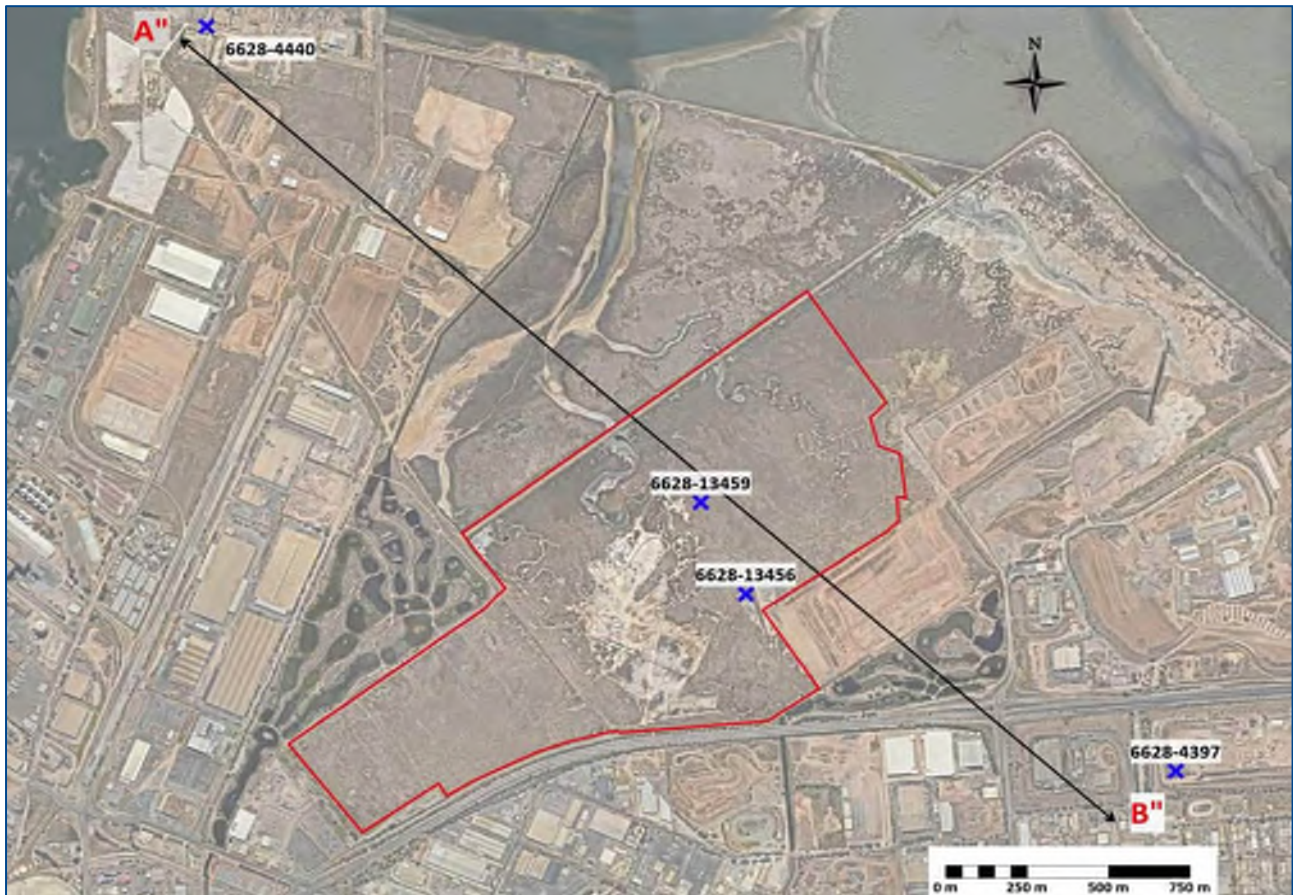
Figure 3: Site Location Relative to Historic Cross Section.

Past investigations have investigated the geology of the broader area, with the site captured between points A” and B” as shown on Figure 3. An indicative cross section shows that the geology of the site comprises Quaternary sediments representative of the St Kilda, Pooraka, Glanville and Hindmarsh formations (Figure 4; Belperio & Rice, 1989). The St Kilda and Glanville formations are similar and comprise silty fine-grained sands with shell debris and decomposed seaweeds. The Pooraka formation comprises sandy clay or clayey to sandy silt, with typically stiff clay. The Hindmarsh formation is predominantly a mottled red brown, yellow brown and grey, stiff to hard clay.

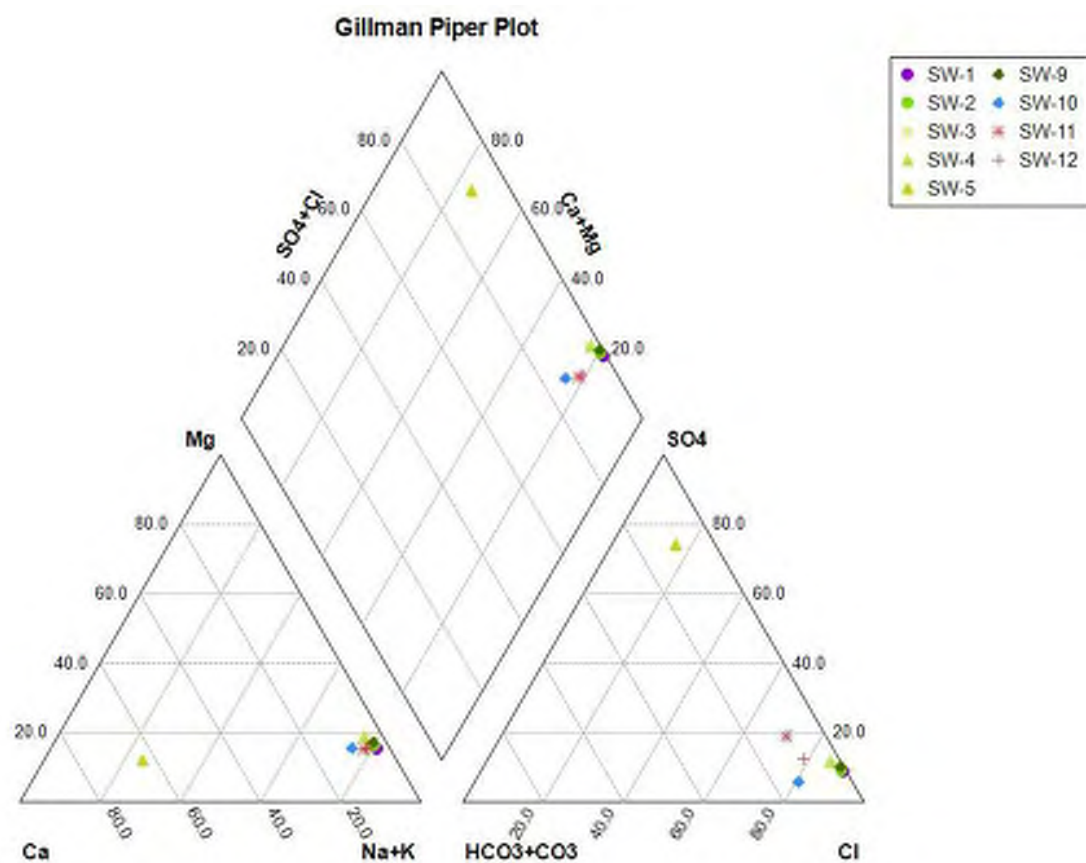
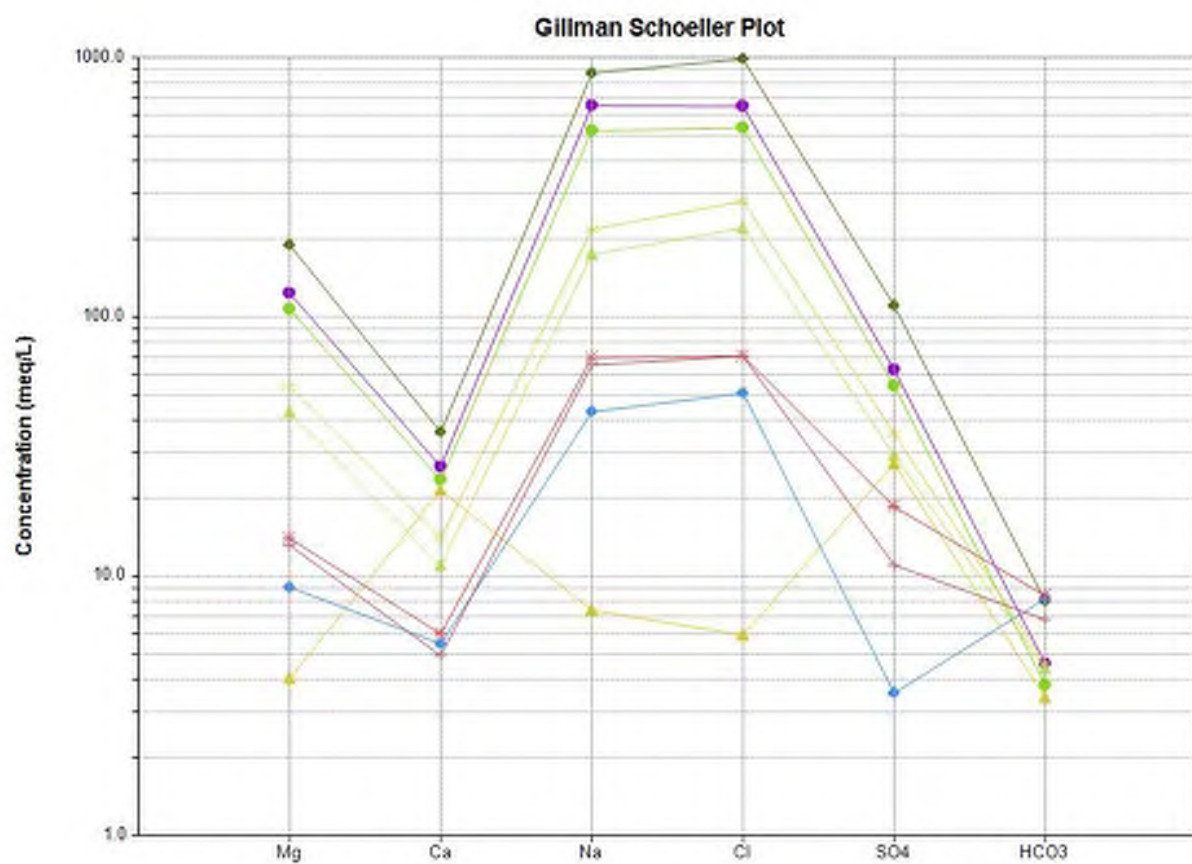
Figure 13: Piper and Schoeller Plots – Surface Water

proportion of sodium, chloride and magnesium. The signature of SW-5 may be a result of local stormwater interaction with local soils (ASS as a source of sulphate and calcium from shell debris).

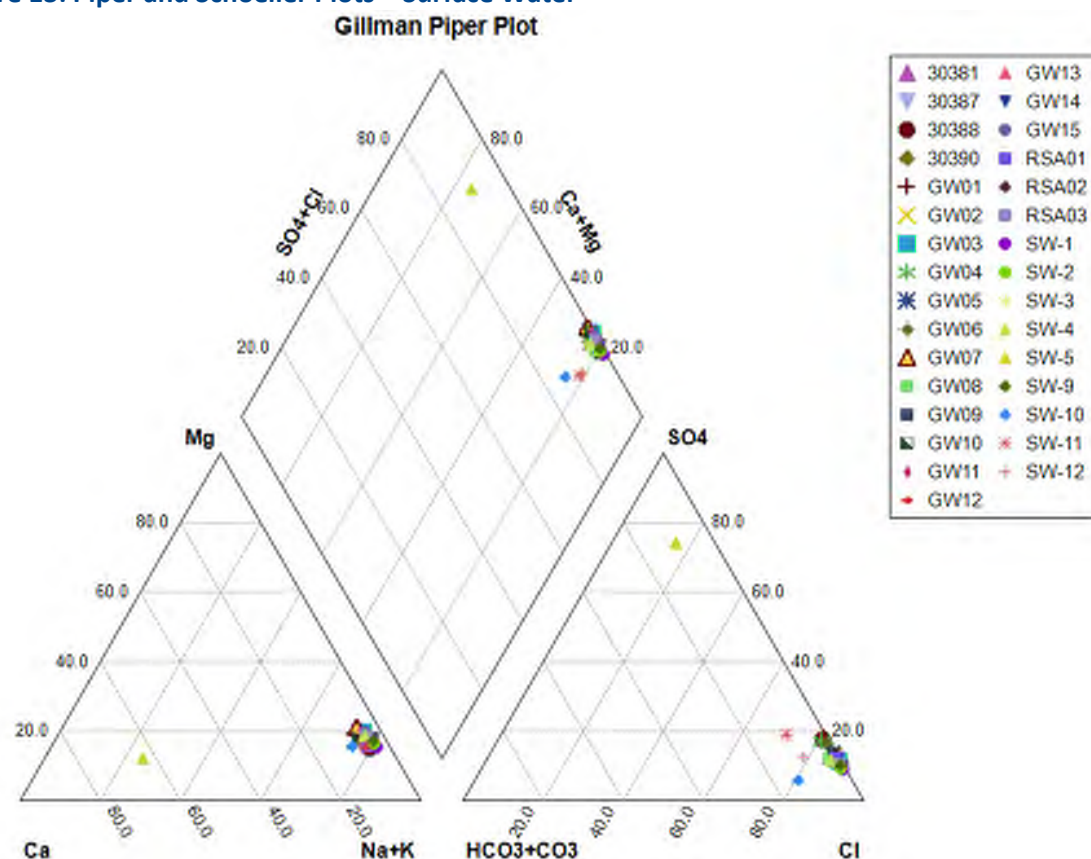
Figure 14: Piper and Schoeller Plots Combined Groundwater & Surface Water

Figure 14 present combined sets of surface water and groundwater signatures. With the exception of SW-5 explained above, all signatures show a consistency on the Piper and parallel lines on the Schoeller plot. This suggests that groundwater and surface water are interconnected with the surface water in the ponds receiving fresh water from stormwater discharges which does not alter major ion proportion significantly.

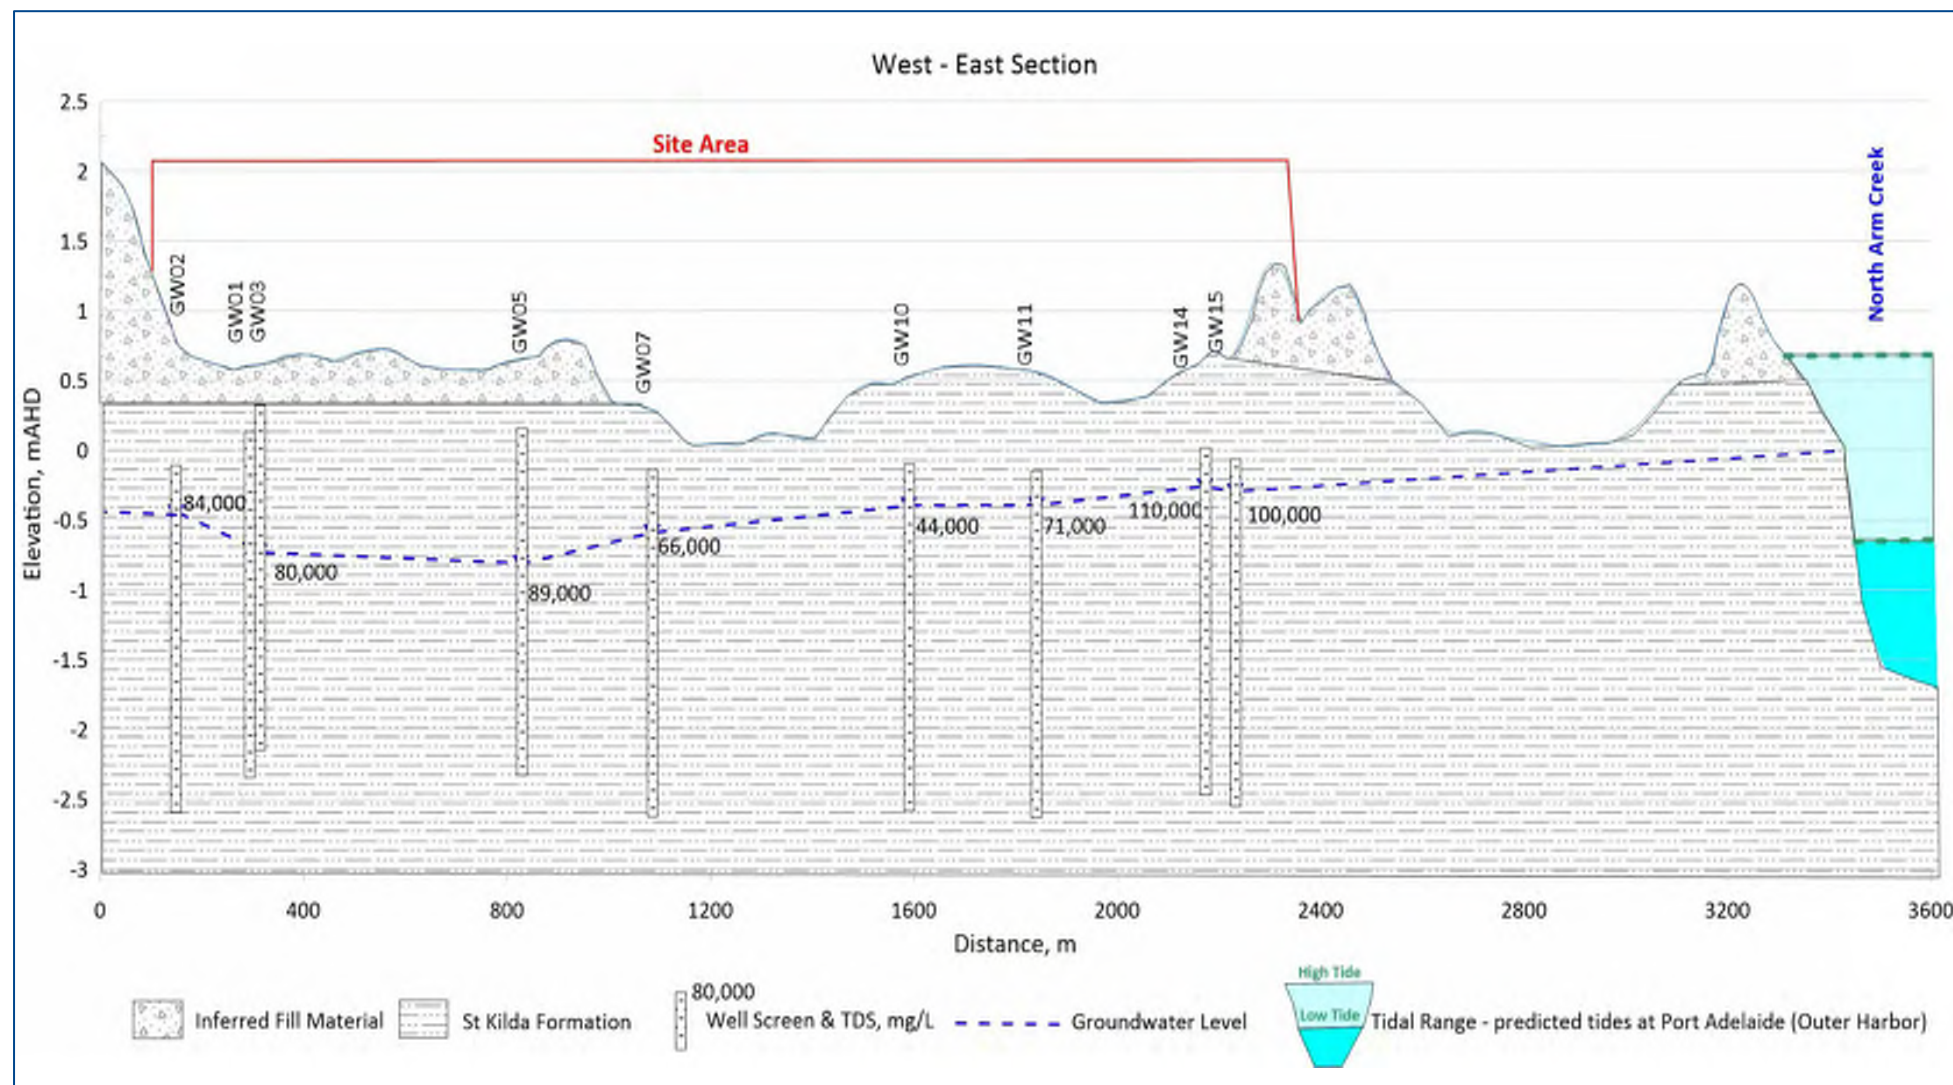
Figure 15: West-East Schematic Cross Section

A comparison of groundwater and surface water hydrochemistry as well as concentrations of chemicals of concern confirms some level of interaction and potential 'exchange' of chemicals. Seasonal surface water release and flooding in some parts of the site may result in infiltration and recharging groundwater, i.e. impacting on groundwater. On the other hand, during seasonal groundwater level rise groundwater may be exposed at the surface, causing some water logging and mixing with surface water causing surface water impacts. Additional investigations including water level gauging and sampling conducted during the wet season would improve the understanding of the surface water and groundwater interaction.
