# Preliminary Site Investigation (PSI)

Arumpo Street,  
Renmark

JHN Investments Pty  
Ltd & The Trustee for  
Callop Le Family Trust

# HAZARDOUS MATERIAL SURVEY AND REPORT

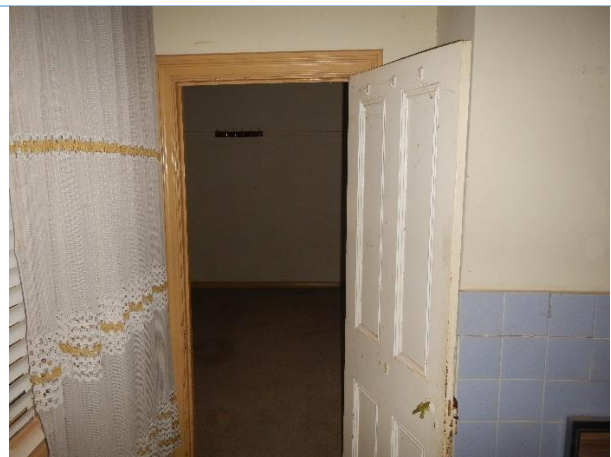
*Example: Internal paint to Residence*

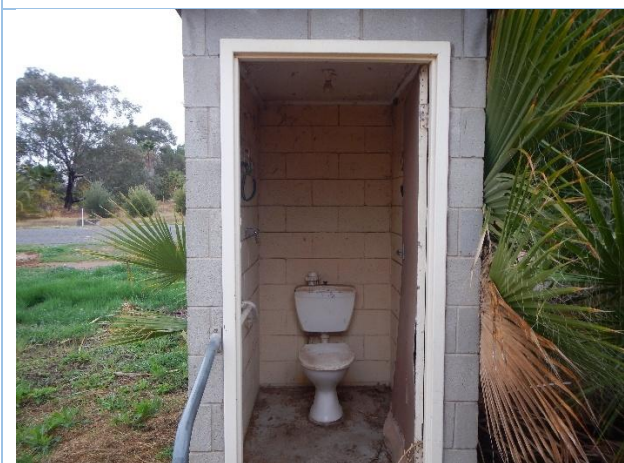
*Example: External/Internal paint to Residence Outhouse*

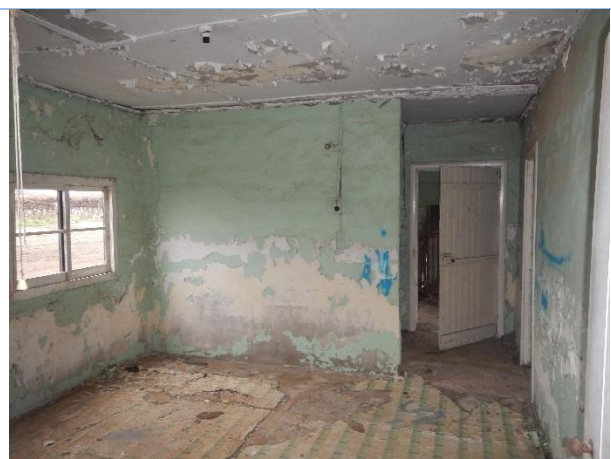
In some locations , for example the internal of the Old Pickers' Quarters, had paint in very poor condition.

*Example: Internal paint to Old Picker's Quarters – flaked*

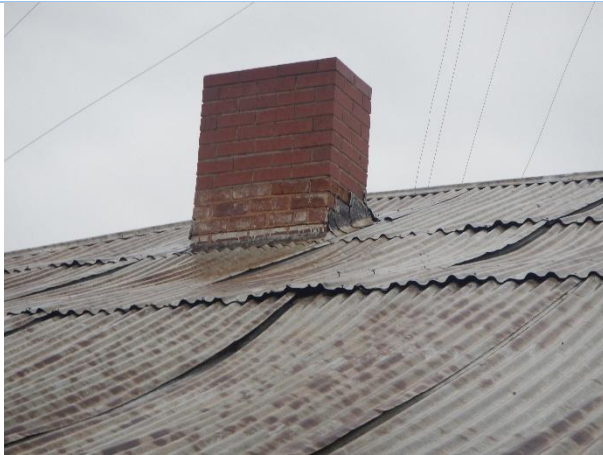
**Residence** – External, Rooftop chimney possible flashing, Gutters have soldered joints, and there are leadlight windows to the northern elevation (will possibly be removed for salvage by the owner).

Example: Residence, External – flashing to chimney

Any “soft” metal flashings should be treated as lead containing if discovered.

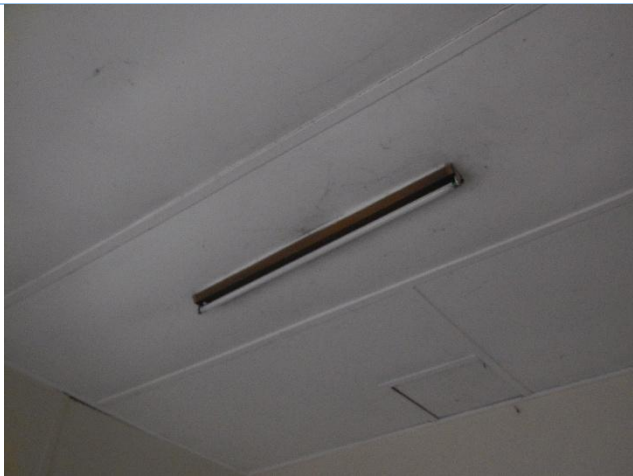
It was likely PCBs were used in this context based on the ban on PCBs in 1975 in Australia and these are older fixtures.

*Example: Fluorescent light fixture in the Residence, Kitchen*

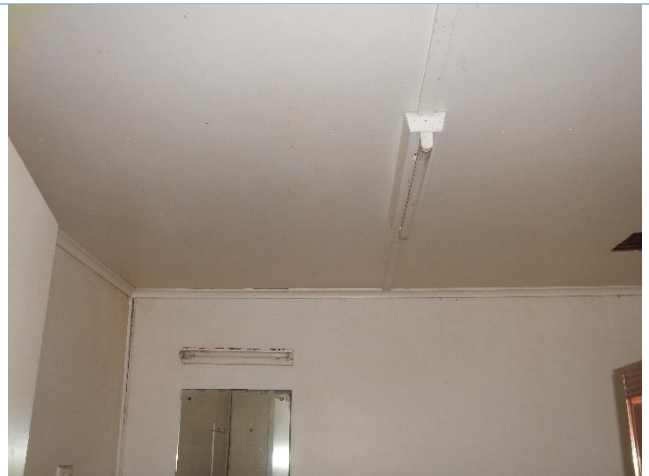
*Example: Fluorescent light fixtures in the Residence, Bathroom*

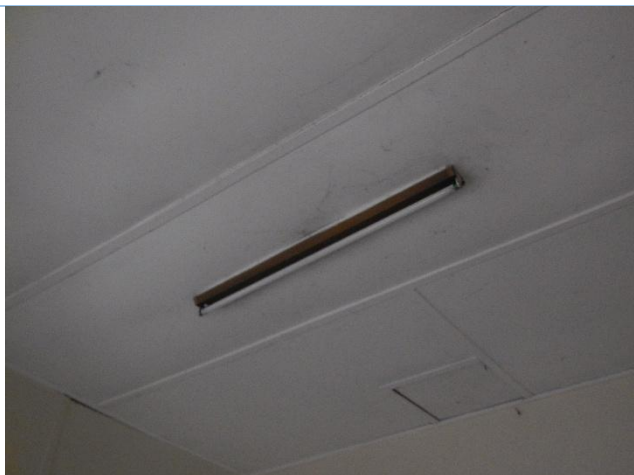
Example: Fluorescent light x 1 in the Residence, Kitchen

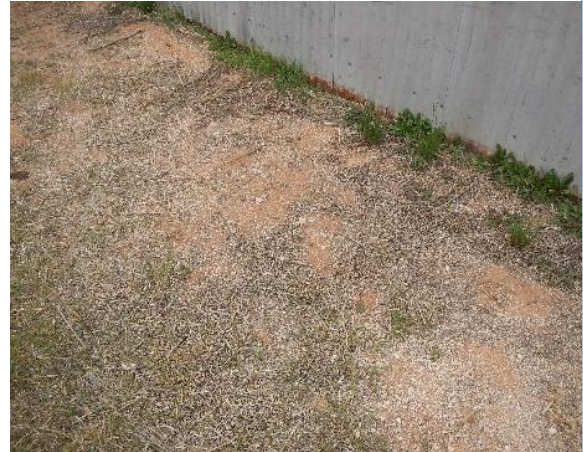
| Findings: | Debris removed as sample during survey |

*Before – minor fragment removed as sample*

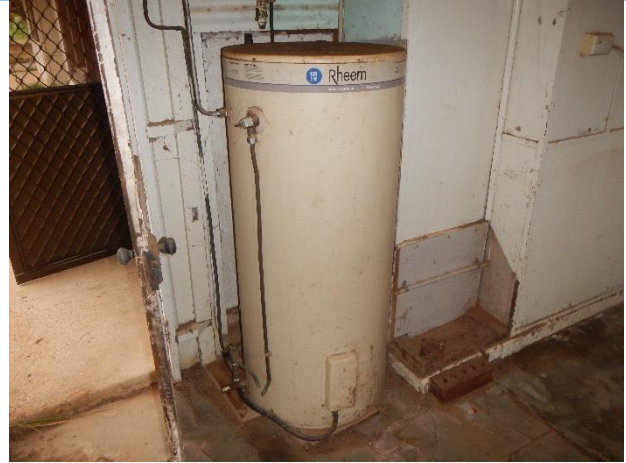
Possible insulation withing hot water service.

*Example: Hot water unit in Laundry of Residence*

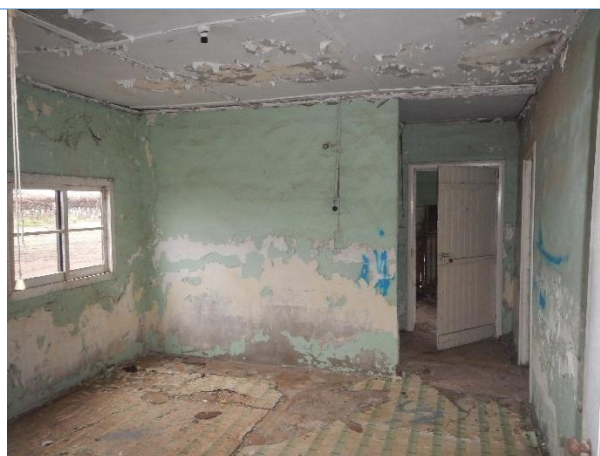
In some locations , for example the internal of the Old Pickers' Quarters, had paint in very poor condition.

*Example: Internal paint to Old Picker's Quarters – flaked*

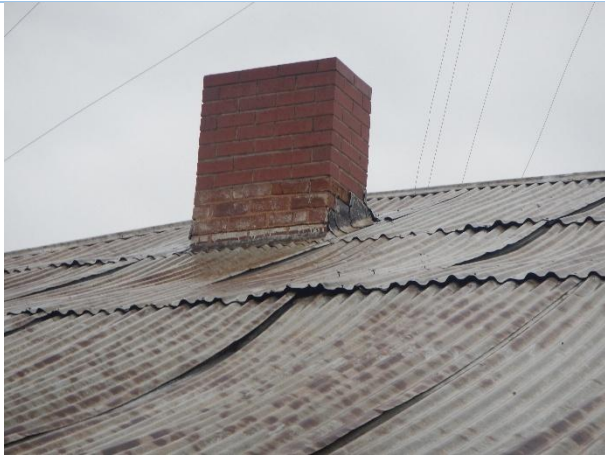
**Residence** – External, Rooftop chimney possible flashing, Gutters have soldered joints, and there are leadlight windows to the northern elevation (will possibly be removed for salvage by the owner).

Example: Residence, External – flashing to chimney

Any “soft” metal flashings should be treated as lead containing if discovered.

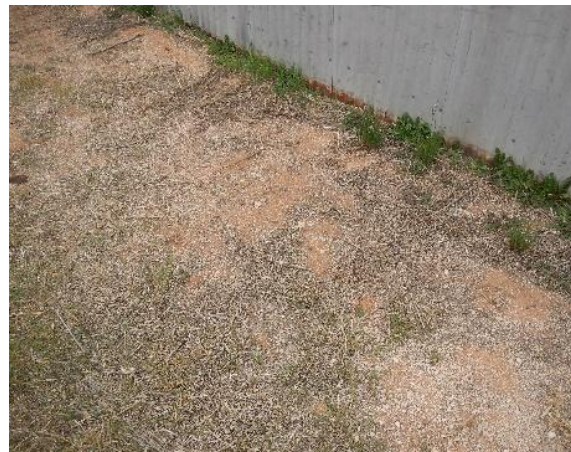
| Findings: | Debris removed as sample during survey |

*Before – minor fragment removed as sample*

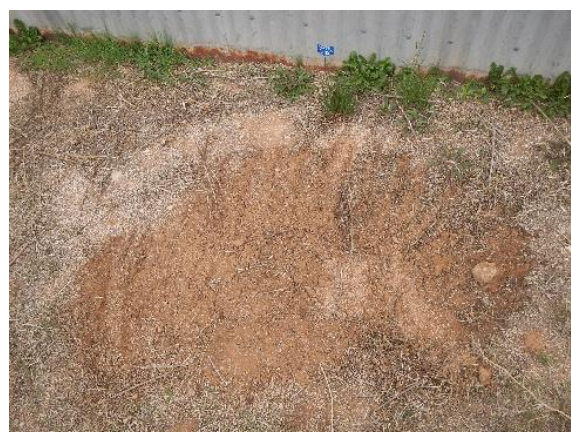
*After - Subsequently the area was raked and checked for other possible fragments – no asbestos was visible*
