# MEMO

Re: Bonded Asbestos Remediation and Validation Methodology Summary

**Arumpo PSI**  
**Arumpo St, Renmark West SA**  
**5341**

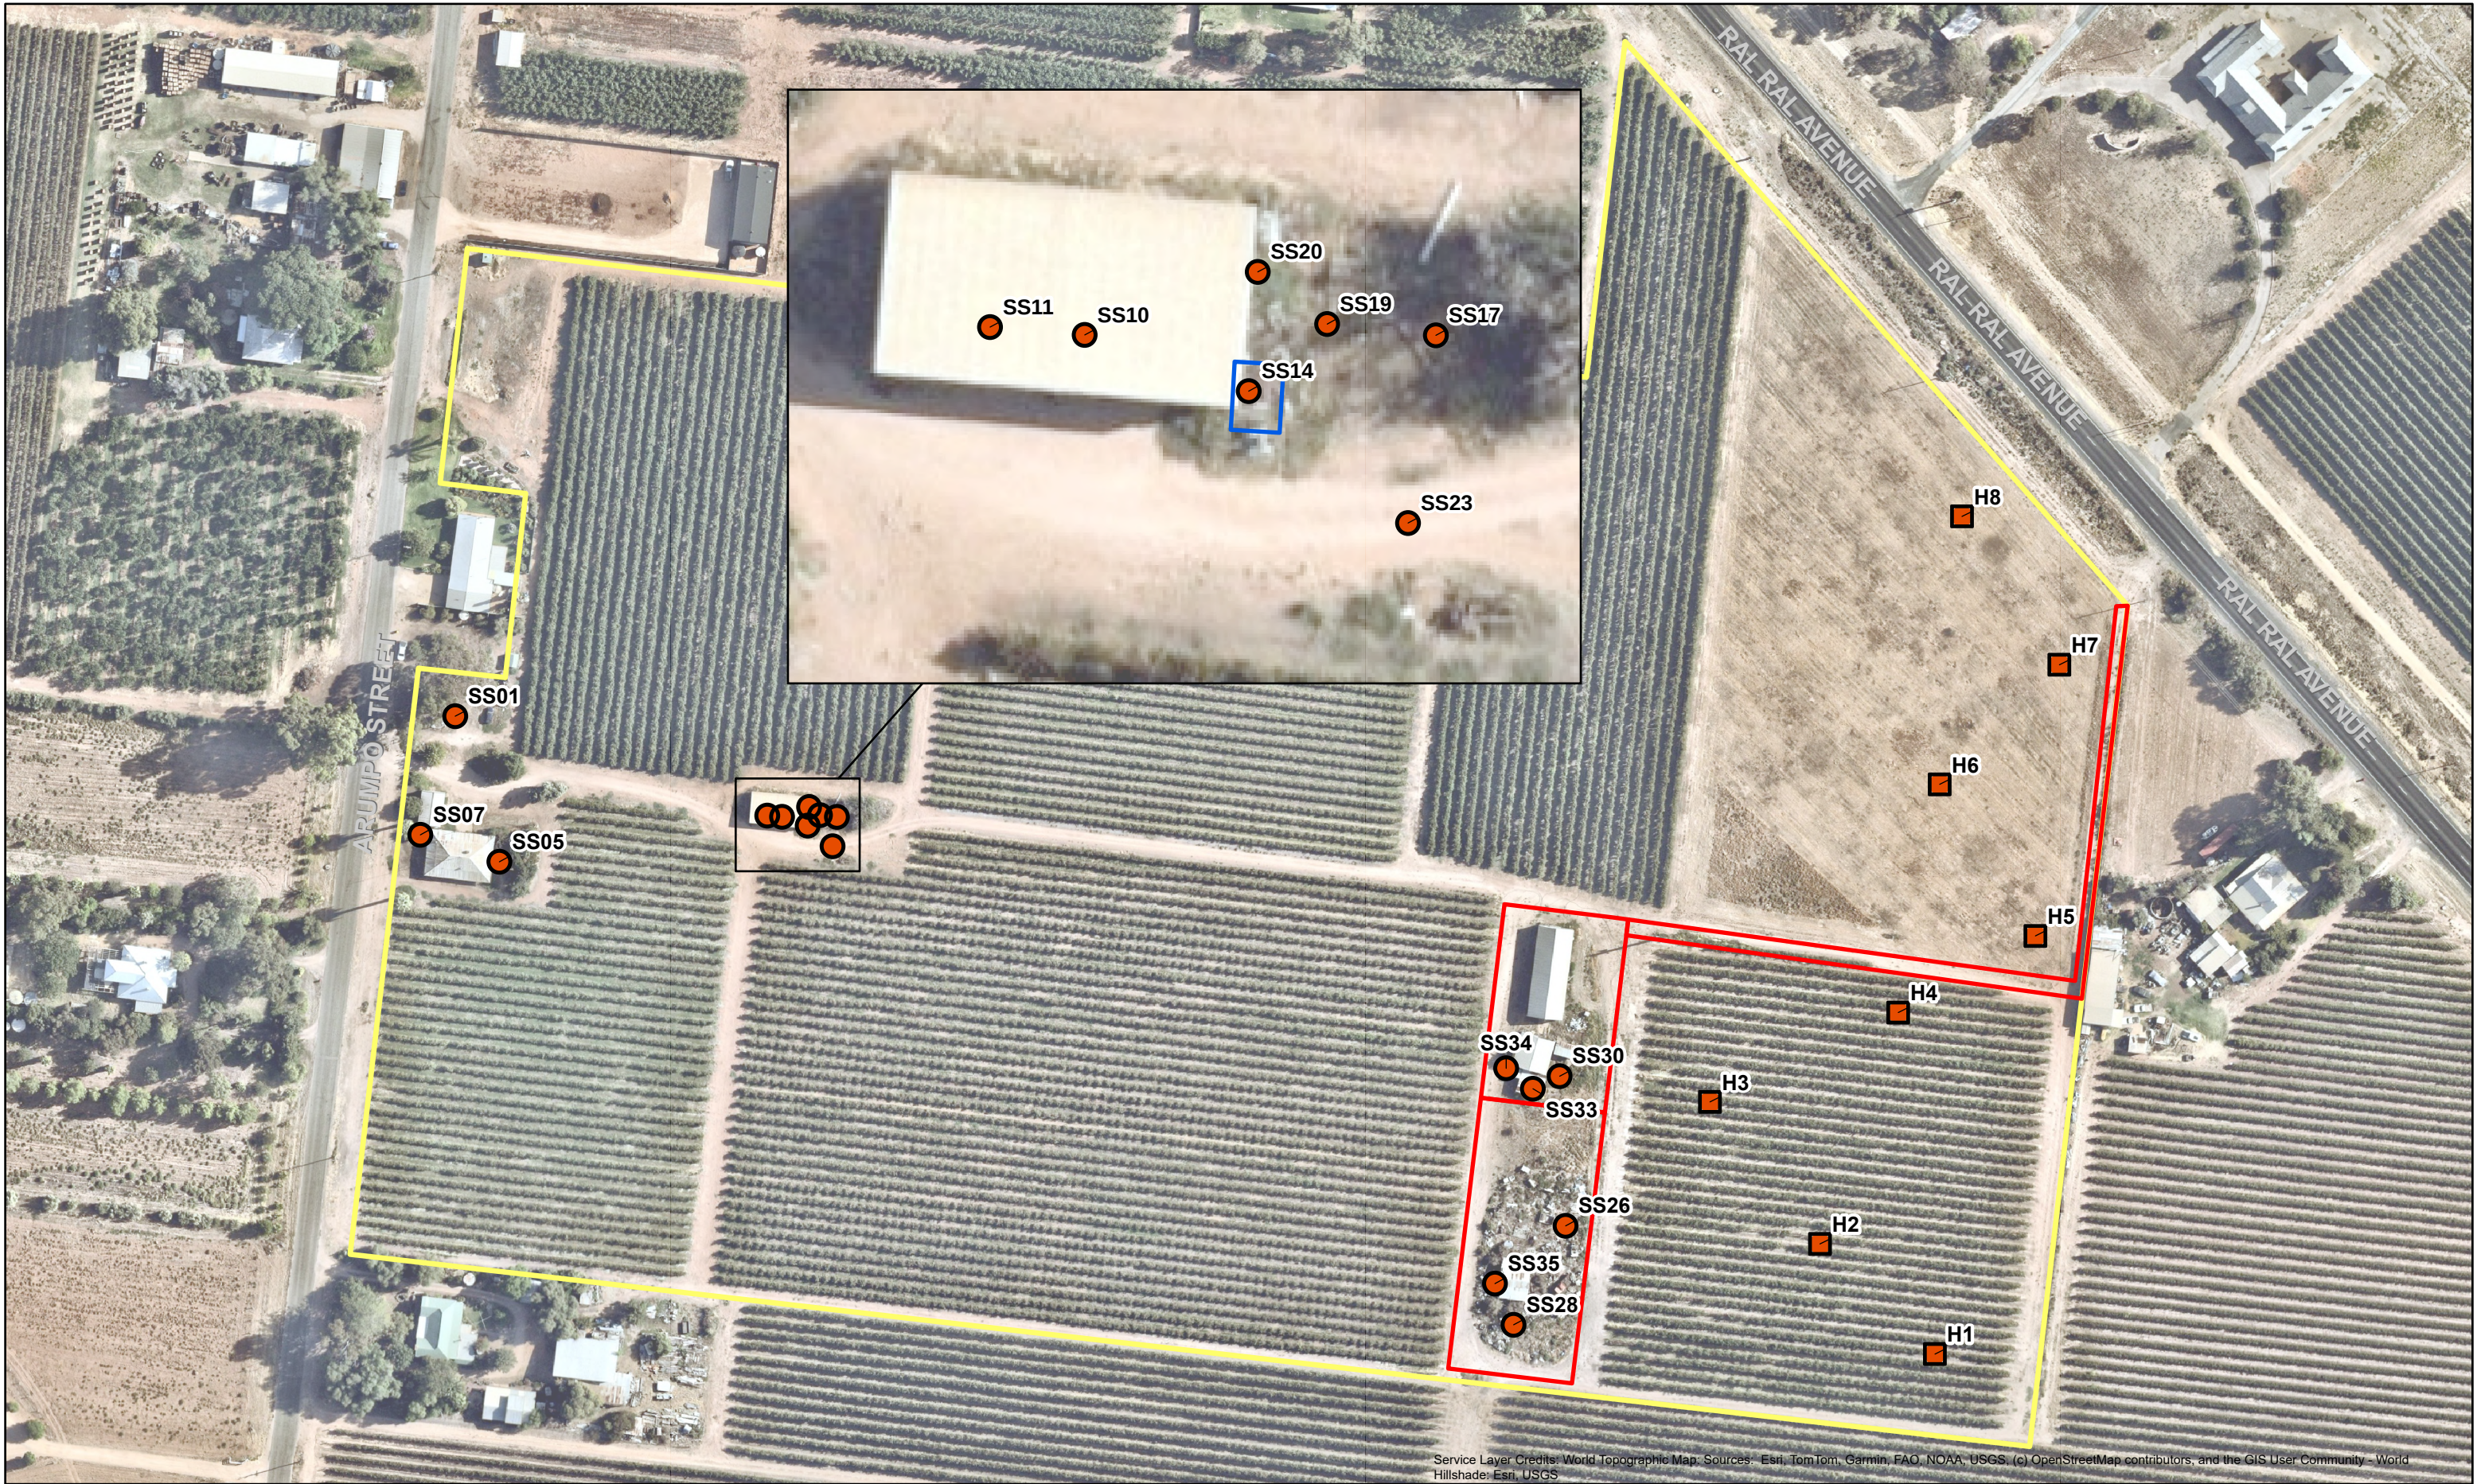
#### **Figure 2 – Sample Location Plan**

This memo summarises the proposed approach to remediate bonded asbestos containing material (ACM) fragments from the surface of 55 Arumpo Street Renmark, which was identified during a Preliminary Site Investigation (PSI) undertaken by EHS Support in 2025. The areas where bonded ACM remains on the surface of the site is presented in **Figure 2** at the end of this memo.

### Sample Location Plan

- Each impacted area identified in the attached plan will be divided into transects in both a north south and east west alignment.
- Each transect will be inspected by an experienced environmental scientist and all suspected bonded ACM will be removed from the surface of the site.
