# Preliminary Site Investigation (PSI)

Arumpo Street,  
Renmark

JHN Investments Pty  
Ltd & The Trustee for  
Callop Le Family Trust

# HAZARDOUS MATERIAL SURVEY AND REPORT

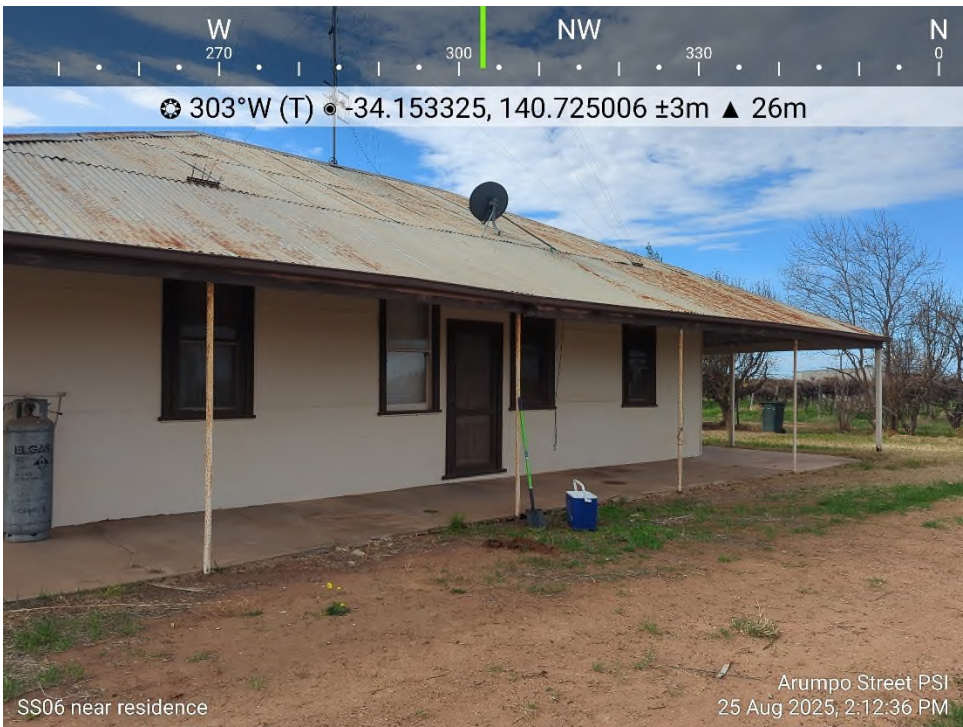
| Client Name:<br>Neilly Group | | Site Location:<br>Arumpo Street | Project No.<br>PTY.06696 |
|---|---|---|---|
| Photo No. | 1. | <p>SS06 near residence</p> <p>Arumpo Street PSI<br/>25 Aug 2025, 2:12:36 PM</p> | |

| Client Name:<br>Neilly Group | | Site Location:<br>Arumpo Street | Project No.<br>PTY.06696 |
|---|---|---|---|
| Description: Eastern side of Residence | | | |

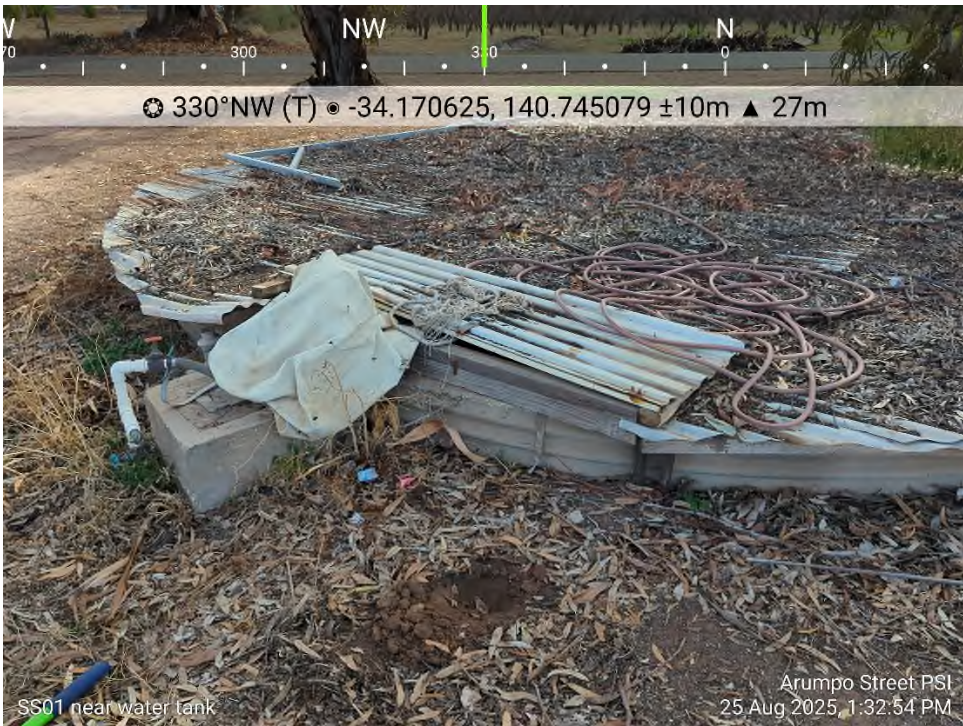
| Client Name:<br>Neilly Group | | Site Location:<br>Arumpo Street | Project No.<br>PTY.06696 |
|---|---|---|---|
| Description: Water tank near Residence | | | |

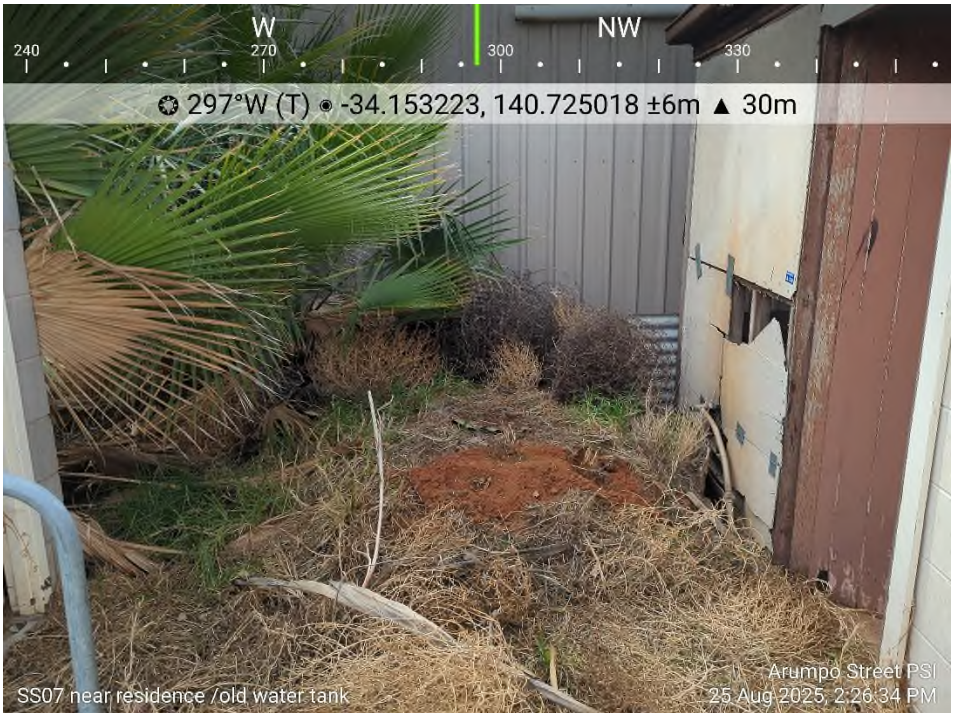
| <b>Description:</b> | Old water tank remnants on western side of Residence | |

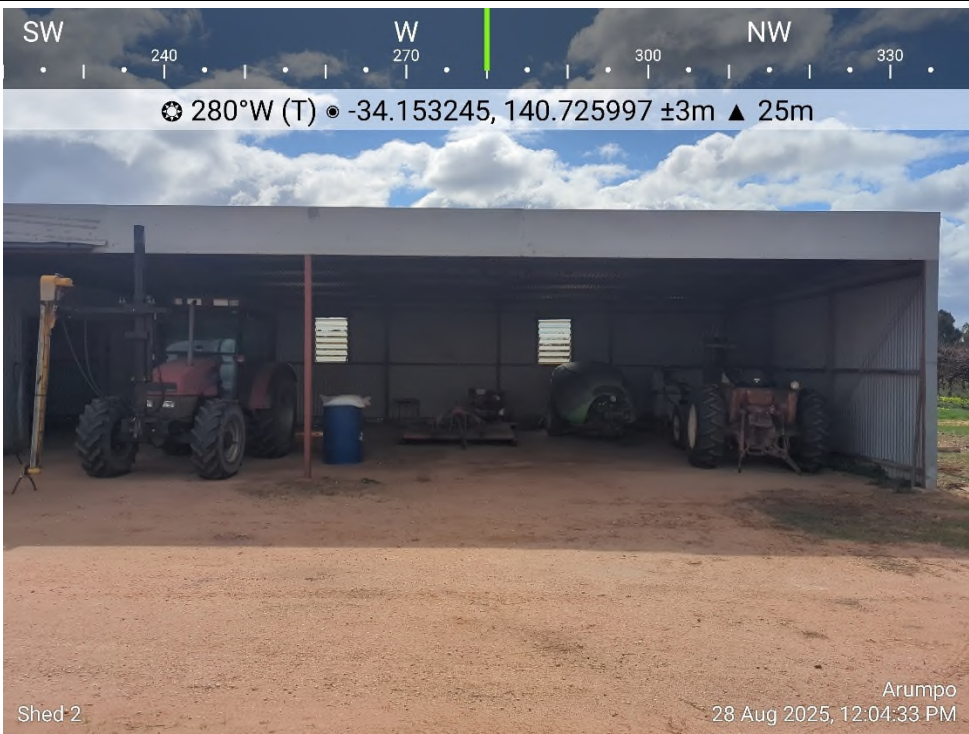
| <b>Description:</b> | Shed 2 | |

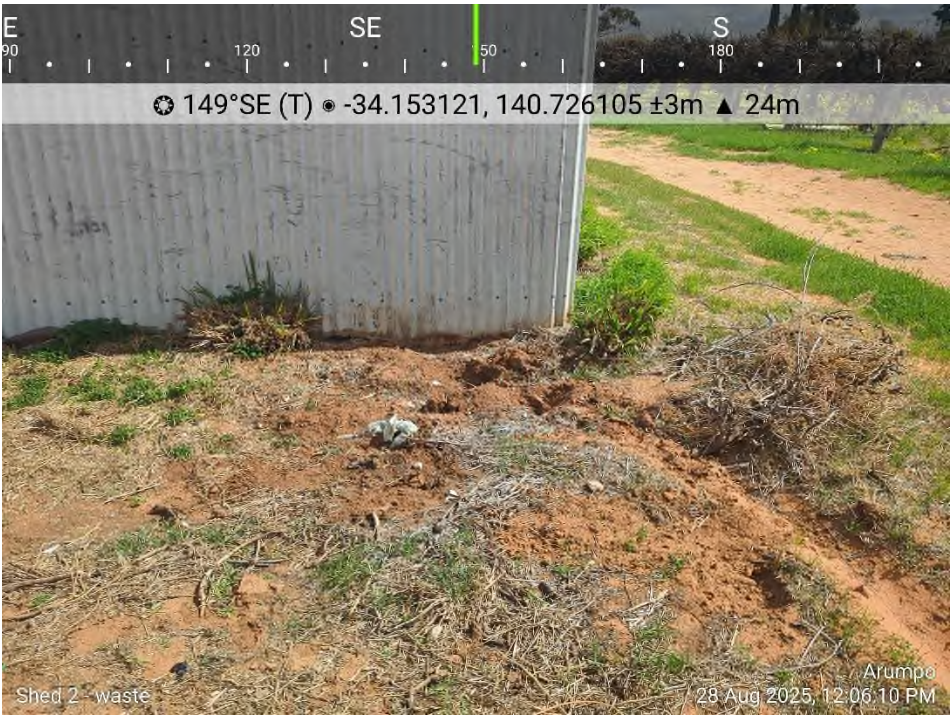
| Description:<br>Disturbed soil and waste near shed | | |

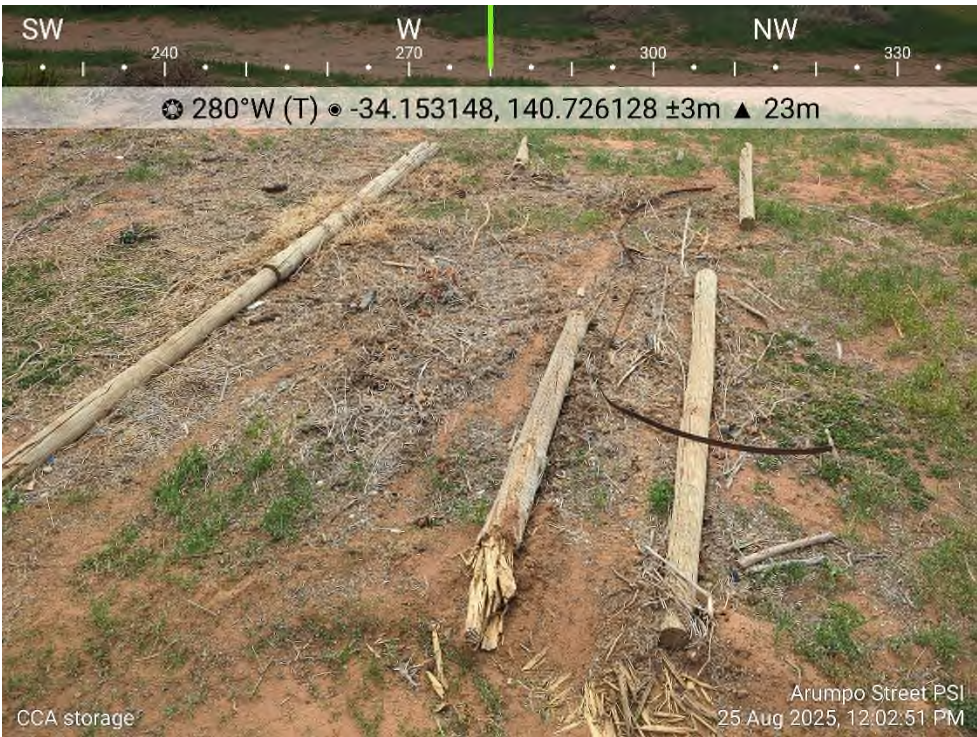
| Description:<br>UST Timber storage area | | |

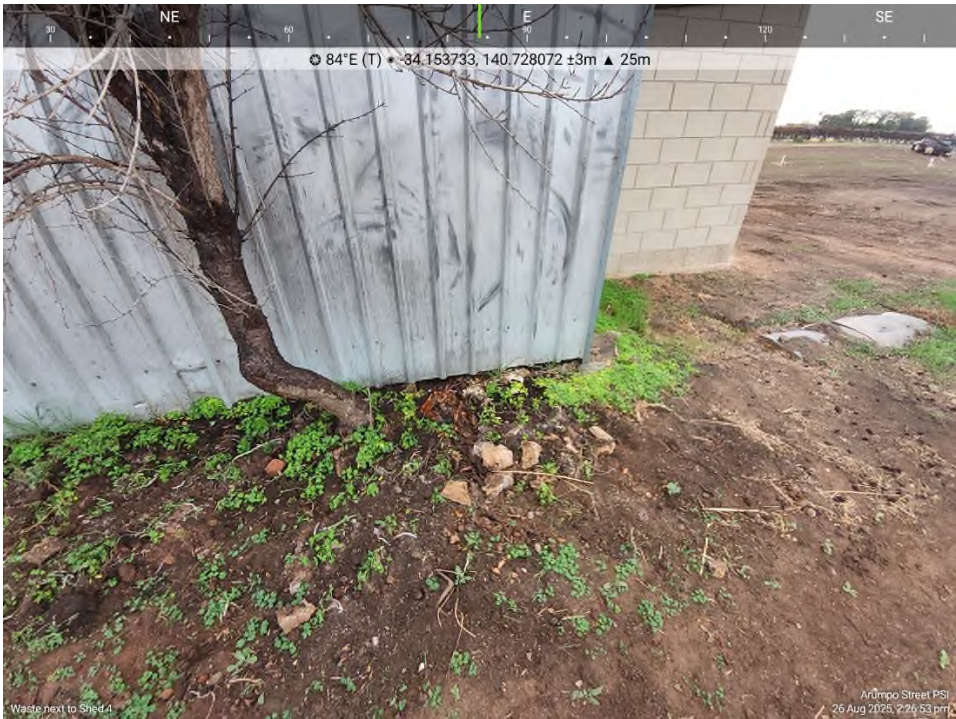
| Description: | Disturbed soil and ACM on western end of Shed 4 | |

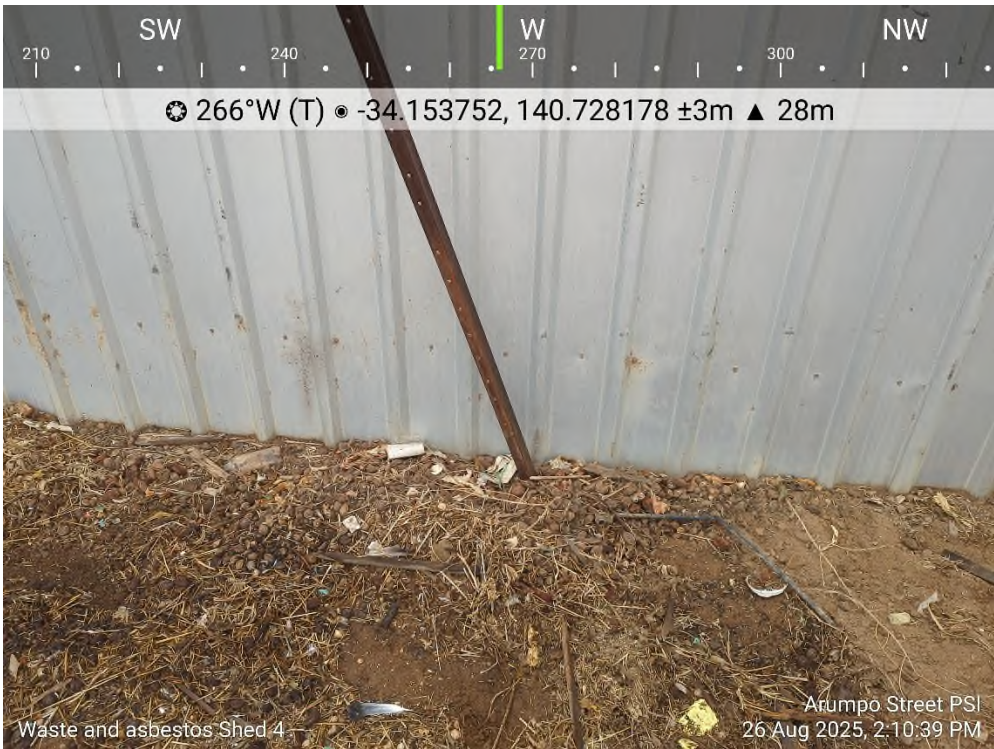
| Description: | Waste and ACM present at southern edge of Shed 4 | |

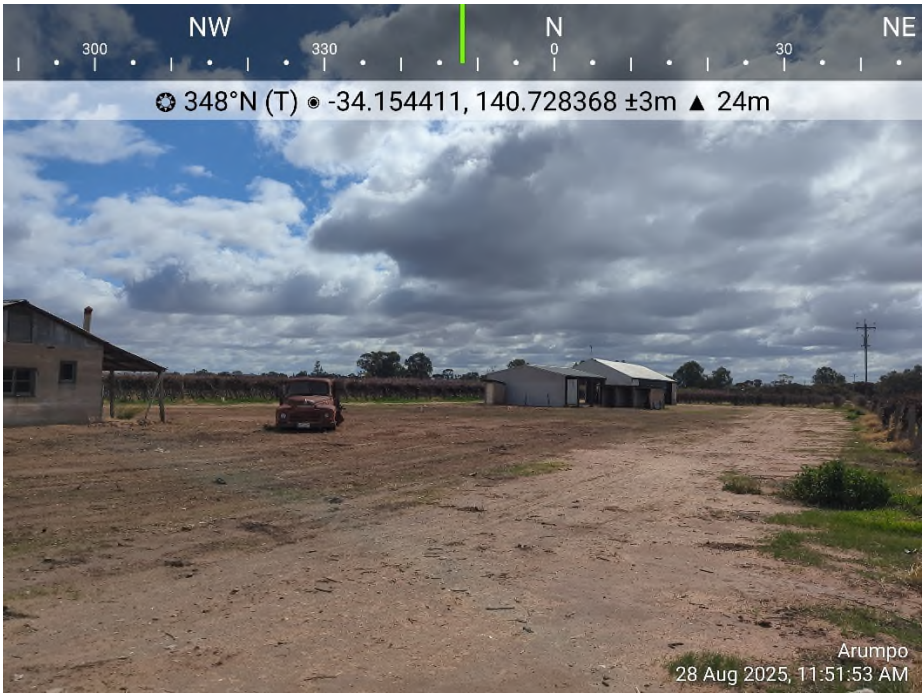
| Description: Looking North towards Shed 3&4. Picker's Quarters to the left of image | | |

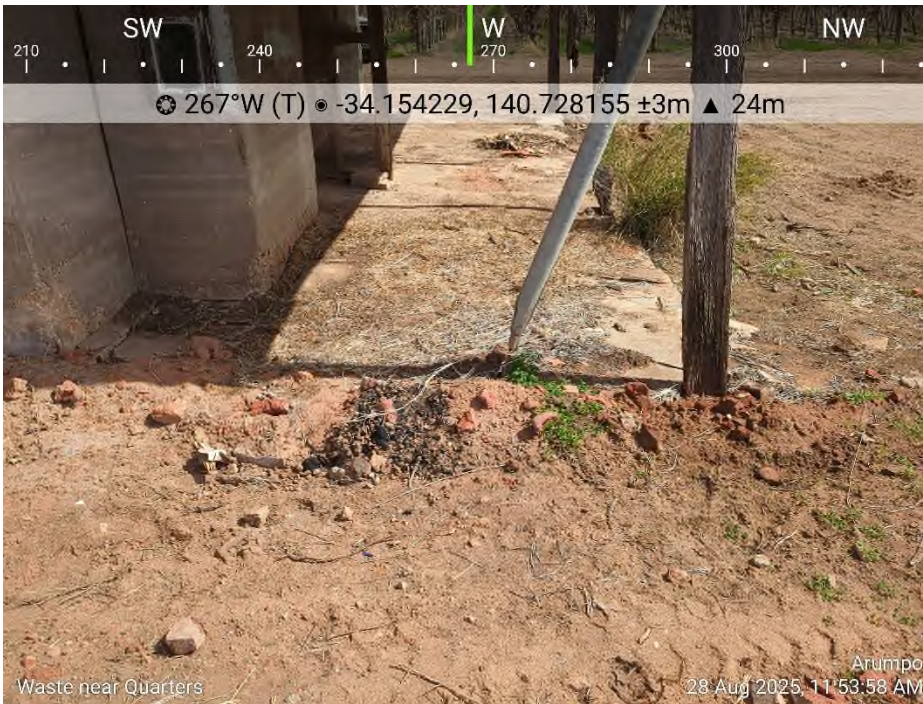
| Description: Rubble and waste east of Picker's Quarters | | |

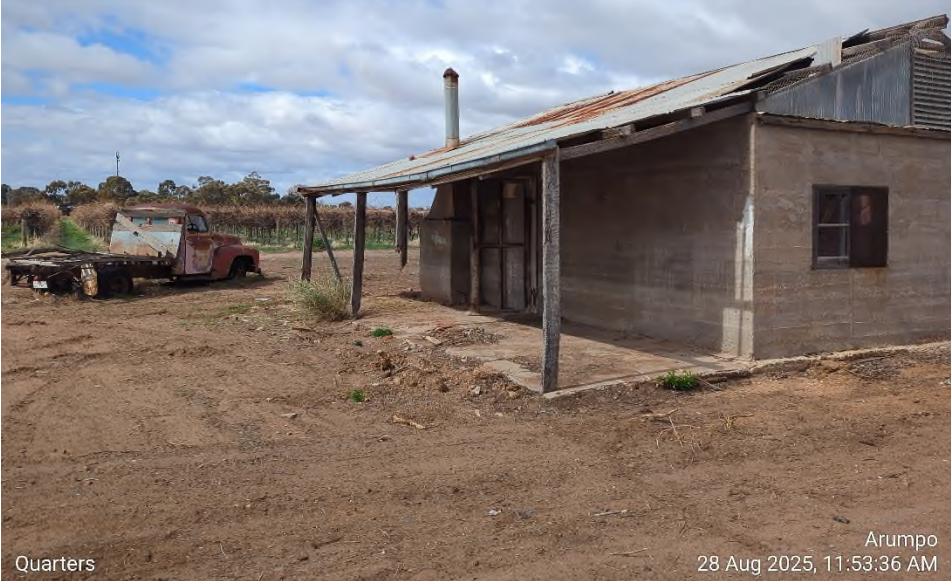
| Description: Building waste at boundary of Quarters | | |

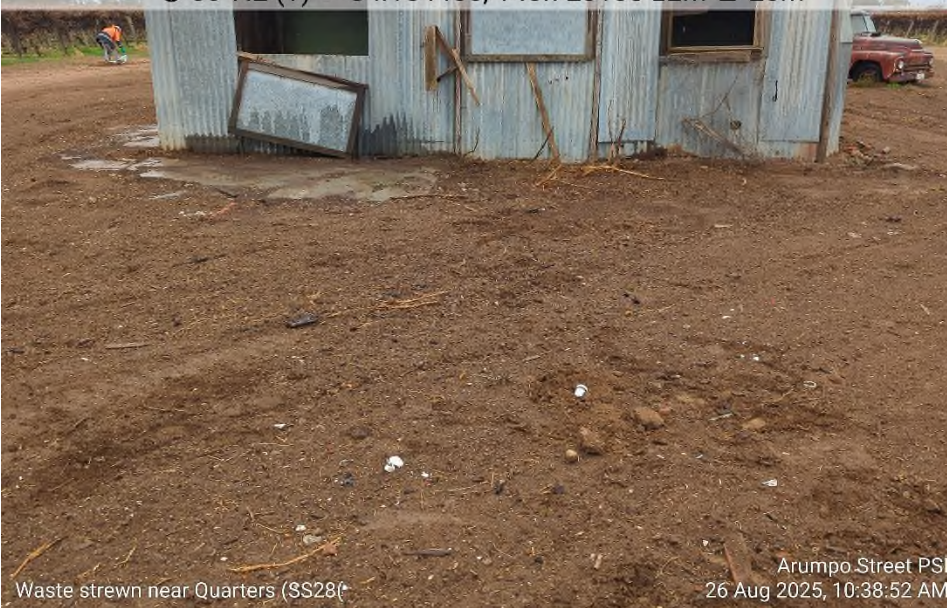
| Description: Waste east of Picker's Quarters | | |

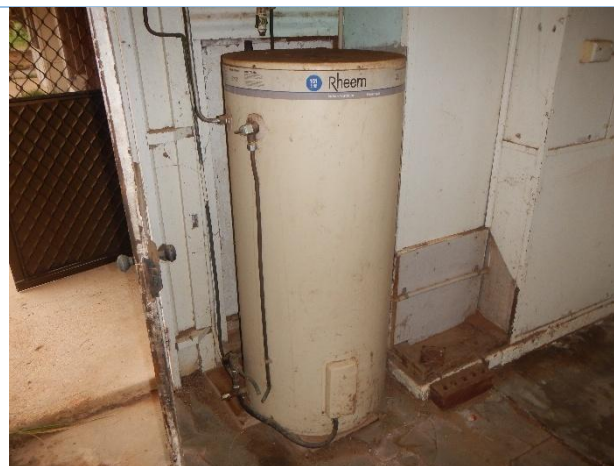
*Example: Hot water unit in Laundry of Residence*

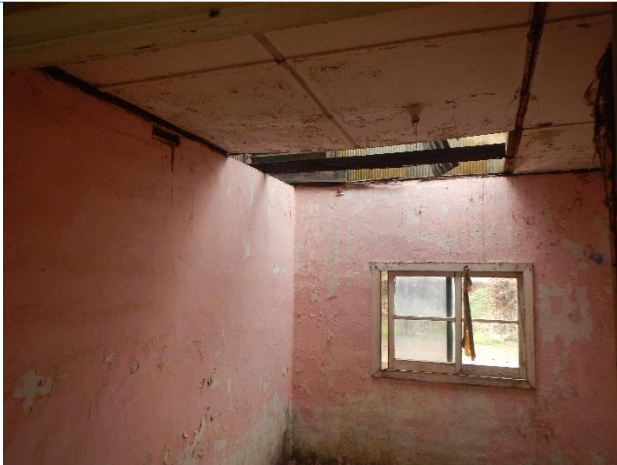
*Example: Internal paint to Old Picker's Quarters*

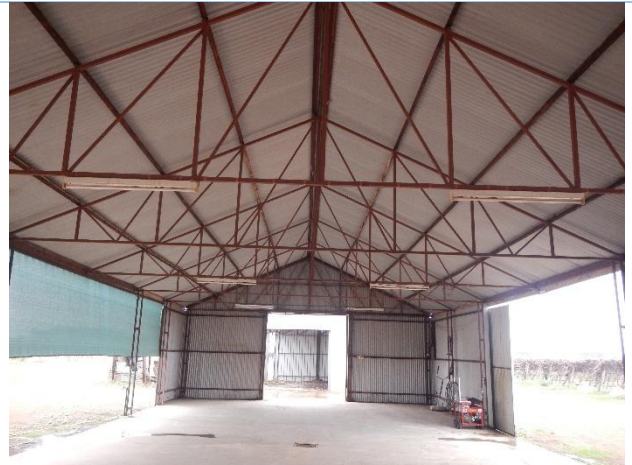
*Example: Internal paint to structural steel frame of Shed 3*

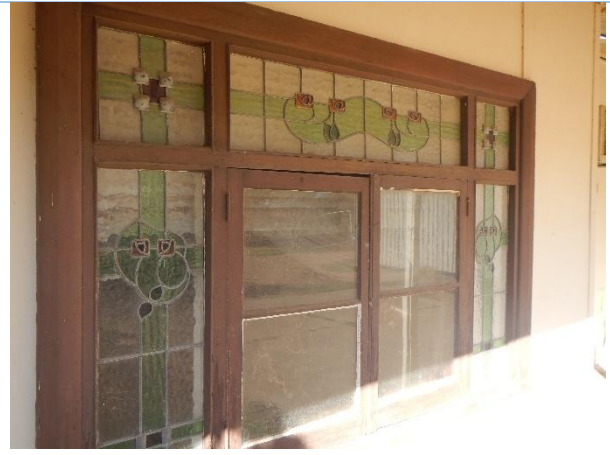
Example: Residence, External – Leadlight windows

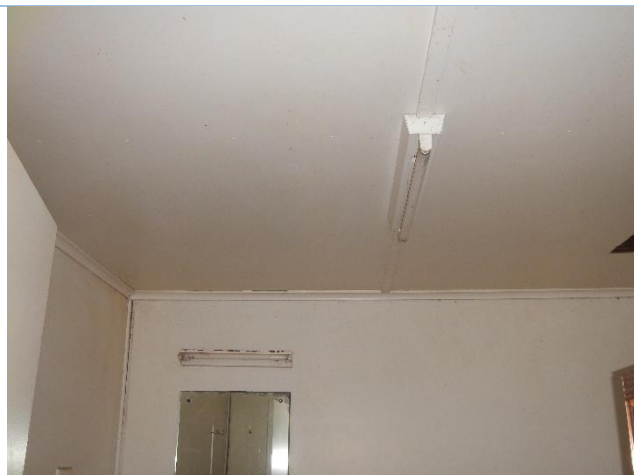
Example: Fluorescent lights x 2 in the Residence, Bathroom

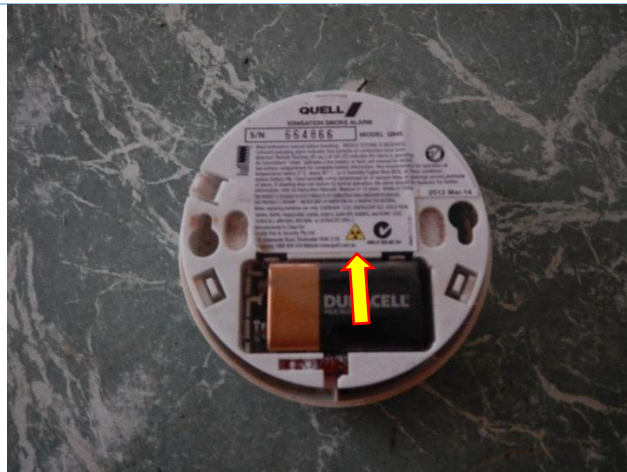
Smoke detector identifies radioactive isotope

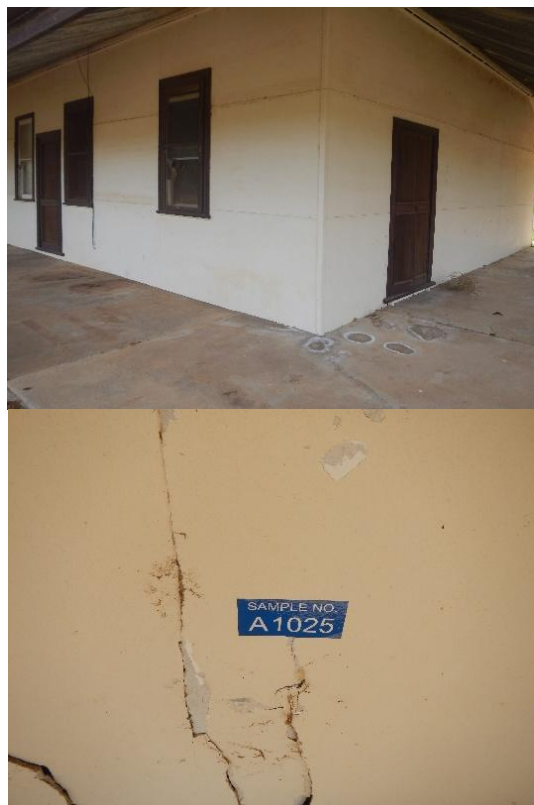
#### 2. Original build, Northern entry porch, east wall mounted upper electrical mounting board

| Material: | Fibre impregnated backing board "Zelemite" |
| Findings: | Good condition. Non-friable. Painted. Limited access.<br><b>The building is due for demolition.</b><br><b>Recommend remove prior to demolition.</b> |

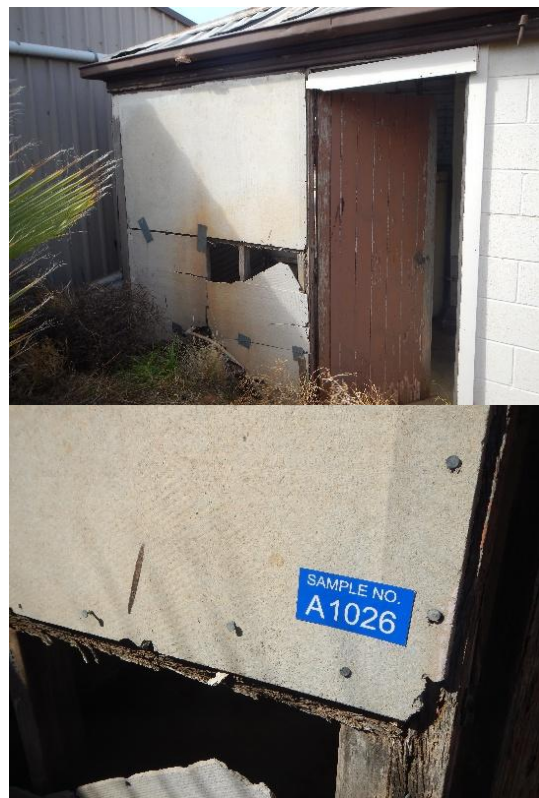
## 5. West extension, southern gable, infill

| Material: | Fibrous cement sheeting |
| Findings: | Good condition. Non-friable. Painted.<br>Limited access.<br><b>The building is due for demolition.</b><br><b>Recommend remove prior to demolition.</b> |
| Action Rating: | <b>A3x</b> |

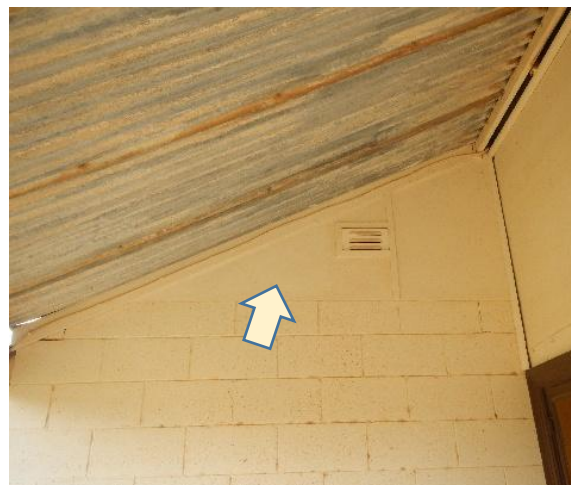
## 6. West extension, northern entry surround, cladding/infill

| Material: | Fibrous cement sheeting |
| Findings: | Medium condition. Non-friable. Painted.<br>Accessible.<br><b>The building is due for demolition.</b><br><b>Recommend remove prior to demolition.</b> |
| Action Rating: | <b>A2x</b> |

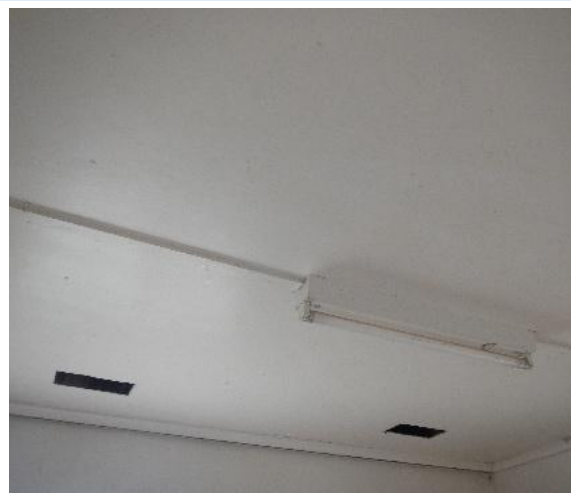
| Findings: | Medium condition, exposed holes. Non-friable. Painted. Limited access<br><b>The building is due for demolition.</b><br><b>Recommend remove prior to demolition.</b> |
| Action Rating: | <b>A2x</b> |

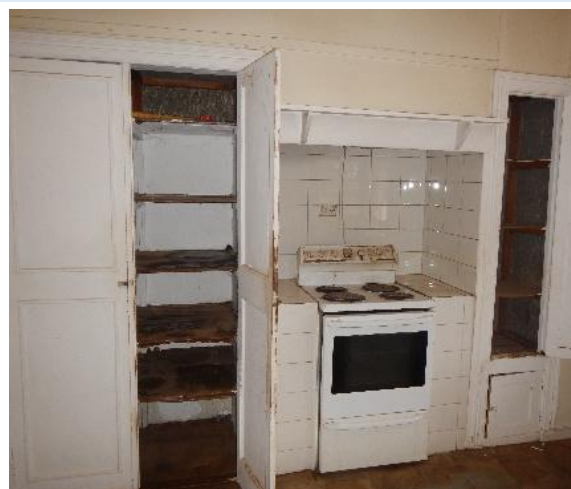
## 11. Kitchen, Range and associated cupboards, linings

| Findings: | Good condition. Non-friable. Not painted.<br>Accessible.<br><b>The building is due for demolition.</b><br><b>Recommend remove prior to demolition.</b> |
| Action Rating: | <b>A3x</b> |

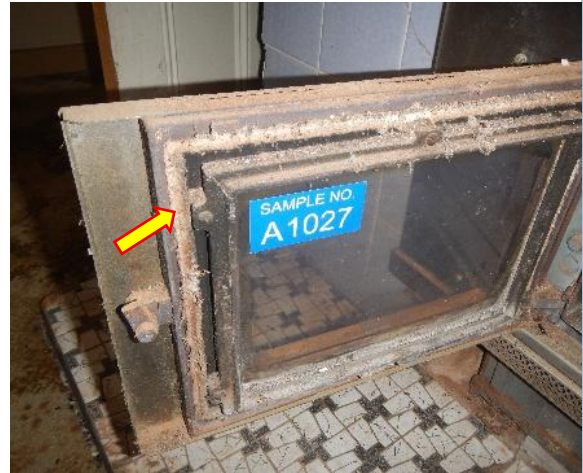
## 12. Central Living room, combustion heater, door seal

| Findings: | Poor condition. Friable. Not painted. Accessible.<br><b>Note:</b> Other internal components may contain asbestos.<br><b>Recommend remove.</b> |
| Action Rating: | <b>A1x</b> |

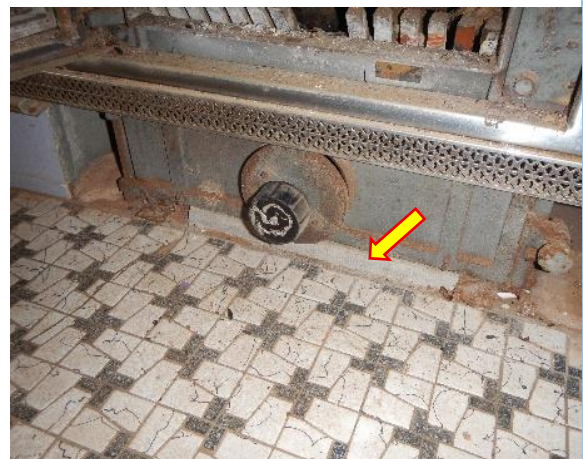
## 13. Central Living room, combustion heater, base infill

| Findings: | Good condition. Non-friable. Not painted. Accessible.<br><b>Recommend remove.</b> |
| Action Rating: | <b>A2x</b> |

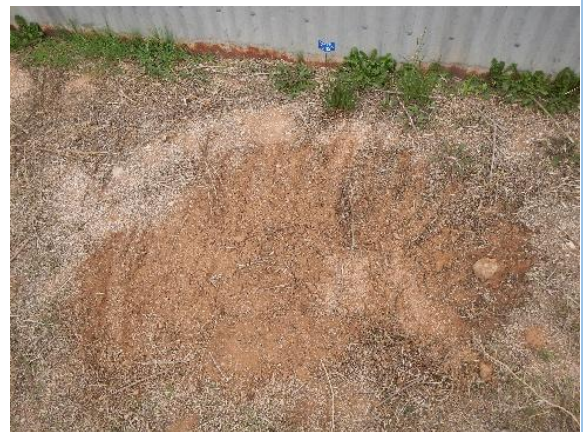
*After - Subsequently the area was raked and checked for other possible fragments – no asbestos was visible*

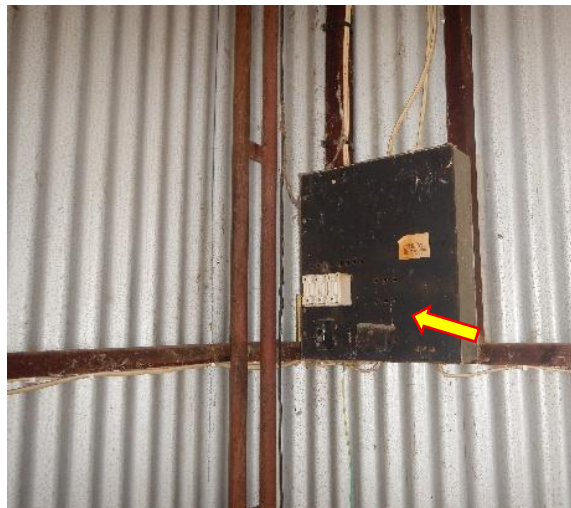
| Findings: | <p>Good condition. Non-friable. Painted. Accessible.</p> <p><b>The building is due for demolition.</b></p> <p><b>Recommend remove prior to demolition.</b></p> |

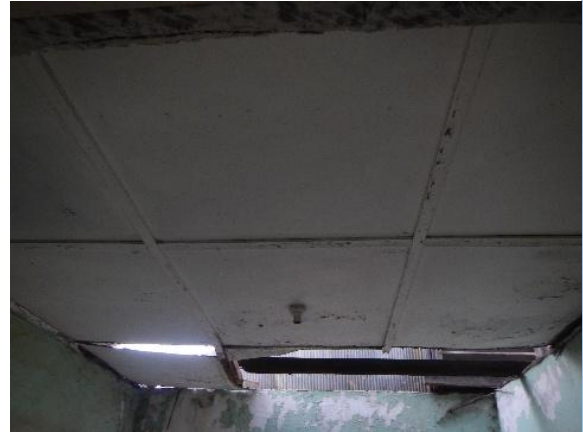
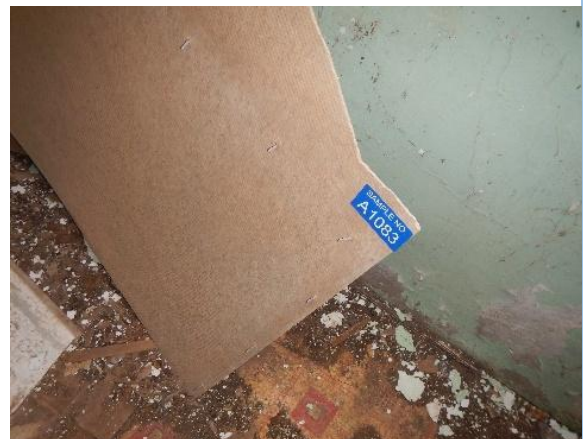
### 20. Main structure ceilings, Linings and debris on ground

| Findings: | Poor condition. Non-friable. Not painted. Accessible.<br><br><b>The building is due for demolition.</b><br><b>Recommend remove prior to demolition.</b> |

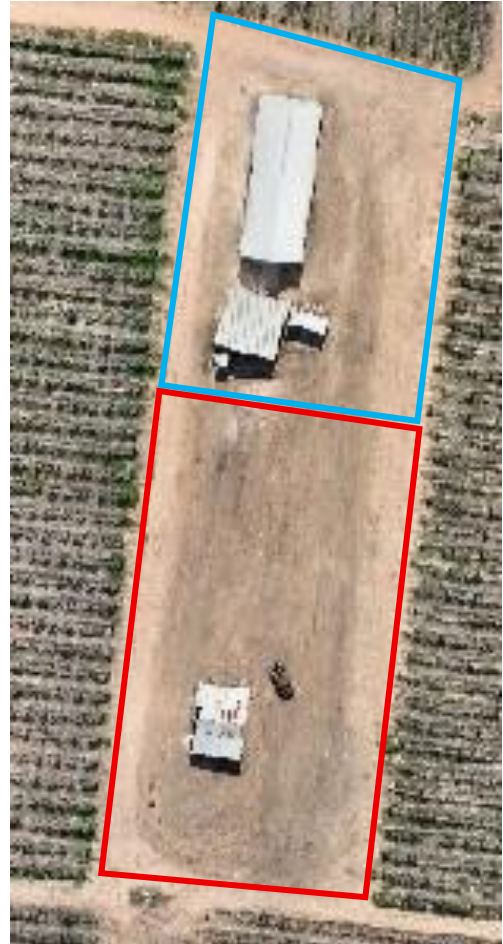
**Recommend a remediation action plan is developed for these two marked areas.**

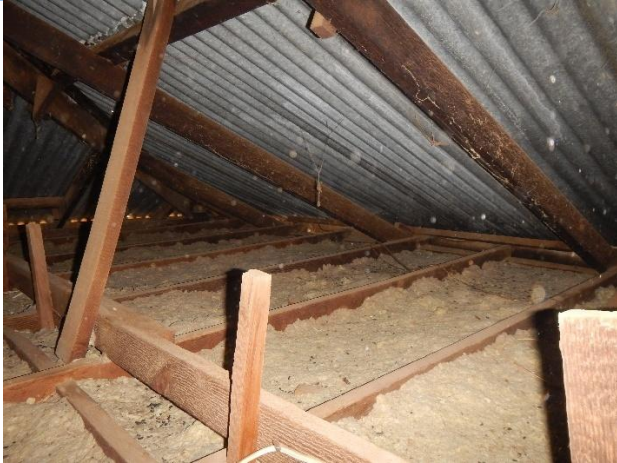
Throughout the main roof space, SMF as insulation loose on ceilings.

*Example: Ceiling insulation over ceilings to main roof of Residence*

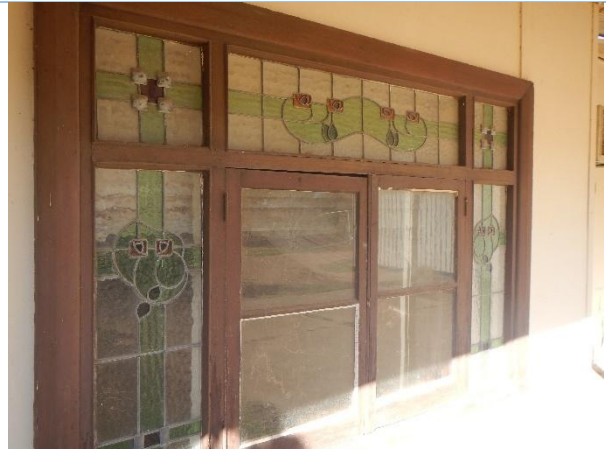
Example: Residence, External – Leadlight windows

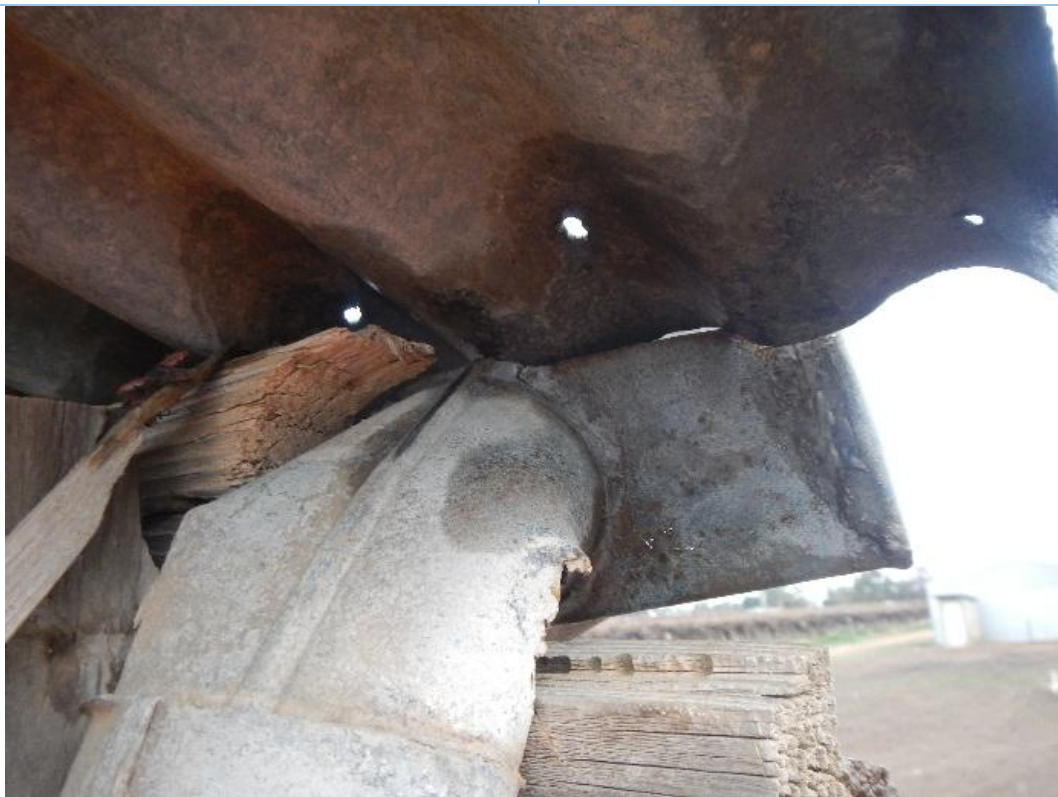
Example: Old Pickers' Quarters, External – solder to gutters/downpipes

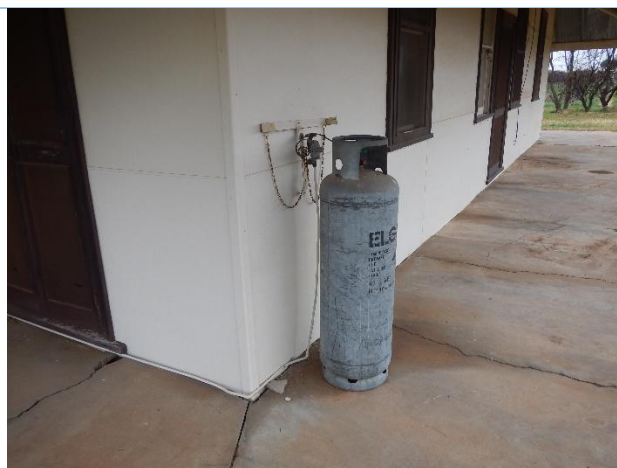
A 45kg propane gas bottle was noted at the southern side of the Residence

Example: Residence, 45kg gas bottle

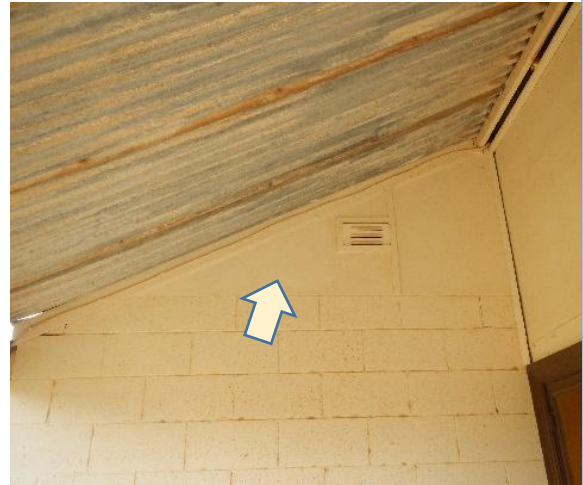
| Findings: | Good condition. Non-friable. Painted.<br>Limited access.<br><b>The building is due for demolition.</b><br><b>Recommend remove prior to demolition.</b> |
| Action Rating: | <b>A3x</b> |

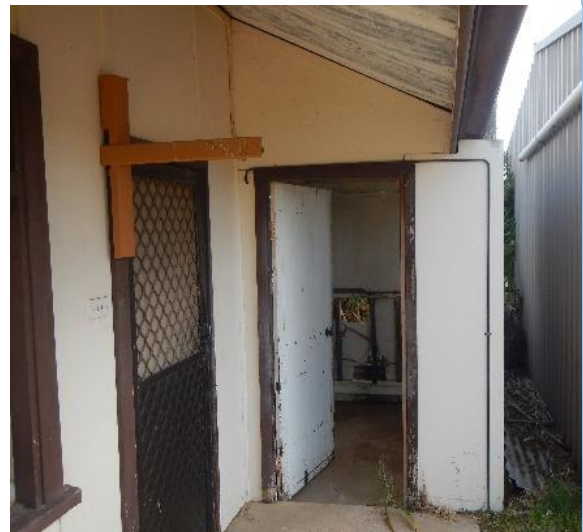
## 6. West extension, northern entry surround, cladding/infill

| Findings: | Medium condition. Non-friable. Painted.<br>Accessible.<br><b>The building is due for demolition.</b><br><b>Recommend remove prior to demolition.</b> |
| Action Rating: | <b>A2x</b> |

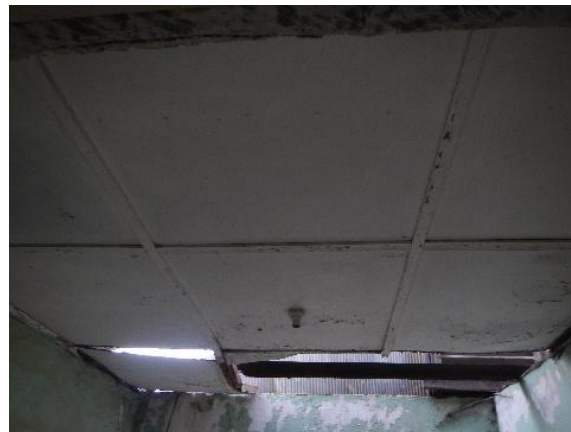
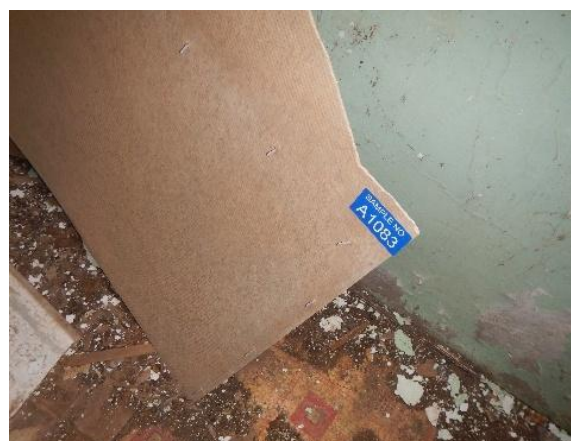
| Findings: | Poor condition. Non-friable. Not painted. Accessible.<br><br><b>The building is due for demolition.</b><br><b>Recommend remove prior to demolition.</b> |

**A1x**

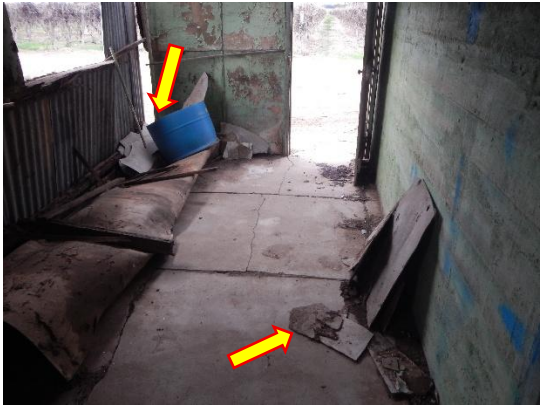
22.Southern Lean-to, stored debris on ground

| Result: | Chrysotile asbestos detected |
| Findings: | Poor condition. Non-friable. Not painted.<br>Accessible.<br><br><b>The building is due for demolition.</b><br><b>Recommend remove prior to demolition.</b> |

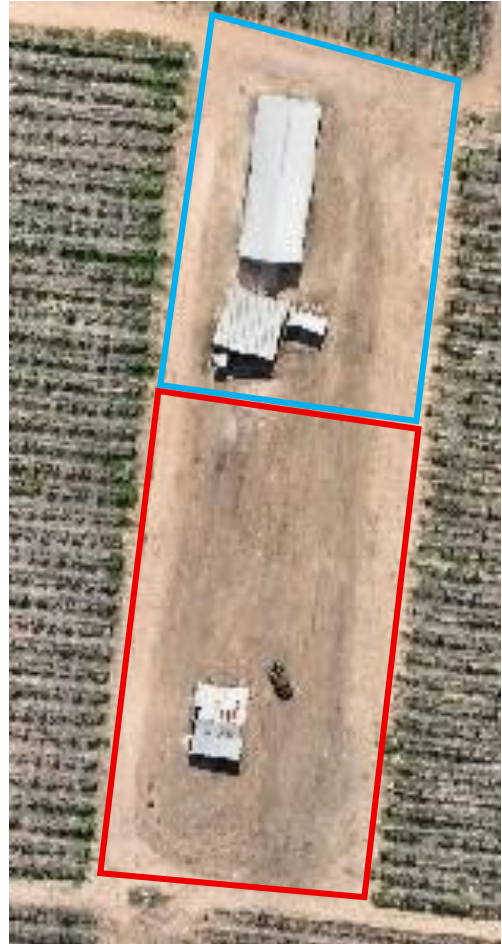
| Findings: | <p>During this survey, an emu pick of the surface was conducted, collecting 11kg of fibrous cement fragments.</p> <p>Based on the site finds to date the remaining soil may be lightly contaminated or impacted with hidden fibrous cement debris but only at a shallow depth down to between 100mm to both the northern section outlined in blue, and approximately down to 50mm to 75mm deep to the southern section outlined in red.</p> <p><b>Recommend a remediation action plan is developed for these two marked areas.</b></p> |

A2

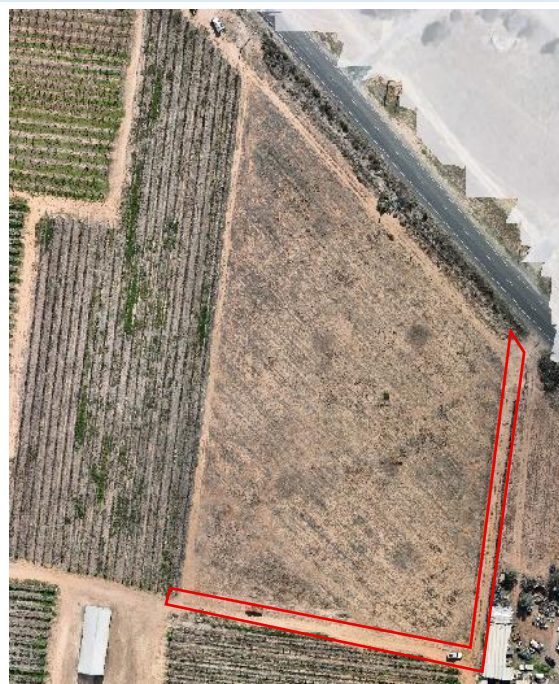
## 24. Five acre division, south and east tracks, debris on surface

| Findings: | <p>During this survey, an emu pick of the track's surface was conducted, collecting 0.5kg of fibrous cement fragments from the track /roadway outlined in red.</p> <p><b>Recommend a remediation action plan is developed for the marked area.</b></p> |
| Action Rating: | <div style="background-color: #FFD700; border-radius: 50%; width: 40px; height: 40px; display: flex; align-items: center; justify-content: center; margin: 0 auto;"> <span style="color: #000; font-weight: bold;">A2</span> </div> |
